MARINE TRANSPORTATION SAFETY INVESTIGATION REPORT M22P0259

CAPSIZING AND SUBSEQUENT SINKING

Passenger vessel *Island Bay*
Carpenter Bay, Haida Gwaii, British Columbia
10 September 2022

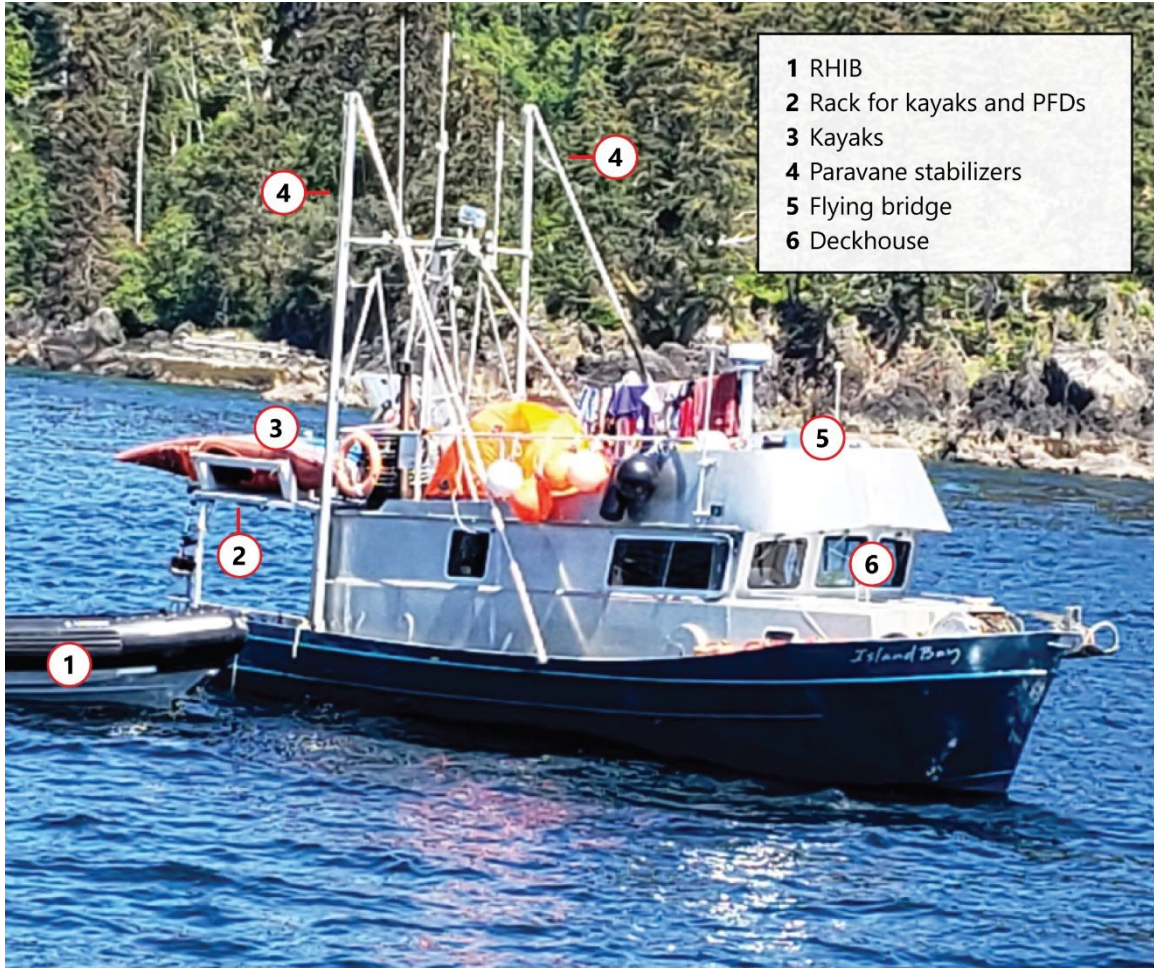
Figure 1. A picture of the *Island Bay* showing the rigid-hulled inflatable boat, rack for kayaks and personal flotation devices, kayaks, paravane stabilizers, flying bridge, and deckhouse (Source: Royal Canadian Mounted Police, with TSB annotations)

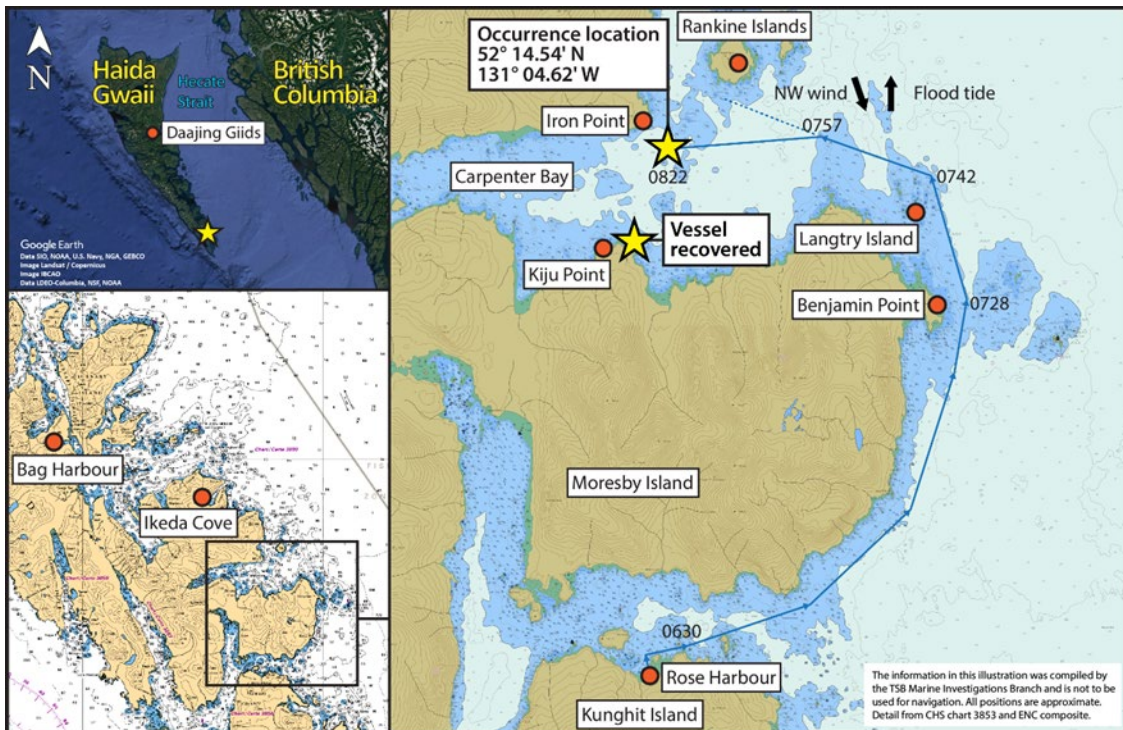
Figure 2. Vessel track and occurrence location (Source of main image: Canadian Hydrographic Service electronic navigation chart composite, with TSB annotations. Source of inset image 1: Google Maps, with TSB annotations. Source of inset image 2: Canadian Hydrographic Service chart 3853, with TSB annotations)

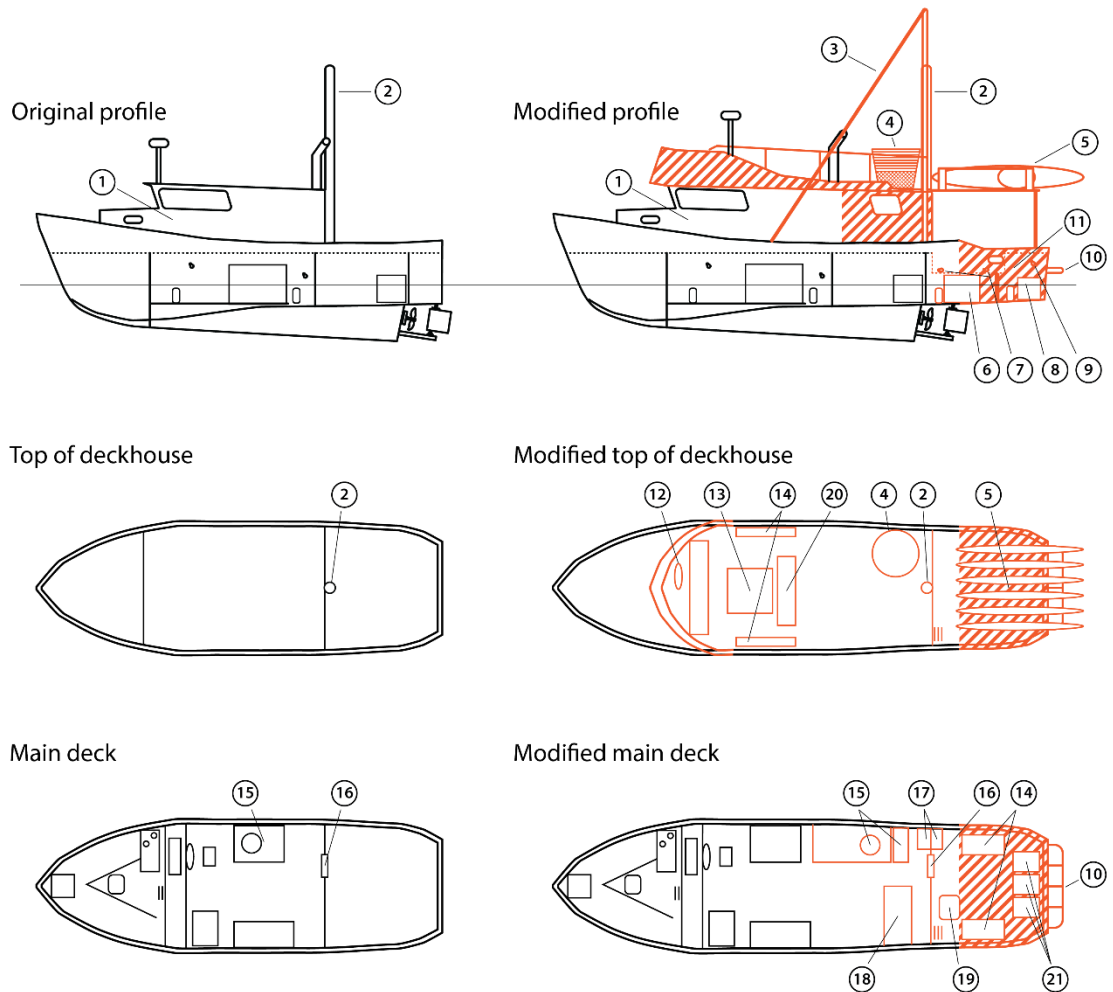
- The overall length was increased to 12.58 m, with a hull extension at the stern of 1.85 m, while the beam remained the same. This extension increased the vessel's gross tonnage.
- The vessel's original deckhouse was replaced and extended.
- Three non-watertight hatches were installed to provide access to the added lazarette.
- The galley's original watertight door was replaced with a non-watertight door.
- The top of the deckhouse was converted into a flying bridge.
- Roll damping paravane stabilizers and associated rigging were installed.
- Six aluminum storage boxes were added throughout the vessel.
- A 0.5 m by 2.7 m aluminum swim grid was added.
- A kayak storage rack was added to the main deck, with kayaks sitting level with the top of the deckhouse.

The vessel changed ownership in 2001 and 2017, and in both cases the new owners were not aware of the extent of past modifications to the vessel's original design. The *Island Bay* had never undergone a full stability assessment, nor was it required to by regulation.²⁹

Figure 5. Diagram comparing the *Island Bay*'s original design with its design after modifications (Source: TSB)

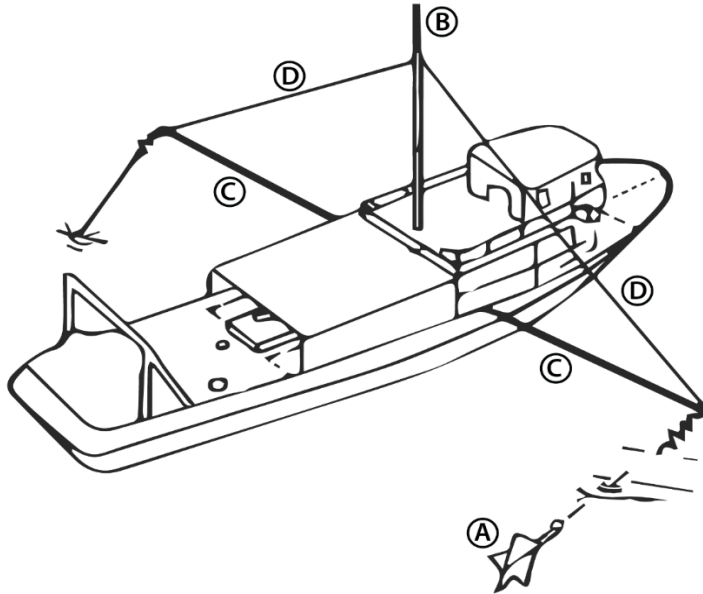
Figure 6. Illustration of paravane stabilizers (Source: TSB)

The *Island Bay* was known to roll slowly and took time to return to an upright position. When its paravane stabilizers were deployed on a windy day, the vessel steadily heeled to one side.

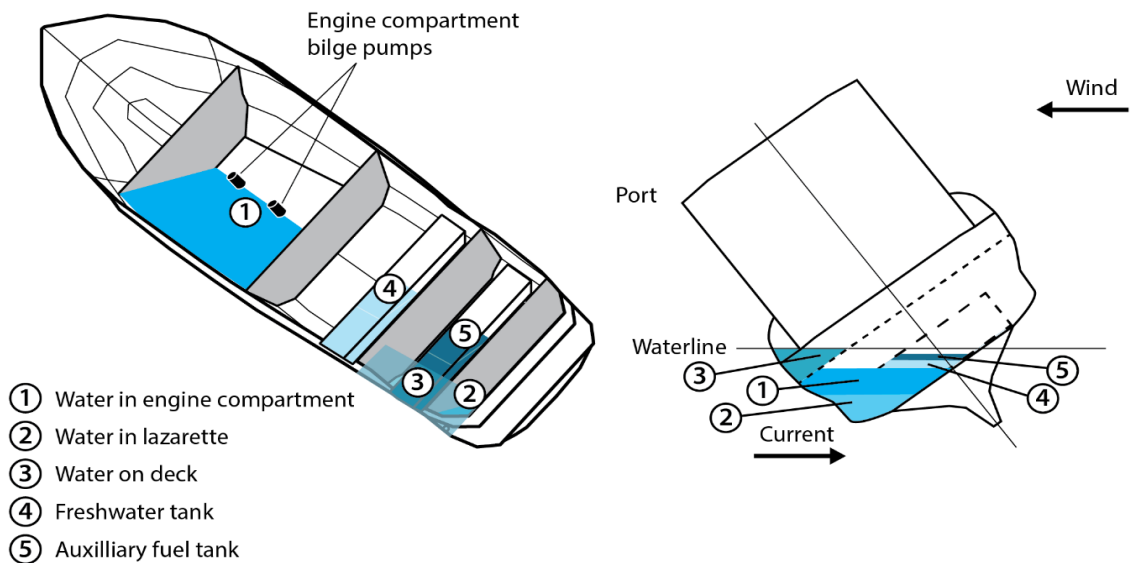
Figure 7. Diagram illustrating water ingress on the *Island Bay* with a 37° angle of heel and list to port (Source: TSB)
