AIR TRANSPORTATION SAFETY INVESTIGATION REPORT A21P0107

COLLISION WITH WATER

Black Tusk Helicopter Inc.
Kaman Aerospace Corporation K-1200 (helicopter), C-FZVM
Killam Bay, British Columbia
04 October 2021

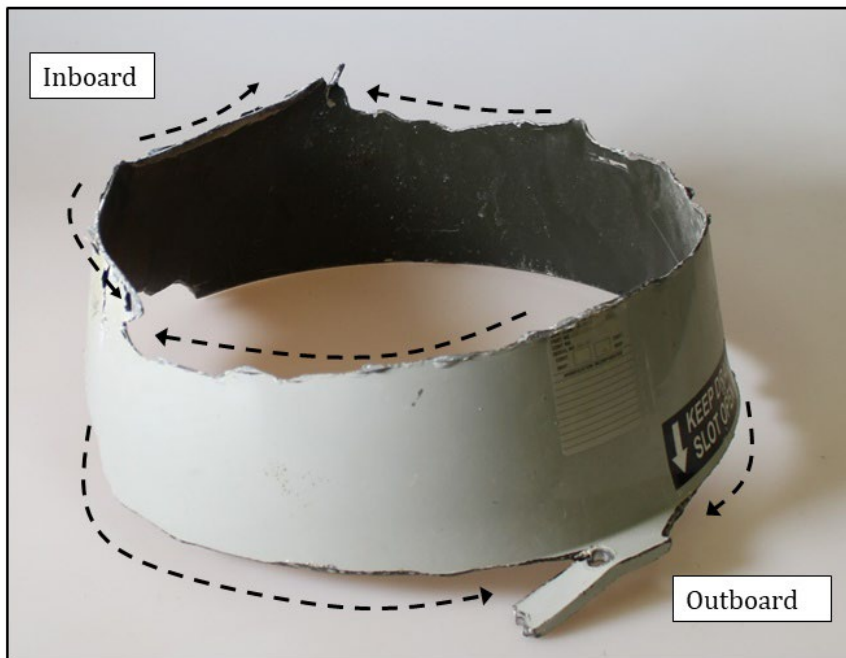
Figure 11. Lower separated piece from the left pylon showing the circumferential fractures and associated direction of propagation on the bottom of the pylon and 5 inches above the base of the pylon (Source: TSB)

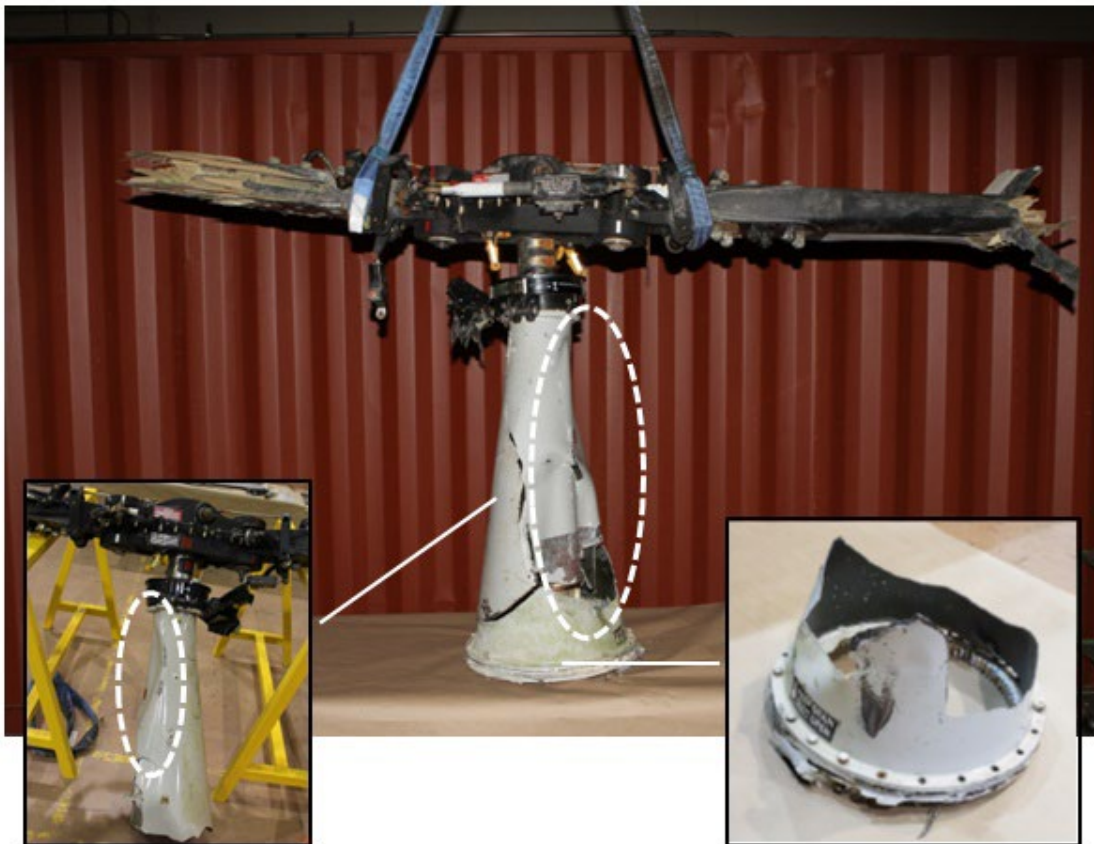
transmission. The 2 pylon pieces had been separated from each other by an inboard transverse fracture that propagated outboard, with half of the inboard fracture exhibiting a 45° shear lip that is consistent with tensile failure in the vertical direction. In addition, the outboard surface of the pylon exhibited compressive buckling due to compression in the vertical direction. Combined, the right-pylon damage characteristics are consistent with the pylon being bent outboard, causing the inboard fracture in tension and the outboard buckling in compression.

Figure 12. Right-rotor pylon with the hub and blade roots indicating the 2 broken pieces of the pylon and highlighting the compressive buckling on the outboard side (Source: TSB)

The tie bar connecting the 2 pylons showed compressive buckling and was fractured because of compression in its longitudinal direction. This is consistent with the left pylon being displaced inwardly toward the right pylon before the right pylon failed in the outboard direction.

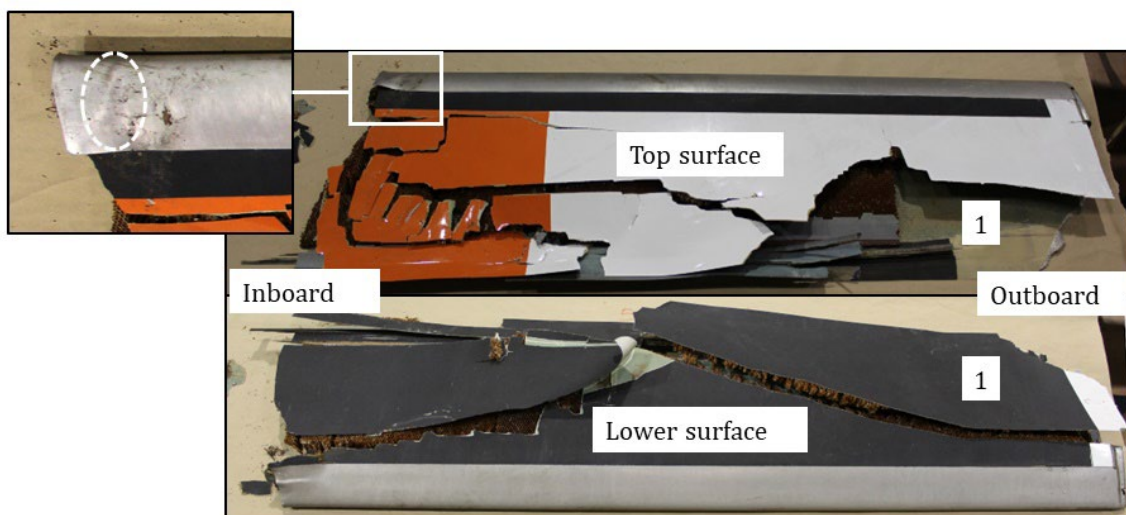
Figure 13. Tip of main rotor blade 0517A and of the lower skin piece that is labelled 1, with leading-edge torsional damage highlighted (Source: TSB)

The trailing-edge bond joint had fractured and opened up completely. Examination of the fracture surface on the separated lower-skin piece indicated there were 2 failure modes:

1. interlaminar²⁵ fracture between the fibreglass lower skin and carbon-fibre layer at the trailing-edge bond joint; and
2. intralaminar^{26,27} fracture within the carbon-composite trailing-edge strip.

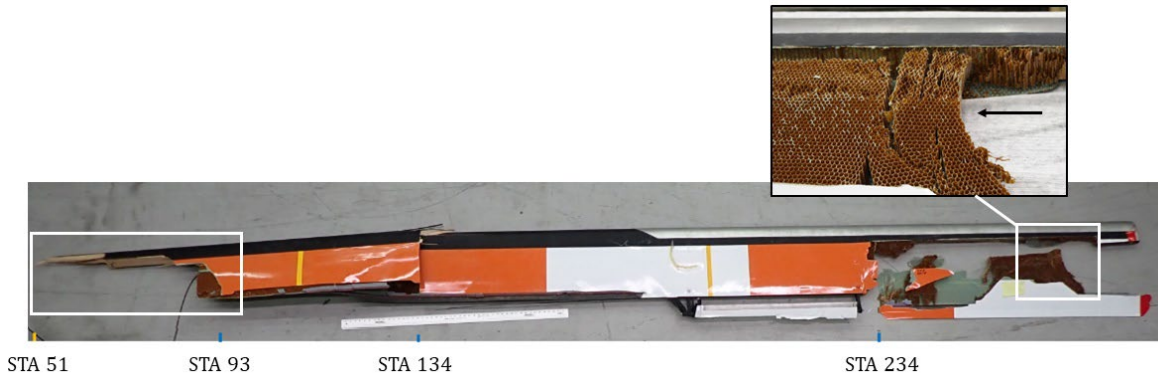
Figure 14. Main rotor blade 0517B highlighting the toothpick shape of the wood spar failure at the blade root and the longitudinal compression of the honeycomb core at the blade tip (Source: TSB)

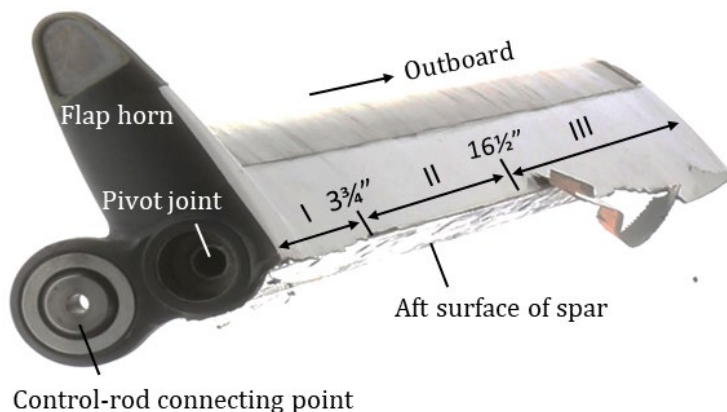
found that the fracture of the bond joint between the inboard closeout and the servo flap afterbody on main rotor blade 0517B likely initiated a fatigue crack in the servo flap skin, between the D-spar and the afterbody, that progressed until the servo flap afterbody separated in flight. If the quality of the bond joint between the inboard closeout and the servo flap afterbody of Kaman K-1200 main rotor blades is inconsistent, the structural integrity of the servo flap can be compromised, leading to a risk that the servo flap will be unable to withstand normal aerodynamic loads.

Of the recovered servo flaps, the flap from rotor blade 0517B was the only one whose afterbody completely separated from the D-spar. The flap afterbody was not recovered. Visual examination of the remaining servo flap upper and lower skins (consisting of the outer, inner, and forward channel plies) revealed that the spanwise fractures and failures had different features.

Figure 15. The servo flap from main-rotor blade 0517B showing the separation of the afterbody and the 3 zones of failure that each presented different fracture characteristics (Source: TSB)

In Zone I, the outer ply fractured approximately $\frac{1}{8}$ inch aft of the spar whereas the inner and channel plies of the upper skin fractured right where they meet with the spar. There was no indication that the forward channel ply peeled off from the aft surface of the spar. In Zone II, the fracture of both outer and inner plies of the upper skin occurred at the aft surface of the spar, and the forward channel ply had partially peeled off from the aft surface

of the spar. In Zone III, the fracture of the upper skin occurred approximately 1 inch aft of the spar, with secondary fractures going in opposite directions.

In addition, the Kaman Model K-1200 K-MAX Maintenance and Servicing Instructions were revised on 01 June 2023. The latest revision provides added instructions for the repair of chordwise paint cracks in the bond line of the servo flap inboard closeout. The instructions note that the flap must be removed from service if the crack extends beyond the paint layer.

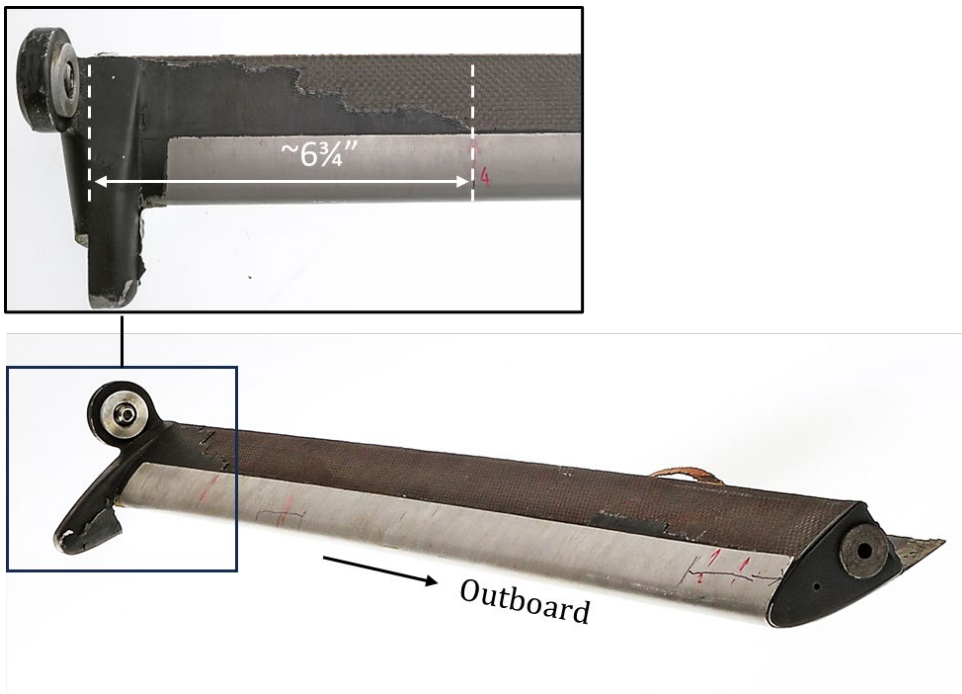
Figure 16. The lower surface of the servo flap of rotor blade 0517B highlighting the peeling pattern of the lower skin from the spar at the inboard end (Source: TSB)

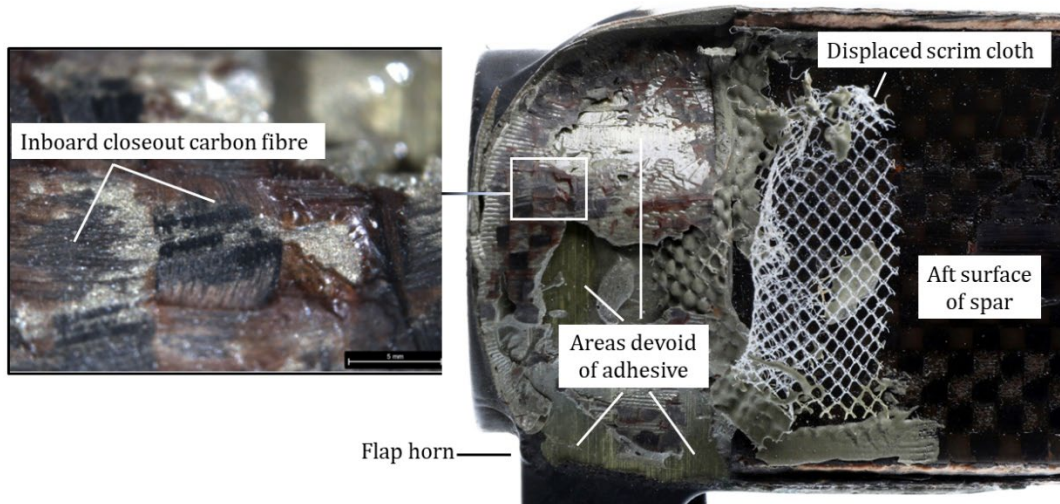
SEM examination of the upper skin at the inboard end of the servo flap revealed evidence of extensive rubbing of the fracture surfaces as follows:

- A pile of compacted fine powder and rounded fibre ends in the outer ply
- Fractured fibre ends worn down and barely visible in the forward channel ply
- Rolled matrix cusps, which are associated with fatigue failure of polymer matrix composites²⁹

Figure 17. The aft view of the servo flap of rotor blade 0517B showing the bonding surface of the inboard closeout and the convex surface of the flap horn, with the inboard closeout carbon fibre remnants and displaced scrim cloth highlighted (Source: TSB)

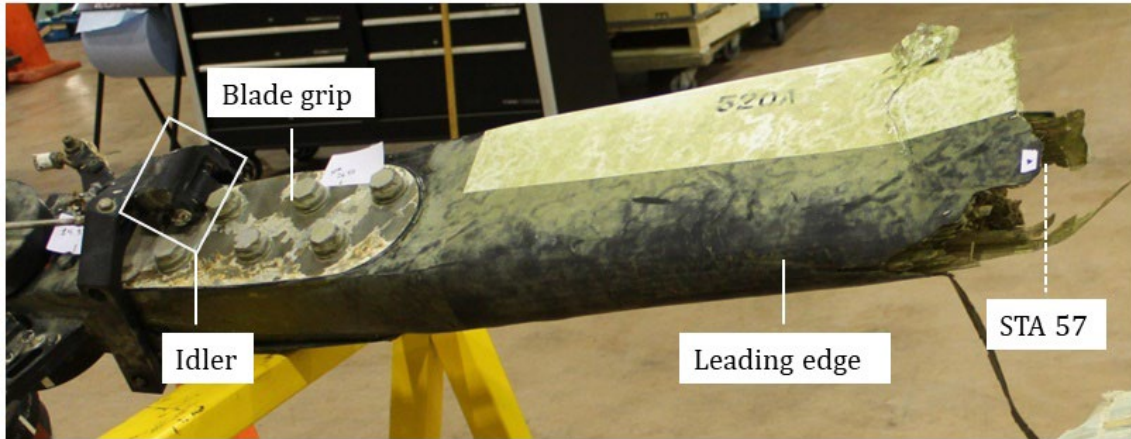
The root section of rotor blade 0520A remained attached to the grip of the main rotor blade, and the blade separated at STA 57. No impact sign was observed on the grip, the root, or the leading-edge guard of the blade (Figure 18).

Figure 18. Main rotor blade 0520A showing the connection of the blade root to the blade grip and rotor hub with no evidence of impact damage on the blade until the separation at STA 57 (Source: TSB)

The upper surface of the steel leading-edge guard was buckled from compression in the vicinity of the servo flap, and wood fibres were pushed into the mating fractures further inboard on the blade spar, which indicates the blade was bent upward during the failure sequence.

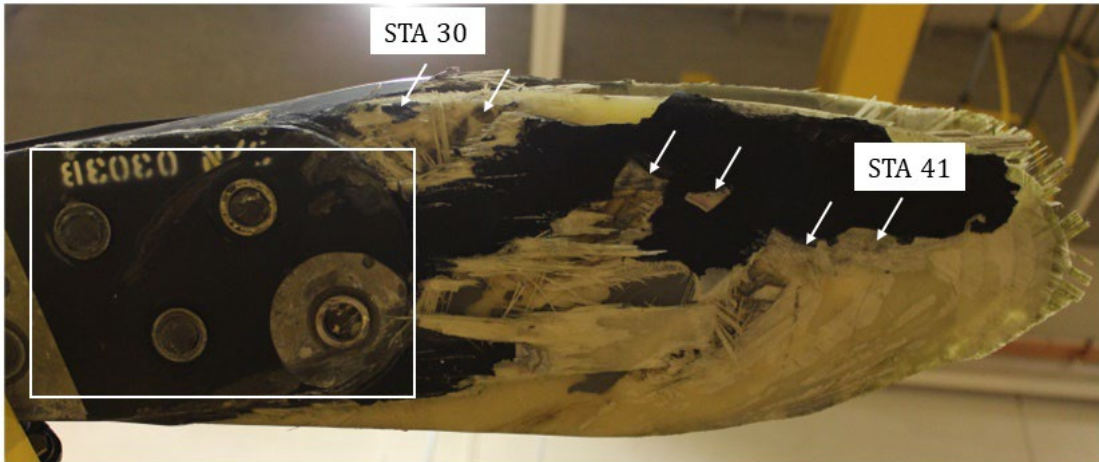
Figure 19. The lower surface and root of main rotor blade 0520B highlighting the sheared bolt ends and the 6 points of impact found between station 30 and station 41 (Source: TSB)

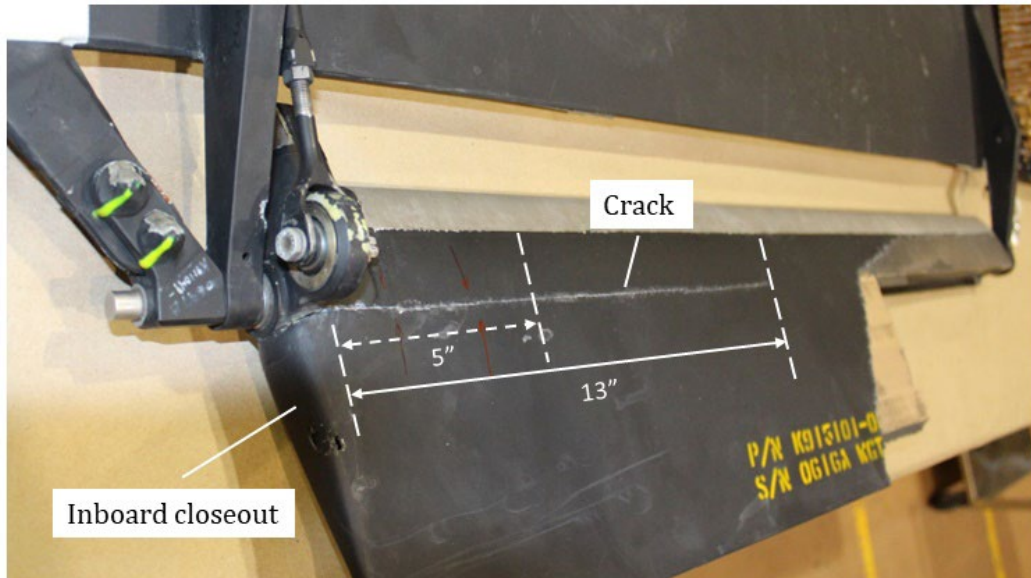
Figure 20. The lower surface of the servo flap from main rotor blade 0520B with the crack in the inboard closeout continuing through to the lower skin, with the first 5 inches being through all the lower-skin plies and the remaining 8 inches through only the lower-skin outer ply (Source: TSB)

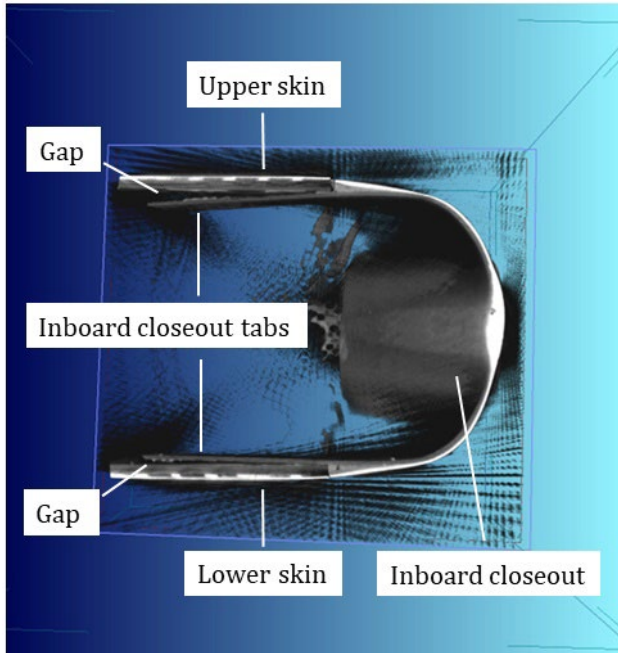
Just like for blade 0520A's servo flap, a CT scan was performed on the bond joint of the inboard closeout of blade 0520B's flap. It revealed a similar gap between the 2 tabs of the closeout and the respective mating inner surfaces of the skins (Figure 21).

Figure 21. CT scan image of the servo flap inboard closeout from main rotor blade 0520B, looking from the trailing edge toward the leading edge, showing the gaps between the inboard closeout tabs and the mating inner surfaces of the skins (Source: TSB)

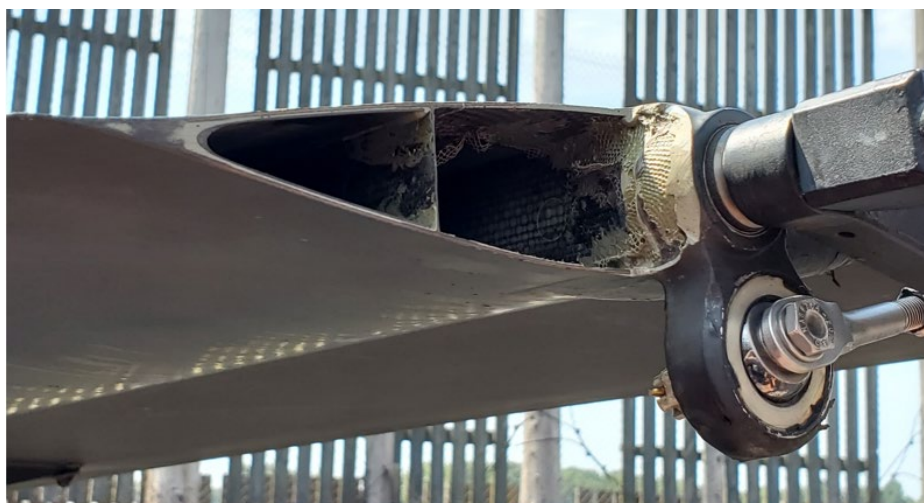
Figure 22. The servo flap on the main rotor blade used for the whirl test showing the inboard closeout removed from the servo flap afterbody (Source: TSB)
