AIR TRANSPORTATION SAFETY INVESTIGATION REPORT A24P0016

RUNWAY OVERRUN

Summit Air Ltd.
British Aerospace Avro 146 Series RJ100, C-FRJY
Prince Rupert Airport (CYPR), British Columbia
07 February 2024

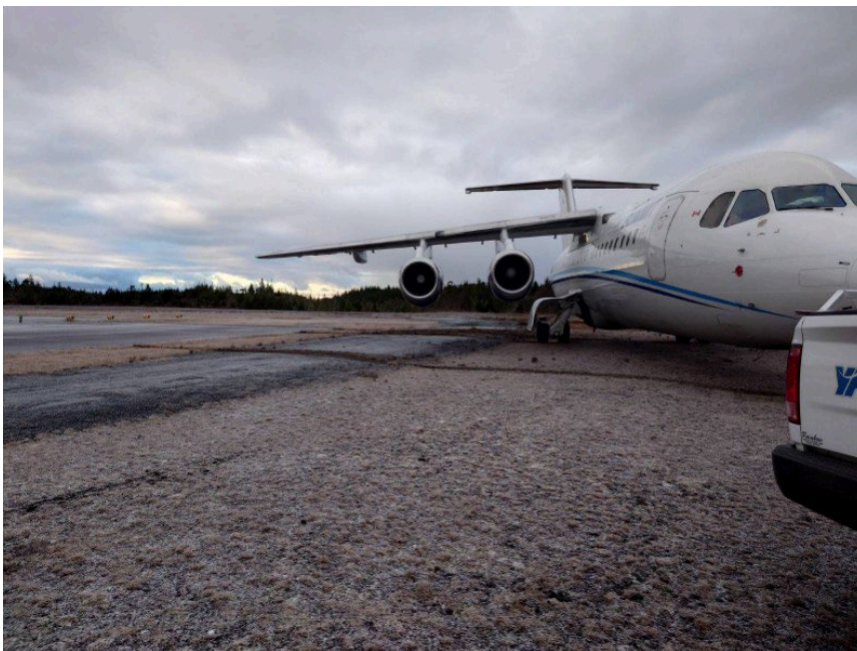
The wing spoilers automatically deployed upon touchdown, and the flight crew members then applied the brakes; however, they did not feel any deceleration from the brakes. The flight crew had the ability to switch between 2 independent hydraulic systems for braking and subsequently switched to the 2nd hydraulic system, with no change in braking effectiveness. As the aircraft started to lose speed and neared the end of the runway with little appreciable deceleration from the application of brakes with either hydraulic system, the flight crew activated the emergency brake system in a final attempt to slow the aircraft. The flight crew also initiated the shutdown of engines No. 1 and No. 4 in an attempt to reduce thrust. As the aircraft was approaching the end of the runway, the captain tried to steer it using the nose wheel tiller. The aircraft started to slide sideways, and it subsequently contacted 2 runway end lights and slid beyond the end of the runway by approximately 30 m (Figure 1).

Figure 1. The occurrence aircraft's final position after the overrun, 30 m beyond the end of the runway (Source: Third party, with permission)

One of the pilots exited the aircraft to assess the damage, visually noting scuffed tires and 2 damaged runway end lights. He also noted, while performing an aircraft walkaround, that the runway was glazed with a light coating of ice and was very slippery.

Following the occurrence, an RSC assessment was conducted, and a report was issued at 0855, approximately 1 hour after the occurrence. The report indicated that the Canadian Runway Friction Index⁶ measurements for all 3 thirds of Runway 31 at a temperature of -1°C were 0.19, 0.23, and 0.21. These small numbers represent low braking coefficients of friction. In contrast, numbers from approximately 0.8 and above indicate the braking coefficients associated with dry runways.

In March 2024, Summit Air Ltd. issued 3 amendments to its *Summit Air Standard Operating Procedures Avro-RJ* and 1 amendment to its *Summit Air Flight Dispatch Manual*. Two of these amendments pertain specifically to the coordination that is necessary between the pilot-in-command and dispatch when runway conditions are a concern, notably when runway reports⁸ are unavailable.

According to 3 of the amendments, when the ambient temperature is colder than 5 °C, an aircraft can be dispatched, but it cannot initiate the approach and landing unless the flight crew has a runway report.^{9,10,11} These 3 amendments also explain that if the report is expired, the flight crew must check the historical weather for precipitation, high winds that could create large snow drifts, and temperatures falling from above to below 0 °C, which could allow ice or frost to form on the runway surface.^{12,13,14}
