AIR TRANSPORTATION SAFETY INVESTIGATION REPORT A23O0046

RUNWAY OVERRUN

Porter Airlines Inc.

De Havilland Aircraft of Canada Ltd. DHC-8-402, C-GLQB

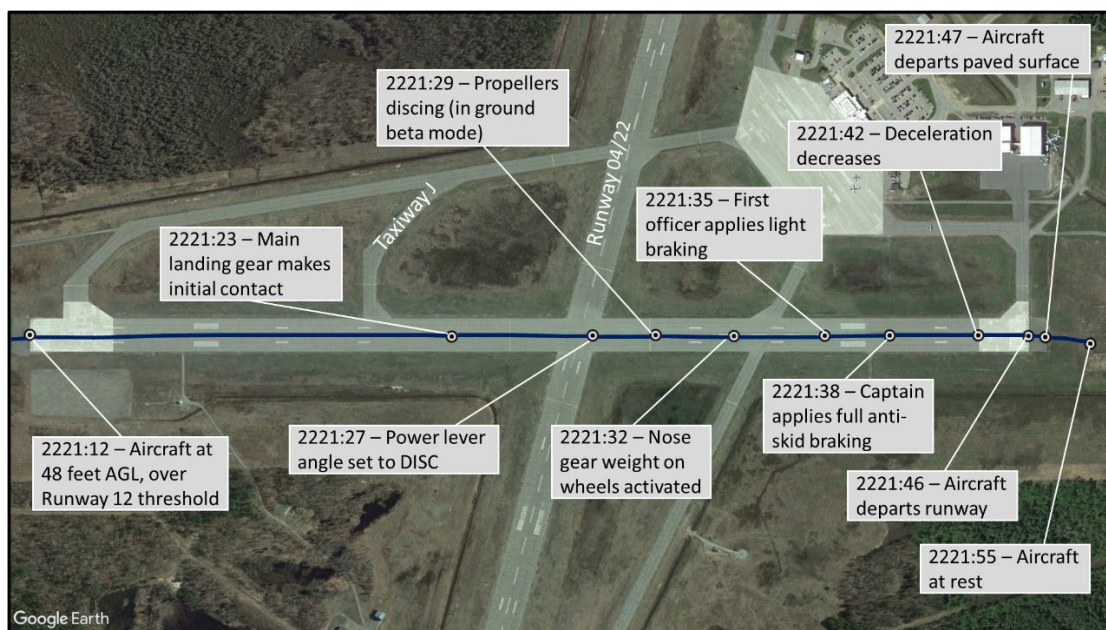
The PF then applied the brakes lightly and, moments later, the PM took over and applied full braking. When the brakes were fully applied, the aircraft was travelling at a ground speed of 78 knots, and the remaining distance to the end of the runway was 850 feet (Figure 1).

Figure 1. Landing sequence of the occurrence aircraft on Runway 12, based on data from the cockpit voice recorder and flight data recorder (Source: Google Earth, with TSB annotations)

The brakes did not perform as well as the flight crew had expected they would, and the wet runway felt slippery to the crew during braking. For the following 4 seconds of full anti-skid

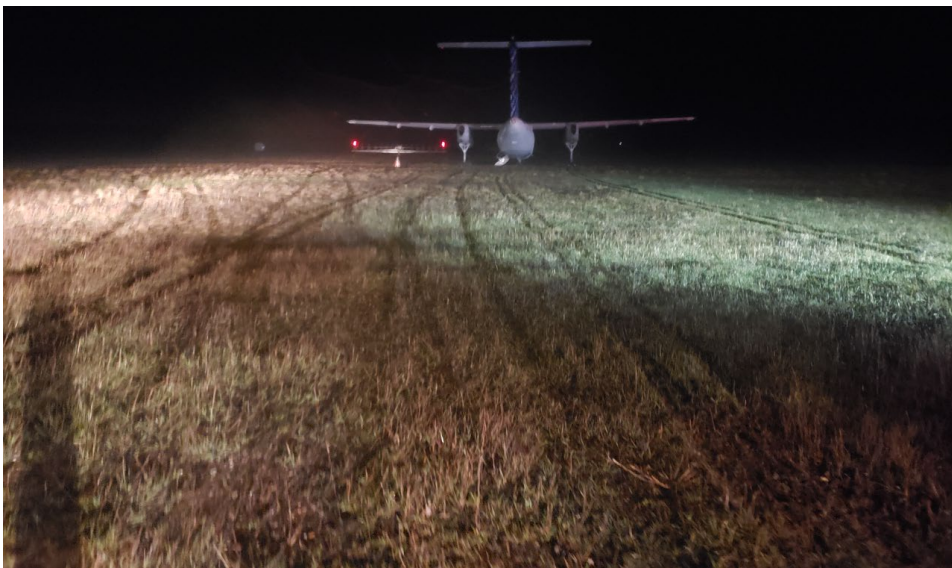
The aircraft departed the end of the runway at a ground speed of approximately 41 knots. It then passed the end of the paved surface at a speed of 35 knots. The captain steered to the right to avoid the approach lighting system, and the aircraft eventually came to a stop in the muddy grass approximately 350 feet beyond the end of the runway, or 250 feet beyond the end of the additional paved surface (Figure 2). There were no injuries. The aircraft was not damaged.

Figure 2. Occurrence aircraft after the runway overrun, photo taken from the end of the paved surface of Runway 12 (Source: Porter Airlines Inc.)

The aircraft was not damaged. However, an extensive amount of dirt was found around the landing gear system.

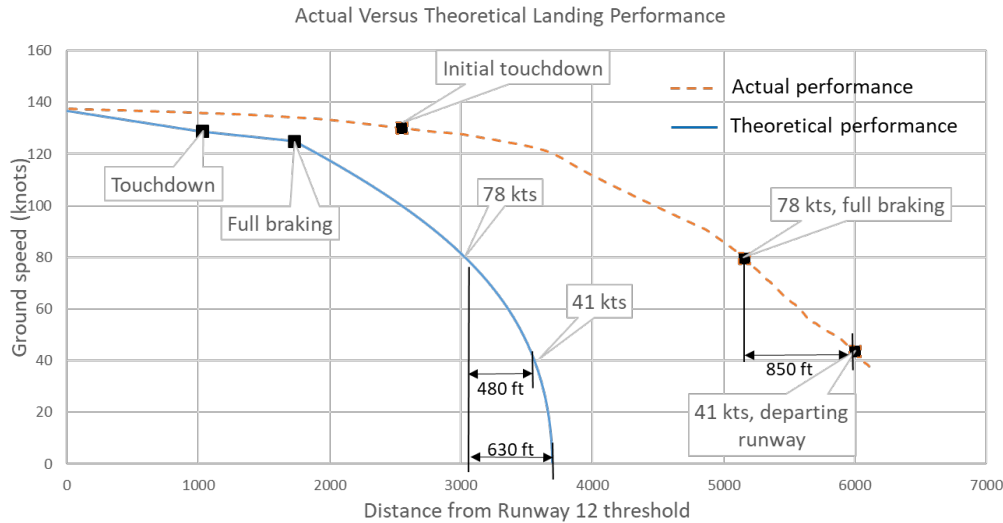
Figure 4. Graph showing the actual versus the theoretical landing performance (Source: TSB, based on data from the aircraft manufacturer)

The actual landing performance data indicate the occurrence aircraft touched down 2500 feet from the runway threshold, and there was a delay in using the DISC setting and applying the brakes. The data indicate that the aircraft used about 850 feet of runway when decelerating from 78 to 41 knots. In comparison, the theoretical performance indicates that the aircraft should have used only 480 feet of runway and that 630 feet of runway should have been sufficient for the aircraft to fully stop from 78 knots. When the occurrence aircraft's speed was 78 knots, there was 850 feet of runway remaining. Therefore, despite the delays in lowering the nose and applying full braking, there should have been sufficient runway available for a DHC-8-402 with a fully serviceable braking system to stop.

The actual braking performance below ground speeds of 78 knots was also analyzed to assess anti-skid braking. It was determined that there was a significant disparity between the expected and actual braking performance. As ground speed decreases, the braking performance (i.e., rate of deceleration) should normally increase; however, in this case, decreased braking performance was observed. In addition, there was an abrupt decrease in the braking performance through 55 knots, which corresponds to the moment the aircraft was transitioning from the asphalt onto the concrete pavement.

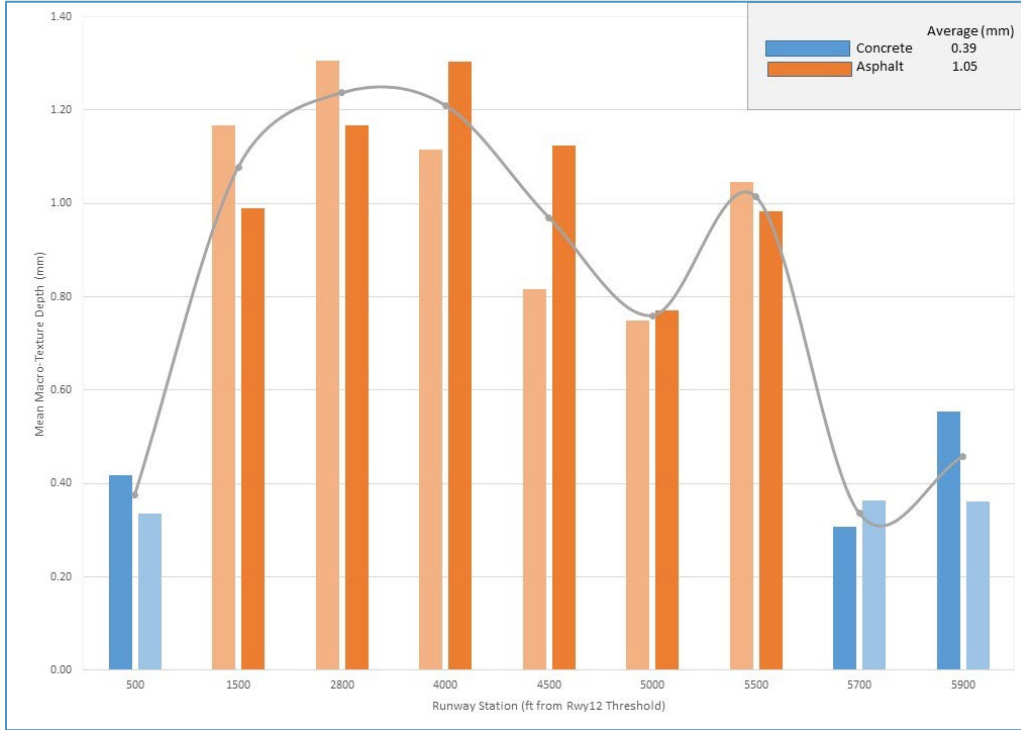
The macrotexture test was conducted in accordance with ASTM International²² Standard ASTM-E965 (*Standard Test Method for Measuring Pavement Macrotexture Depth Using a Volumetric Technique*)²³ and shows a degradation in macrotexture when the surface transitions from asphalt to concrete (Appendix A, Figure A1). The final 300 feet of Runway 12 is concrete; there is an additional 100 feet of asphalt after the end of the runway. Therefore, 35% of the distance of the occurrence aircraft's friction-limited anti-skid braking was on the concrete surface.

Five days after the occurrence, the TSB laboratory conducted a survey of the surface microtexture and macrotexture of Runway 12 at CYAM. A general degradation in the surface microtexture was observed. The macrotexture survey also showed significantly low measurements on the concrete pavement of the last 300 feet of Runway 12 and on the asphalt pavement of the 100 feet of overrun. The aircraft's deceleration decreased from 0.29 to 0.16*g* when the aircraft moved from the asphalt portion of the runway to the concrete portion, indicating a degradation of the braking performance.

Figure A1. Results of the macrotexture tests using the ASTM-E965 standard test method

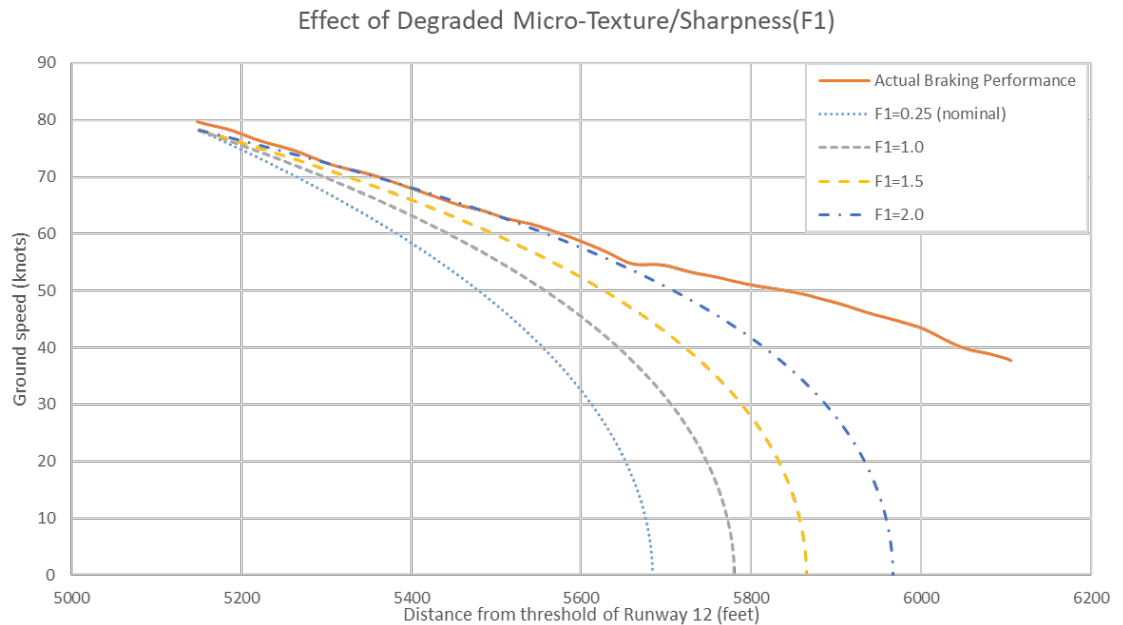
The TSB's braking performance calculations considered different microtexture values, from a sharpness factor of 0.25 (for nominal, new pavement) to a degraded sharpness factor of 2.0 (Appendix A, Figure A2). The theoretical landing performance presented in Section 1.6.3.4 *Braking performance* used a sharpness factor of 1.25. The investigation determined that even on an asphalt runway surface that has a degraded surface microtexture with a sharpness factor of 2.0, once a DHC-8-402 with a fully serviceable braking system applies full braking, it should be able to stop within the same runway

distance remaining at the time when the occurrence aircraft fully applied its brakes, which is 850 feet. However, the occurrence aircraft transitioned at 55 knots from asphalt to concrete where the macro- and microtextures were significantly degraded, resulting in reduced deceleration.

The theoretical landing performance considered different runway surface conditions (from a nominal, new surface to a moderately polished one) and varying "sharpness" factors of the asperities on the paved runway surface. The results indicate that regardless of the runway surface microtexture or macrotexture, the aircraft should have been theoretically able to stop within the runway distance available, even if it came very close to the limit. However, the degraded surface texture of the concrete portion of the runway and the asphalt overrun had an impact on braking performance.

Figure A2. Effect of degraded microtexture on landing performance
