AIR TRANSPORTATION SAFETY INVESTIGATION REPORT A24A0038

HARD LANDING AND AFT FUSELAGE STRIKE

Porter Airlines Inc.
Bombardier Inc. DHC-8-402, C-GLQP
Fredericton International Airport (CYFC), New Brunswick
28 June 2024

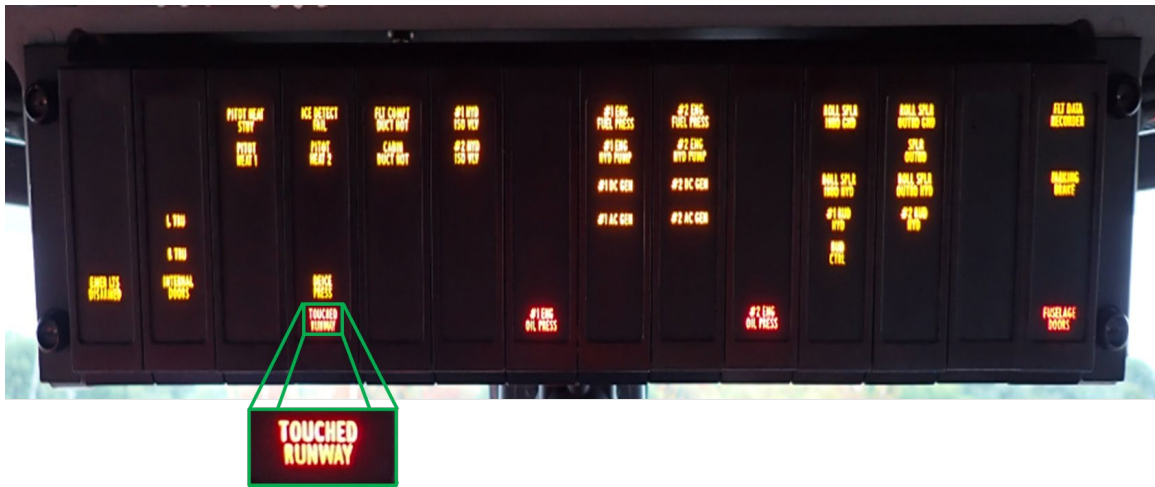
After the first touchdown, the TOUCHED RUNWAY warning light illuminated, indicating that a sensor near the tail section of the aircraft had been triggered by contact with the runway surface. In addition, the master warning light started flashing. During the climbout, the flight crew noticed the master warning and TOUCHED RUNWAY warning lights; however, they did not discuss the issue further at that time.

The red TOUCHED RUNWAY warning light (Figure 1) informs the flight crew that the lower aft fuselage structure of the aircraft came into contact with a hard surface. The illumination of the TOUCHED RUNWAY warning light requires an inspection of the aircraft by qualified maintenance personnel before further flight.

The TOUCHED RUNWAY warning light may be associated with possible structural damage to the aircraft. De Havilland Aircraft of Canada Limited recommends that, when circumstances permit, flight crews consider completing the landing rather than initiating a go-around when this light illuminates.

Figure 1. Red TOUCHED RUNWAY warning light, with close-up view in inset (Source of main image and inset: TSB)

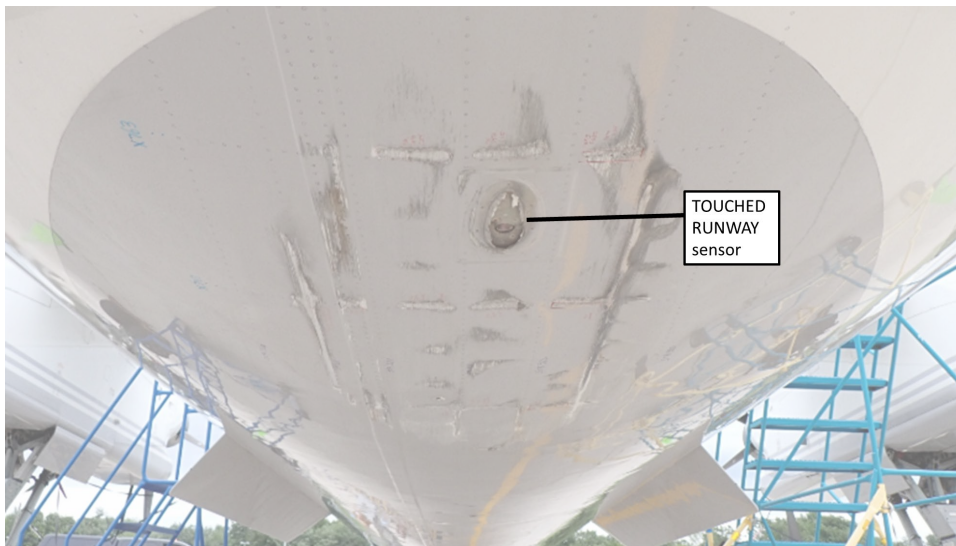
At 1359:30, when the aircraft was 267 feet above touchdown zone elevation (TDZE), the PF disconnected the autopilot and began to fly the approach manually. When the aircraft was 135 feet above the TDZE, the aircraft was travelling at 126 KIAS, the descent rate was 700 fpm, and the pitch was 3.2°. When the aircraft was 20 feet above the TDZE, it was travelling at 124 KIAS, the descent rate had increased to 980 fpm, and the pitch was 1.1°. The headwind component decreased from 5.5 knots to 0.5 knots within 3 seconds, increasing the maximum descent rate to 1050 fpm. In response, over a period of 2 seconds, the PF increased the pitch from 1.1° to 6.8°. The power was consistently at 14% torque.

At 1359:53, the right main landing gear contacted the runway, followed by the left main landing gear. A vertical acceleration of 3.51 *g* was recorded. After the initial contact with the runway, the aircraft bounced, and the flight crew initiated a go-around in accordance with Porter Airlines Inc.'s standard operating procedures (SOPs).³ Two seconds later, a second runway contact occurred with a recorded vertical acceleration of 1.42 *g*.

In addition, at the time of landing, there was a headwind component of 5.5 knots, which decreased to 0.5 knots within 3 seconds. This rapid reduction in headwind most likely resulted in a decreased performance shear. Decreased performance shear

The occurrence aircraft sustained substantial damage to the fuselage and main landing gear as a result of the first landing attempt. The vertical g exceeded the main landing gear tolerance of $2.8g$; therefore, the gear had to be replaced. The TOUCHED RUNWAY sensor was sheared off from the fuselage upon impact with the runway surface (Figure 2).

Figure 2. Damage to the occurrence aircraft's TOUCHED RUNWAY sensor (Source: TSB)

In December 2024, Porter Airlines Inc. published a new revision of its SOPs. The revision includes a new landing techniques section, which states that during the recovery after a bounced landing, pilots are to “apply full power and maintain a pitch attitude of no more than 6 degrees until the aircraft has reached an altitude where a tail strike is not possible, then continue with the normal go-around.”⁹
