RAIL TRANSPORTATION SAFETY INVESTIGATION REPORT R22C0065

MAIN-TRACK DERAILMENT

Canadian Pacific Railway Company
Train 301-222
Mile 97.4, Brooks Subdivision
Near Bassano, Alberta
13 July 2022

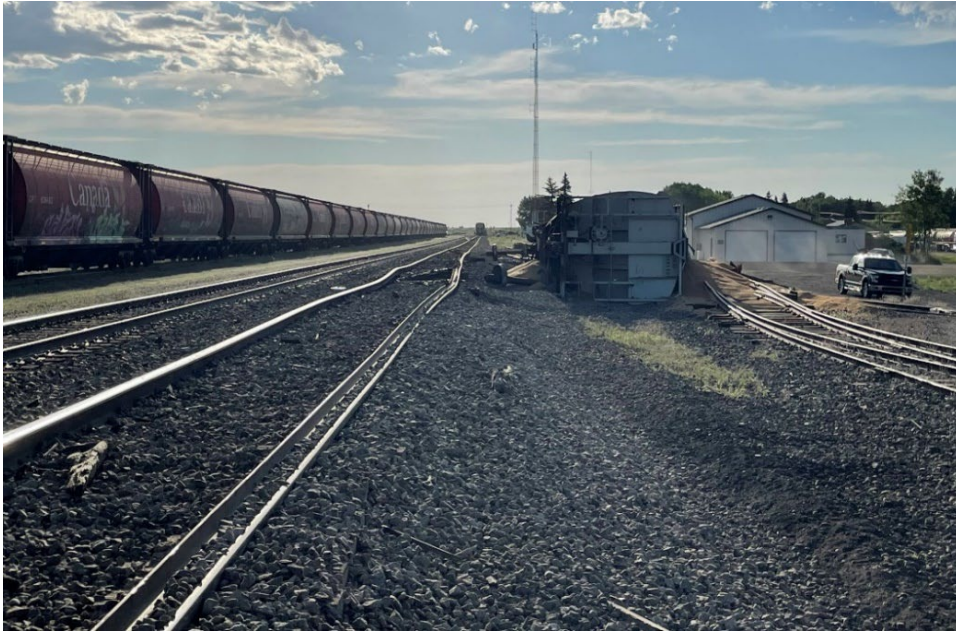
The 1st car to derail (SOO 115291, the 9th car behind the 2 mid-train remote locomotives, in position 116) was upright and remained coupled to the head-end portion of the train. There was a gap of approximately 1500 feet to the next car (SOO 115130, in position 117), which was on its side to the north of the track and separated from the other cars (Figure 2). In the vicinity of this car, the south rail was upright but kinked; the north rail was rolled to the north.

Figure 2. View from the north side of the main track, looking west, showing the second derailed car rolled on its side and, further in the distance, the first derailed car, which remained upright and coupled to the head end of the train (Source: Canadian Pacific)

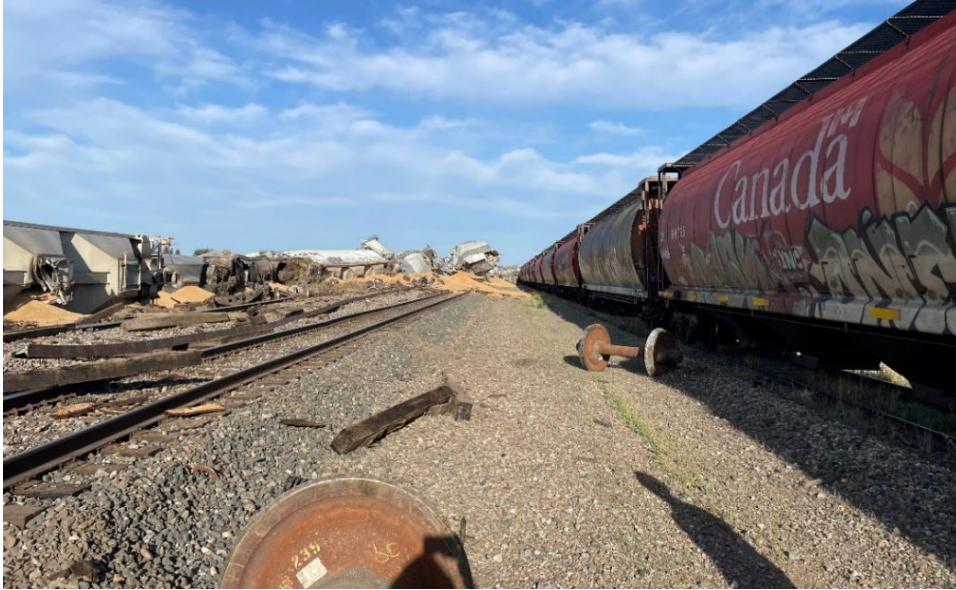
Figure 3. View from the south side of the main track, looking east, showing several pile-ups of derailed cars (Source: Canadian Pacific)

Some of the cars in the 2nd pile-up had come to rest against a cut of cars in the adjacent yard track and were damaged.

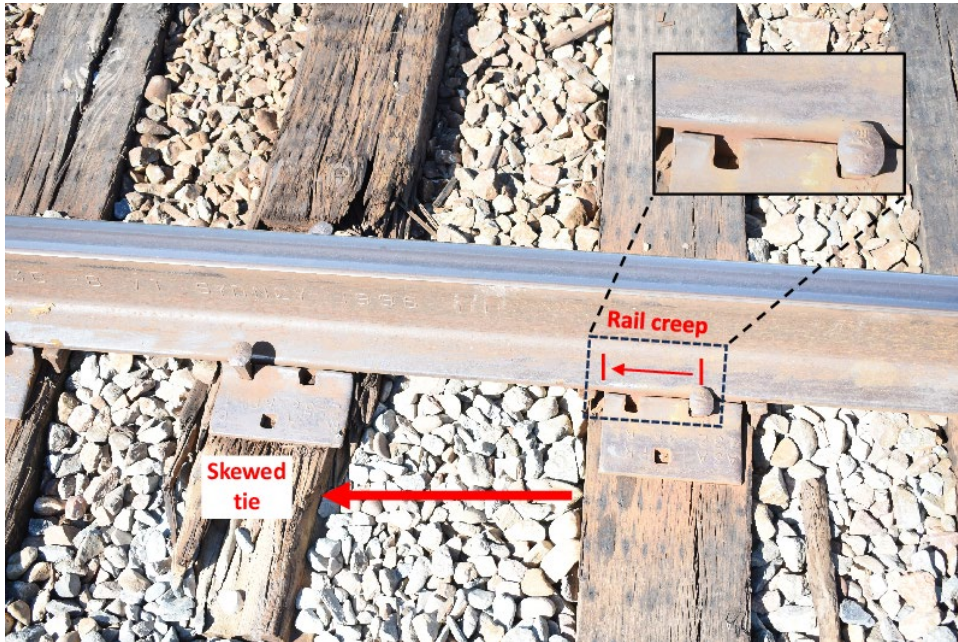
TSB investigators visually examined about 10 miles of undamaged track east of the derailment area. It was determined that the east-end main-track switch at Bassano had been replaced in September 2021. The rail, ties, tie plates, elastic fastenings, anchors, and ballast in the vicinity of the switch were in excellent condition. However, the track further to the east, and to the west between the newly installed switch and the east end of the section of track destroyed by the derailment, showed signs of deterioration (Figure 4), including:

- contaminated and worn crushed rock ballast, with some rounded stones and degraded ballast pieces;
- skewed, worn, and plate-cut ties;

- base rail movement (rail creep)⁴ through anchors and spikes;
- lifted spikes; and
- missing or loose anchoring.

Figure 4. Condition of the main track just east of the derailment, showing the south rail with lifted spikes, worn ties, a skewed tie, and rail creep (Source: TSB)

At the time of the TSB's site examination, CP personnel were in the process of replacing missing anchors, repositioning anchors that might have moved, and also box anchoring⁵ every tie between the Bassano east switch and the main track that had been reconstructed post-occurrence.

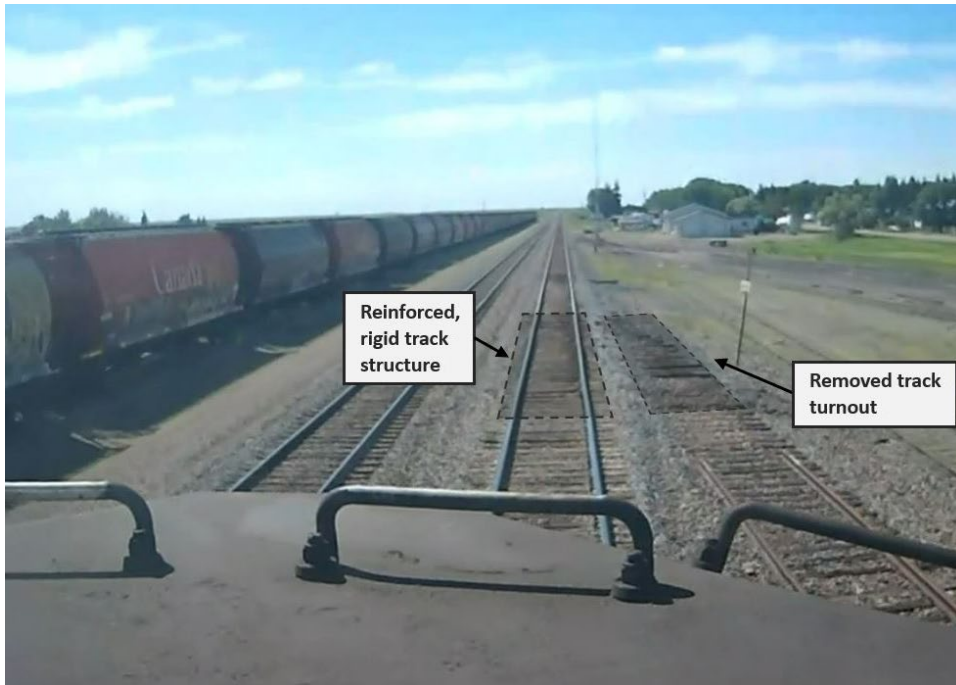
Although the track turnout at this location had been removed, the main-track structure that had previously been reinforced, per turnout design standards, remained as a rigid and solidly fixed location.

Figure 5. View of the location where the track turnout had been removed at Mile 97.48, as seen from the train's lead locomotive (Source: Canadian Pacific, with TSB annotations)
