AIR TRANSPORTATION SAFETY INVESTIGATION REPORT A2200161

RUNWAY OVERRUN

Flair Airlines Ltd.

Boeing 737-800, C-FFLC

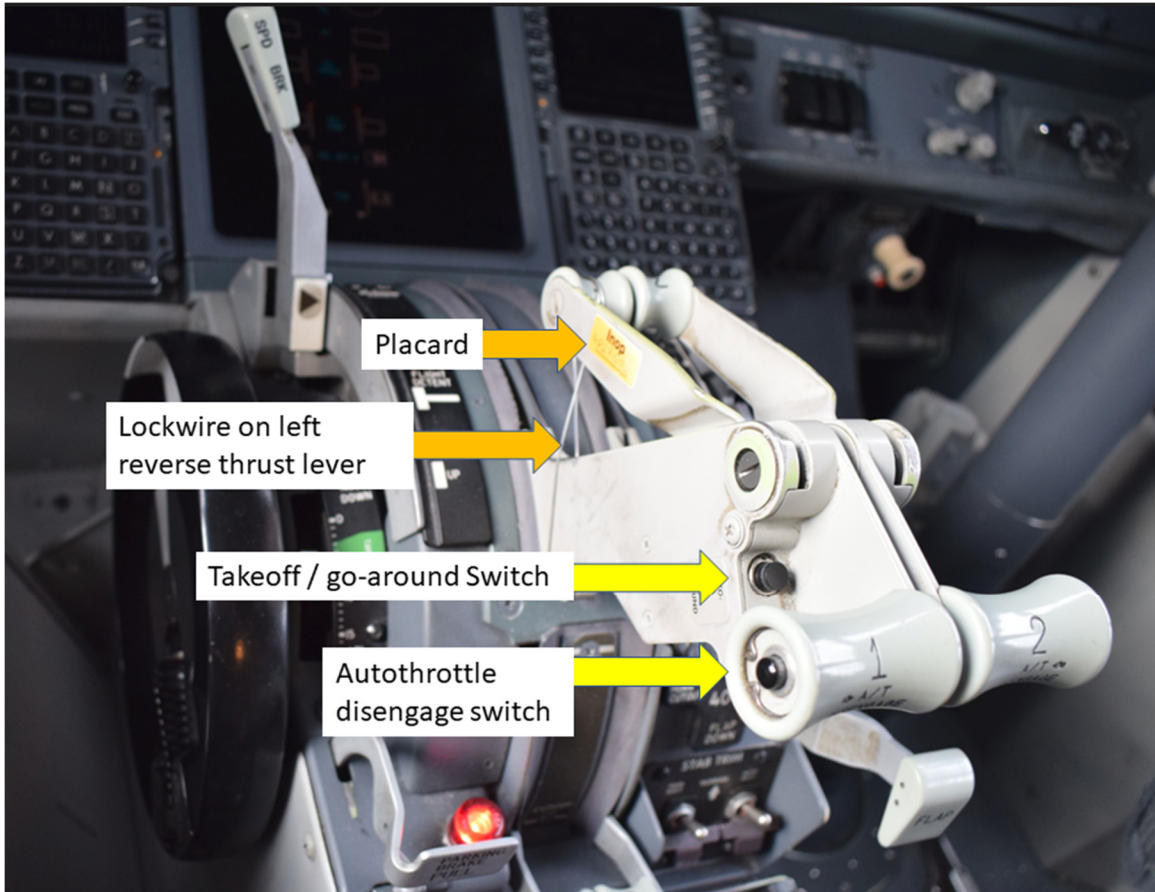
At 0624 EST, the aircraft touched down on Runway 26. The left reverse thrust lever had been locked in the stowed position per the minimum equipment list. When selecting the right reverse thrust lever following touchdown, the pilot removed his hand from the forward thrust levers, allowing the left one to advance, undetected, as commanded by the autothrottle. This had a number of consequences: the advancing thrust lever caused the speed brakes, which had briefly deployed, to retract and resulted in the deactivation of the auto-braking system, significantly reducing deceleration during the initial ground roll.

Figure 1. The layout of the control stand in the occurrence aircraft, showing the lockwired left reverse thrust lever, placard, takeoff/go-around switch, and autothrottle disengage switch (Source: TSB)

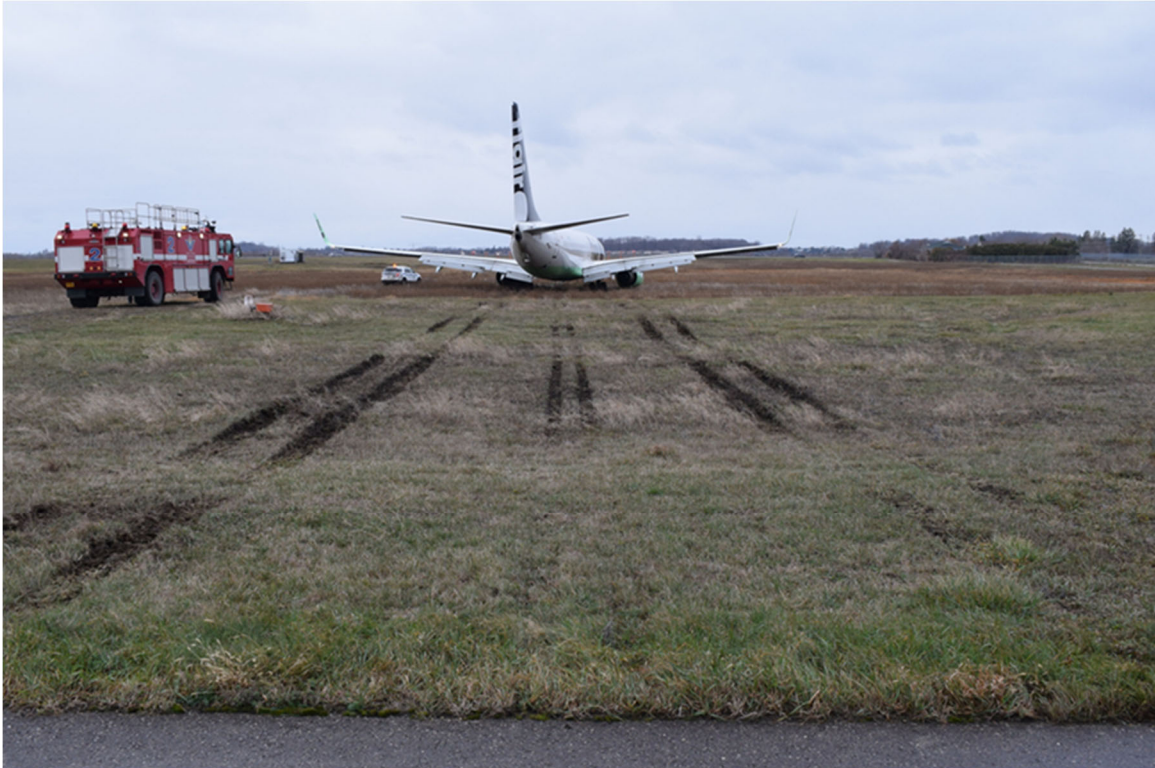
At 0625:09, the aircraft overran the runway onto the paved surface beyond the runway end. Three seconds later, 36 seconds after the initial touchdown, the aircraft overran the paved surface at a ground speed of approximately 45 knots. It entered the soft, grassy area beyond the runway's end before coming to a stop approximately 300 feet beyond the paved surface (approximately 500 feet beyond the end of Runway 26) (Figure 2).

Figure 2. Occurrence site, taken from the edge of the paved surface, facing west (Source: TSB)

The aircraft exited the runway onto wet grass. The wheels created ruts in the surface that caused the aircraft to decelerate more quickly. The underside of the aircraft was splashed with mud and dirt.

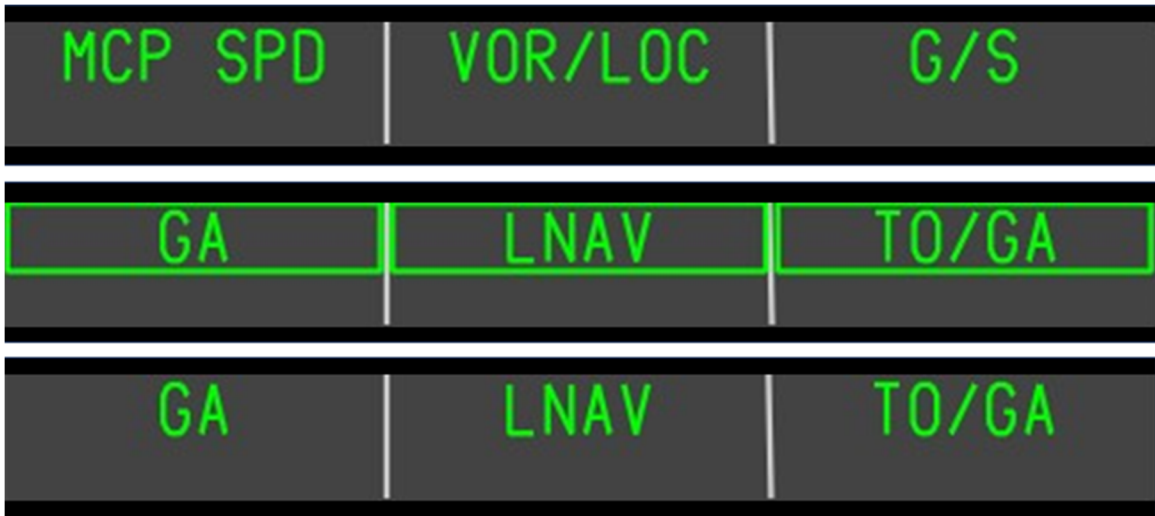
Figure 8. Flight mode annunciator indicators as they would have appeared during approach (top), after the inadvertent TO/GA switch activation (middle), and after touchdown (bottom) (Source: The Boeing Company)

Selecting TO/GA when the autothrottle is armed activates the autothrottle GA mode, which commands the forward thrust levers to advance towards a thrust setting which will result in a 1000-to-2000 fpm rate of climb. This is accompanied by audible and tactile indications due to engine spool-up, as well as tactile and proprioceptive indications such as those due to acceleration forces and pitch-up forces.

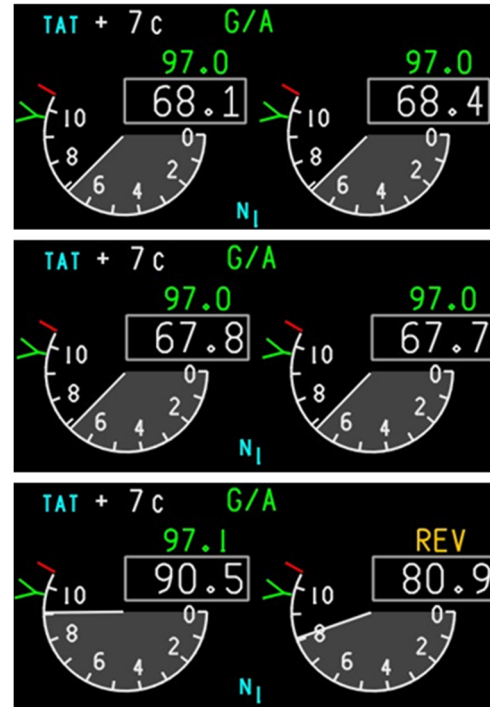
Figure 9. Engine N1 indications as they would have appeared during occurrence approach (top), after the inadvertent TO/GA switch activation (middle), and during occurrence landing roll with the right thrust reverser deployed and the left engine developing nearly full forward thrust (bottom) (Source: The Boeing Company)
