AIR TRANSPORTATION SAFETY INVESTIGATION REPORT A24O0048

TAIL ROTOR STRIKE DURING GROUND HANDLING

Heli Explore Inc.
Aerospatiale AS350 BA (helicopter), C-GWMO
Akimiski Island, Nunavut
21 April 2024

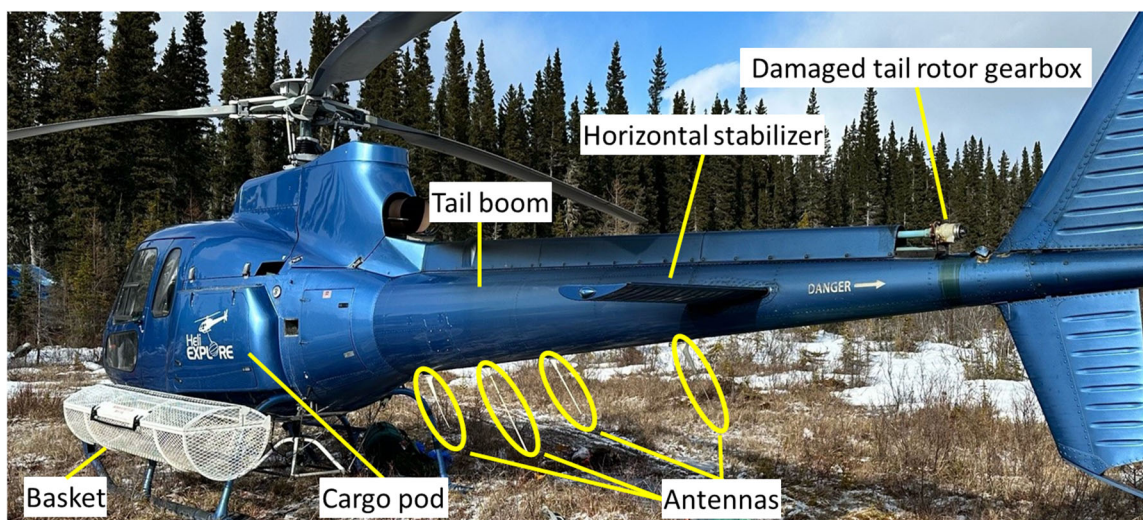
The snowmobile driver saw that the passenger was approaching the back of the helicopter, and tried to warn him by yelling and gesturing for him to stay away from the back of the helicopter. The passenger continued along the left side of the tail boom toward the back of the helicopter, past 4 antennas mounted below the tail boom, and past the left-side horizontal stabilizer (Figure 2). He then ducked under the tail boom, aft of the horizontal stabilizer, but forward of the tail's vertical fin. As he crossed to the right side, he was struck by the spinning tail rotor³ and was fatally injured. The impact caused the tail rotor and most of the tail rotor gearbox to detach from the helicopter.

Figure 2. Occurrence helicopter (Source: Heli Explore Inc., with TSB annotations)

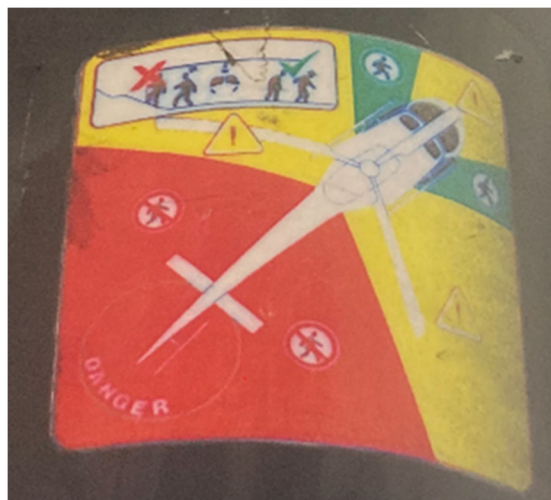
An aircraft safety card is another way to inform passengers about the hazards and danger areas of a helicopter. A safety card identifies or depicts in graphic form emergency exits, proper use of safety belts, how to approach and leave the helicopter, and danger areas such as engine exhaust areas and main rotor and tail rotor arcs. The occurrence helicopter had this information in a safety card and on a placard (Figure 3) that was on the back of the front seats.

The investigation was unable to determine if the passenger had reviewed the safety card; however, being seated in the front seat, the placard would not have been visible to the passenger. Finally, while the word "DANGER" and the associated arrow were visible on the tail boom, the location of these markings inside the radius of the tail rotor arc limit their effectiveness in identifying the actual danger area and preventing persons from approaching the tail rotor.

Figure 3. Occurrence helicopter's safety placard (Source: Heli Explore Inc.)

The company has revised its passenger guidance to provide more information and to warn of the danger of going near the back of a helicopter.

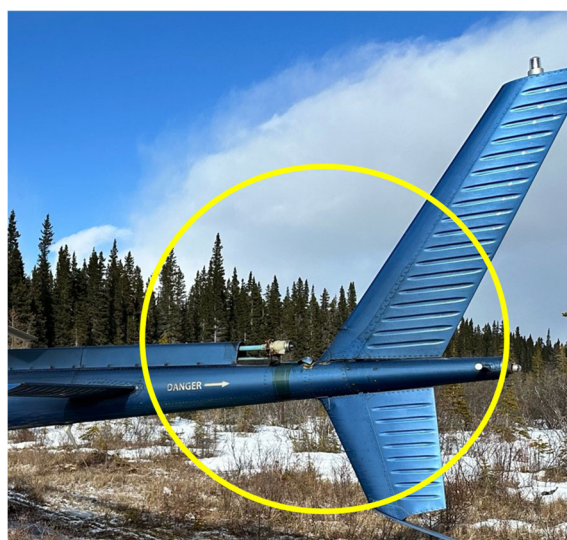
Aircraft markings can also be used to identify safe or danger areas around a helicopter, such as a tail rotor. The occurrence helicopter had the word "DANGER" and an associated arrow painted on the tail boom to identify the tail rotor danger area (Figure 4).

Figure 4. Occurrence helicopter's tail boom, showing the "DANGER" and arrow markings as well as the approximate radius of the tail rotor arc (Source: Heli Explore Inc., with TSB annotations)

On 31 January 2024, before the accident, Airbus Helicopters issued a Safety Information Notice⁸ that introduced a new tail rotor paint scheme that will increase the

visibility of the spinning tail rotor to enhance the safety of passengers and personnel during operations on the ground.
