AIR TRANSPORTATION SAFETY INVESTIGATION REPORT A24W0086

MID-AIR COLLISION

L R Helicopters Inc.
Bell Helicopter Company, a Division of Textron Inc., 212 (helicopter), C-FTLR
and
Namao Flying Club
Cessna 172M, C-GJIL
Edmonton/Villeneuve Airport (CZVL), Alberta, 13 NM NW
09 July 2024

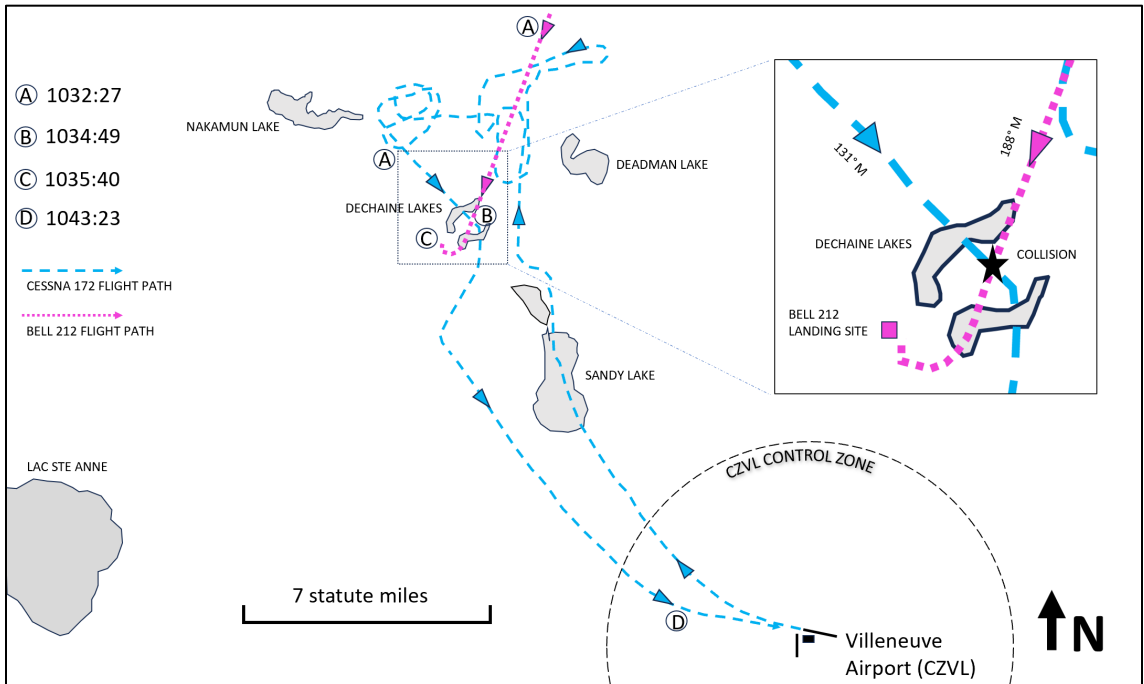
At 1033:34, the Cessna 172 levelled off at 3500 feet ASL⁵ (1200 feet AGL) on a southeast track towards CZVL after climbing away from a simulated forced-landing exercise. At 1034:49, the Bell 212 was at 3500 feet ASL on a track of 188° magnetic (M) and at a ground speed of 114 knots when the 2 aircraft collided. At the time of the collision, the Cessna 172 was on a track of 131°M and at a ground speed of 80 knots (Figure 1, inset).

Figure 1. Map showing flight paths of the Cessna 172 (blue dashed line) and the Bell 212 (magenta dotted line), with a close-up view of the collision location in inset (Source of main and inset image: TSB)

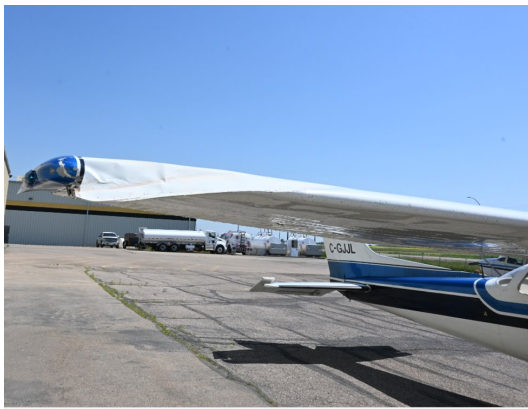
The leading edge of the Cessna 172’s right wing tip (Figure 2), and the tail skid of the Bell 212 (Figure 3) made contact. Both pilots in the Cessna 172 saw the Bell 212 passing from left to right moments before impact. The instructor reacted by pitching the aircraft’s nose down. The pilot of the Bell 212 did not see the Cessna 172 at all.

Figure 2. Damage to right wing tip on the Cessna 172 (Source: TSB)

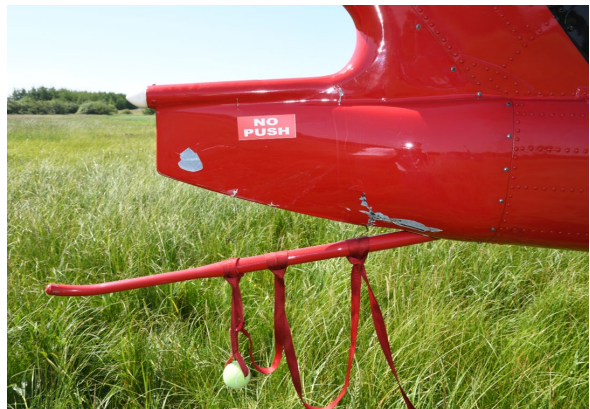
Figure 3. Damage to tail skid area on the Bell 212 (Source: TSB)

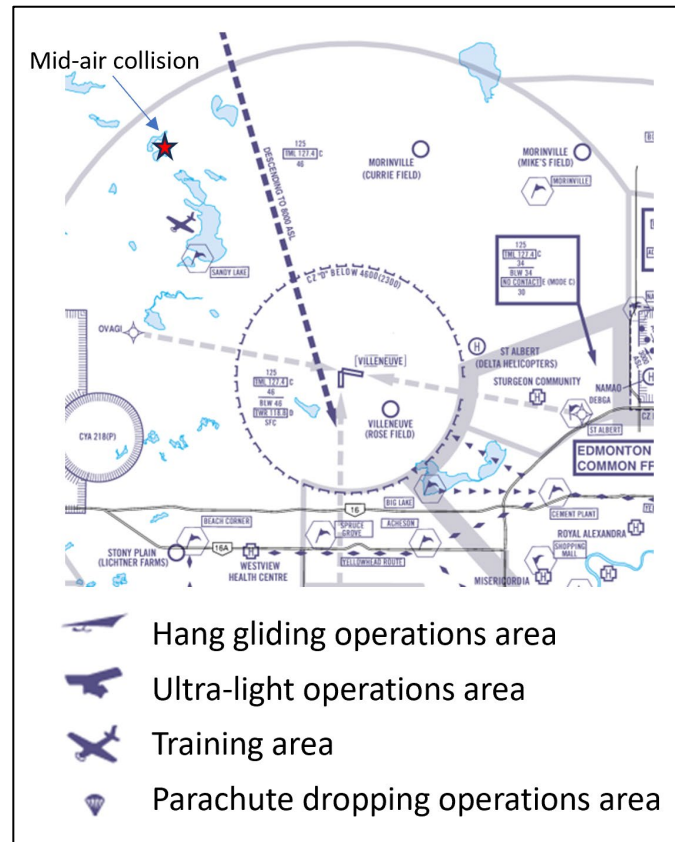
Various symbols are used on maps to depict areas of interest to pilots. The training area near Sandy Lake was depicted on the back side of the Edmonton VFR Terminal Area Chart (VTA) (Figure 4). The back side of the VTA supplies pilots with additional information when operating within the Edmonton area.

The training area near Sandy Lake was not depicted on the front/map side of the VTA, the Edmonton VFR Navigation Chart, or the *Canada Flight Supplement* Edmonton VFR Terminal Procedures Chart.

Figure 4. Back side of Edmonton visual flight rules terminal area chart showing the training area symbol near the site of the mid-air collision (Source: NAV CANADA, with TSB annotations)
