MARINE TRANSPORTATION SAFETY INVESTIGATION REPORT M23C0143

COLLISION

Ferry *Svanoy* and pleasure craft
St. Lawrence River
Saint-Joseph-de-la-Rive, Quebec
02 July 2023

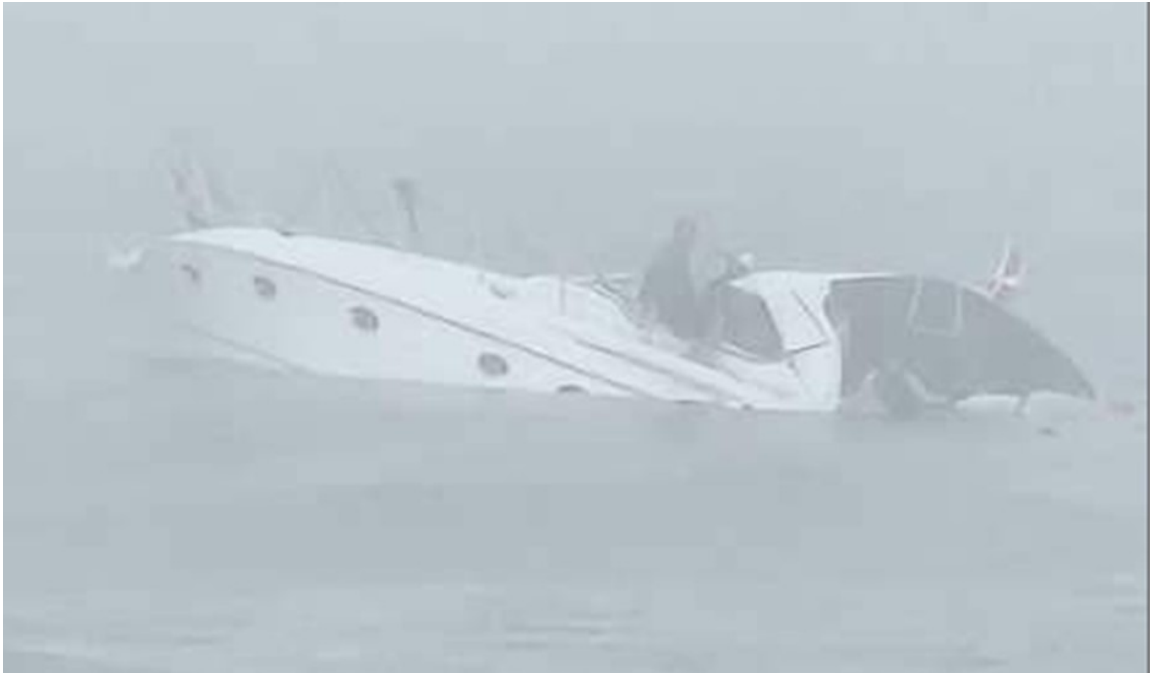
itself, while the 4th occupant was trapped below deck. Water entered the pleasure craft through the breached hull and the craft started to sink by the stern.

Figure 5. Pleasure craft QC5998860 as seen from the deck of the *Svanoy* (Source: France Gagnon)

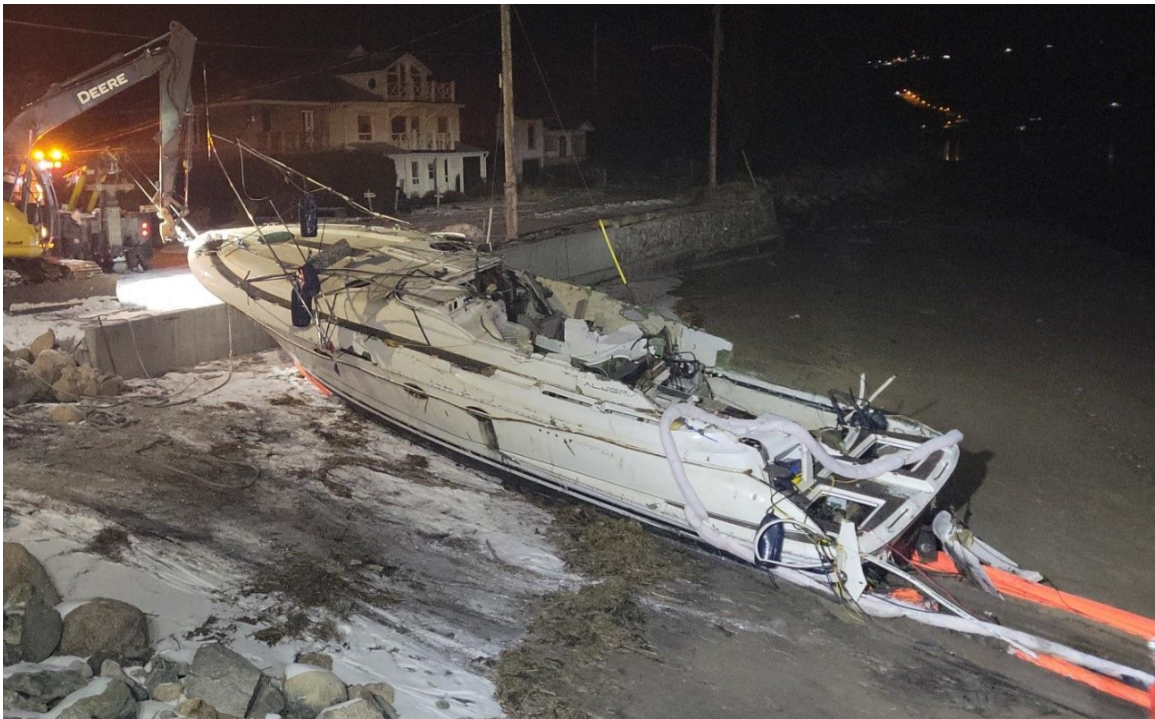
The pleasure craft was a constructive total loss. When it was salvaged (Figure 6), the following was observed:

- damage throughout the hull, especially to the aft starboard side that had collapsed under the force of impact with the ferry
- the cockpit enclosure, navigational equipment, electrical components, and steering were damaged
- the inflatable dinghy was missing and loose equipment was scattered

Figure 6. Pleasure craft QC5998860 after being salvaged (Source: Canadian Coast Guard)
