# RAIL TRANSPORTATION SAFETY INVESTIGATION REPORT R24W0021

## MAIN-TRACK TRAIN DERAILMENT

Canadian National Railway Company  
Freight train G89641-05  
Mile 34.3, Rivers Subdivision  
Near Elie, Manitoba  
06 March 2024

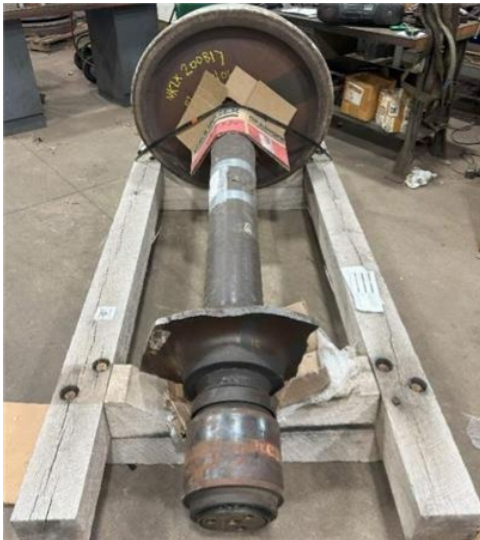
A post-derailment on-site examination determined that car NKLX 200817 (position 93) was the first to derail; only its trailing truck had derailed. The L2 wheel on this car was broken (figures 1 and 2). About 90% of the wheel rim and plate was recovered and sent to the wheel manufacturer's facility for further examination and analysis.

Figure 1. Recovered R2/L2 wheel set of car NKLX 200817 (Source: TSB)

The L2 wheel had a dent (plastic deformation) to the back side of the plate, and there was a surface crack on the front side of the plate, directly opposite the dent location.

The dent was about 6 inches away from the wheel centre hub. It was 0.18 inch deep and 1 inch wide. Its length could not be determined because 1 of the wheel fragments adjacent to the dent was not found at the occurrence site.

According to the manufacturer, the dent on the back side of the plate initiated cracking on the front side. The crack then progressed by fatigue, under service loads, through the plate; turned radially through the thinner portion of the plate; and propagated into the rim until the wheel failed during operational loading.

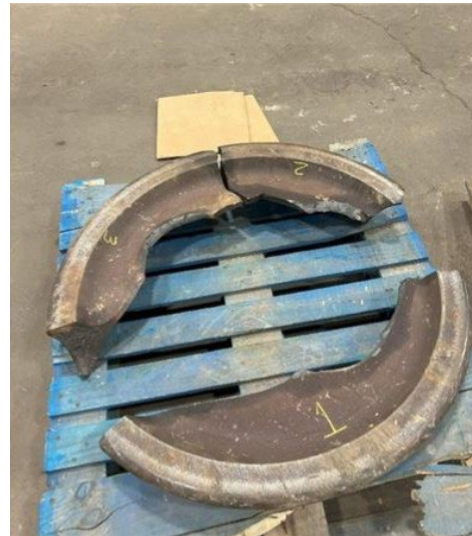
Figure 2. Recovered fragments of the L2 wheel of car NKLX 200817 (Source: TSB)

The dent on the L2 wheel exceeded the condemning limit by 44%. However, this area of the wheel is not typically inspected for damage after a wheel set is mounted on a car.
