# AIR TRANSPORTATION SAFETY INVESTIGATION REPORT A24W0066

## FUEL STARVATION AND COLLISION WITH TERRAIN

Rocking Star Adventures Ltd.  
Cessna U206G, C-GRSA  
Haines Junction Aerodrome (CYHT), Yukon  
10 June 2024

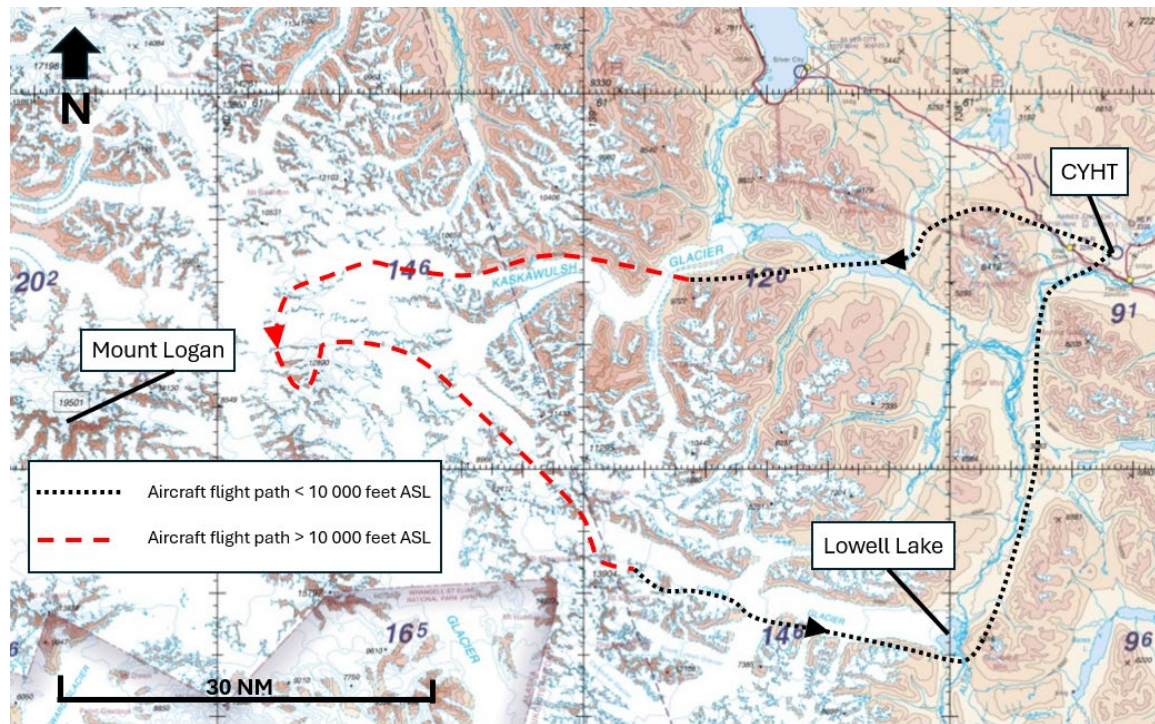
At 1220<sup>1</sup> on 10 June 2024, the Rocking Star Adventures Ltd. (RSA) Cessna U206G aircraft departed Haines Junction Aerodrome (CYHT)<sup>2</sup> on a local visual flight rules (VFR) sightseeing flight to the Kluane National Park and Reserve of Canada, with the pilot and 5 passengers on board. The flight was intended to be the company's standard 1.5-hour tour of the Kluane icefields and Mount Logan, but because of clouds in the park, the route was modified to remain clear of clouds. The aircraft departed with approximately 42 U.S. gallons of fuel on board: 24.5 U.S. gallons in the right fuel tank and 17.5 U.S. gallons in the left fuel tank. The right fuel tank had been selected for the departure, with the intention of selecting the left fuel tank for the return to CYHT, when the aircraft was over Lowell Lake (Figure 1).

Figure 1. Occurrence aircraft flight path based on data from the Garmin global positioning system on board (Source: NAV CANADA, with TSB annotations)

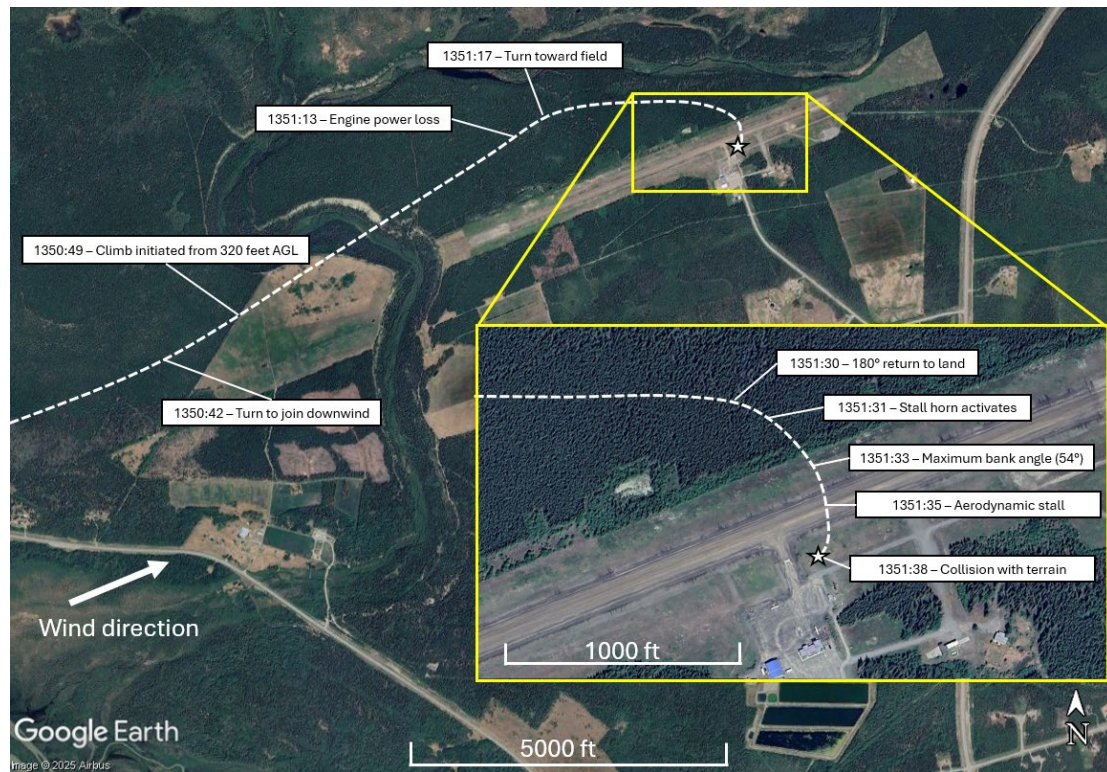
When the aircraft was  $\frac{3}{4}$  NM back from Runway 05's threshold, at a height of 300 feet above ground level (AGL), the pilot observed that the windsock at the airfield indicated the winds were favouring a landing on Runway 23 and began to manoeuvre the aircraft to join the right downwind leg for Runway 23. The aircraft climbed to a maximum height of 400 feet AGL while on the downwind leg. At 1351:13, the aircraft's engine ceased producing power. The pilot angled the aircraft toward the runway and attempted to restart the engine by switching to the left fuel tank. The pilot was not successful in restarting the engine. Fifteen seconds later, at a horizontal distance of 600 feet from the runway centreline and at a height of 300 feet AGL, the pilot attempted a 180° turn to land into the wind on Runway 23. The stall warning system's horn began to sound immediately during the manoeuvre and remained on until the end of the flight. The aircraft banked to a maximum of 54° during the manoeuvre. The aircraft entered an accelerated aerodynamic stall and impacted the terrain in a slight right-wing-low, flat-pitch attitude on the aerodrome infield at 1351:38 (Figure 2).

Figure 2. Occurrence aircraft flight path based on data from the Garmin global positioning system on board (Source: Google Earth, with TSB annotations)

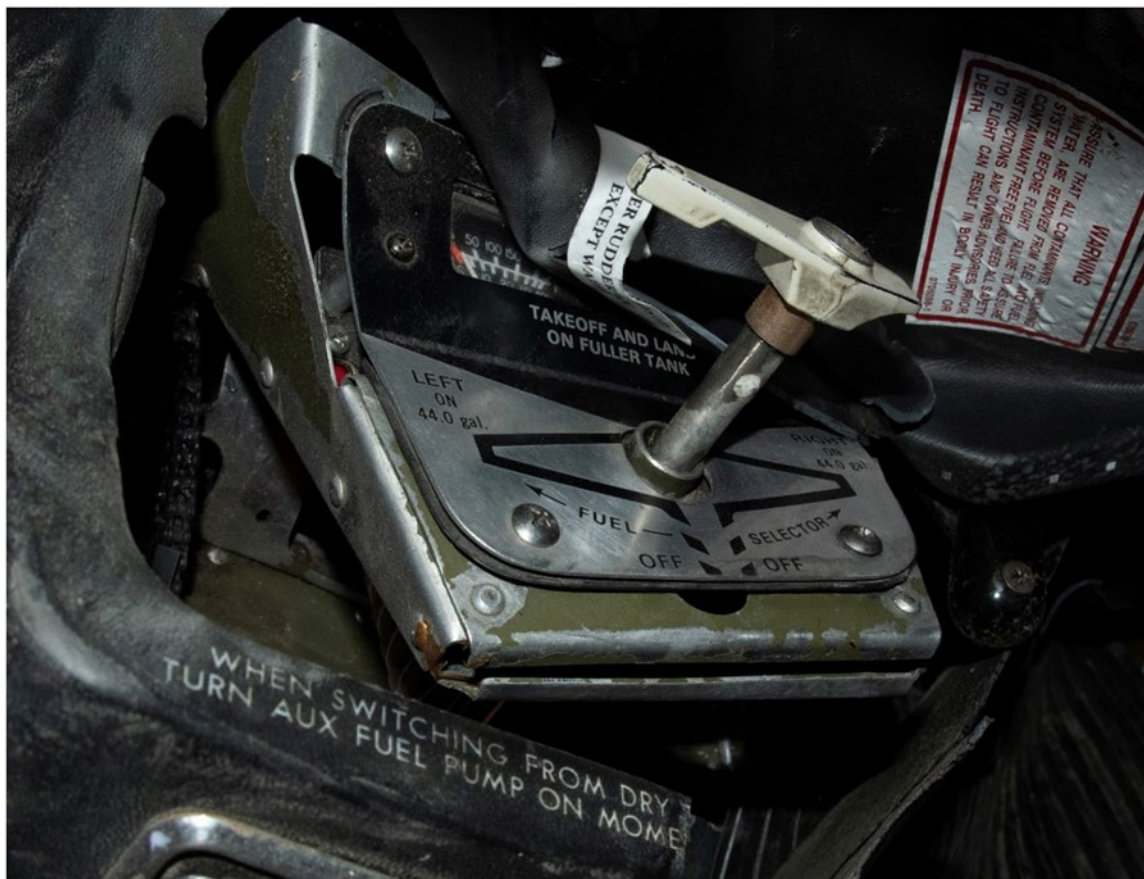
The occurrence aircraft's fuel selector handle was found in the LEFT ON position (Figure 4).

Figure 4. Occurrence aircraft's fuel selector handle in the LEFT ON position, as found post occurrence (Source: TSB)

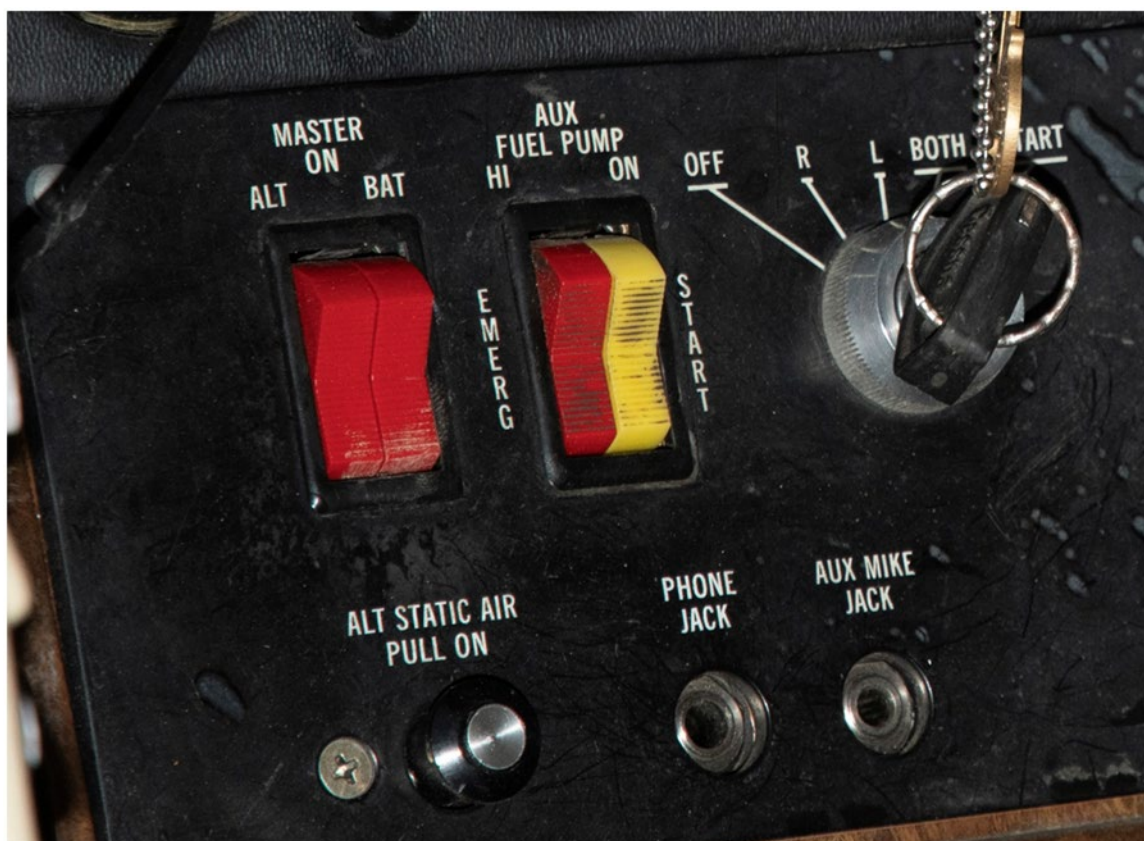
The auxiliary fuel pump switch in the occurrence aircraft was found with both halves toggled down. The MASTER ON switch was selected off by company personnel post occurrence for safety (Figure 5).

Figure 5. AUX FUEL PUMP switch and MASTER ON switch, as found on the occurrence aircraft post occurrence (Source: TSB)

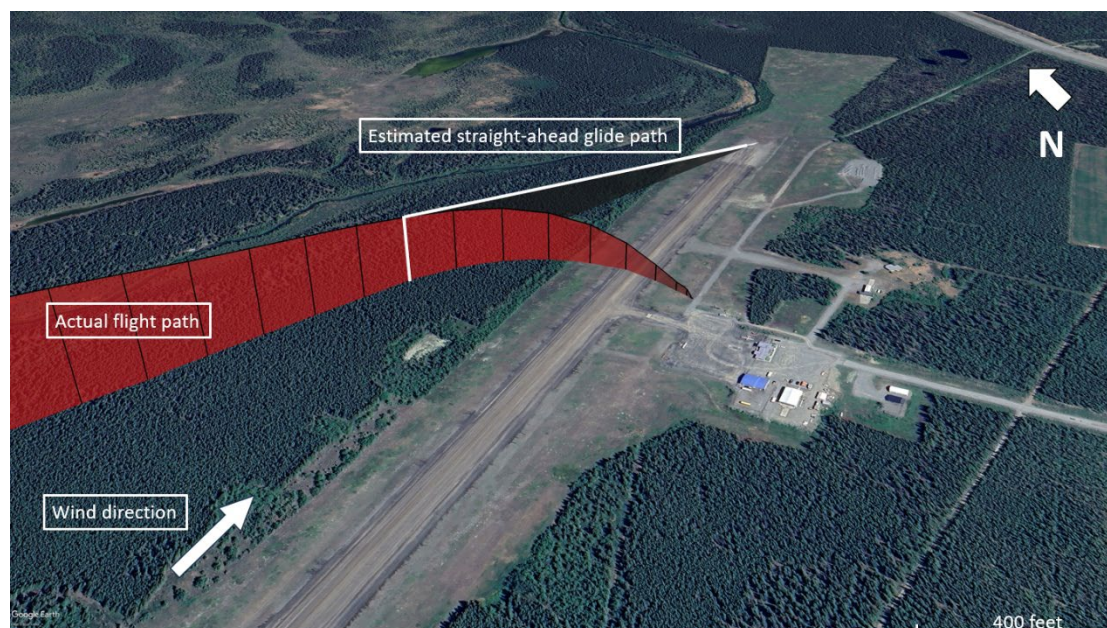
Figure 6. Occurrence aircraft's actual flight path retrieved from the Garmin 296 compared to a straight-ahead glide path from the point of turn initiation (Source: Google Earth, with TSB annotations)

If an emergency happens when an aircraft is at a low height and at a low airspeed, time is a scarce resource to the pilot, who must make an immediate decision on the proper course of action. Once the engine lost power, the occurrence pilot did not reconsider landing straight ahead with a tailwind. The pilot continued his revised plan of landing into the wind, assuming that the tailwind would be too strong to land straight ahead. At that point, when the engine failed, the aircraft's low-energy state, configuration, and height were similar to those of an aircraft immediately after takeoff. A desire to save the aircraft by landing on a prepared surface likely influenced the pilot's decision to attempt a 180° turn to land as opposed to risking a runway overrun and damaging the aircraft by landing straight ahead with a tailwind.
