# MARINE TRANSPORTATION SAFETY INVESTIGATION REPORT M24A0412

## FIRE

Fishing vessel *Fundy Leader*  
100 nautical miles southwest of Cape Sable, Nova Scotia  
06 December 2024

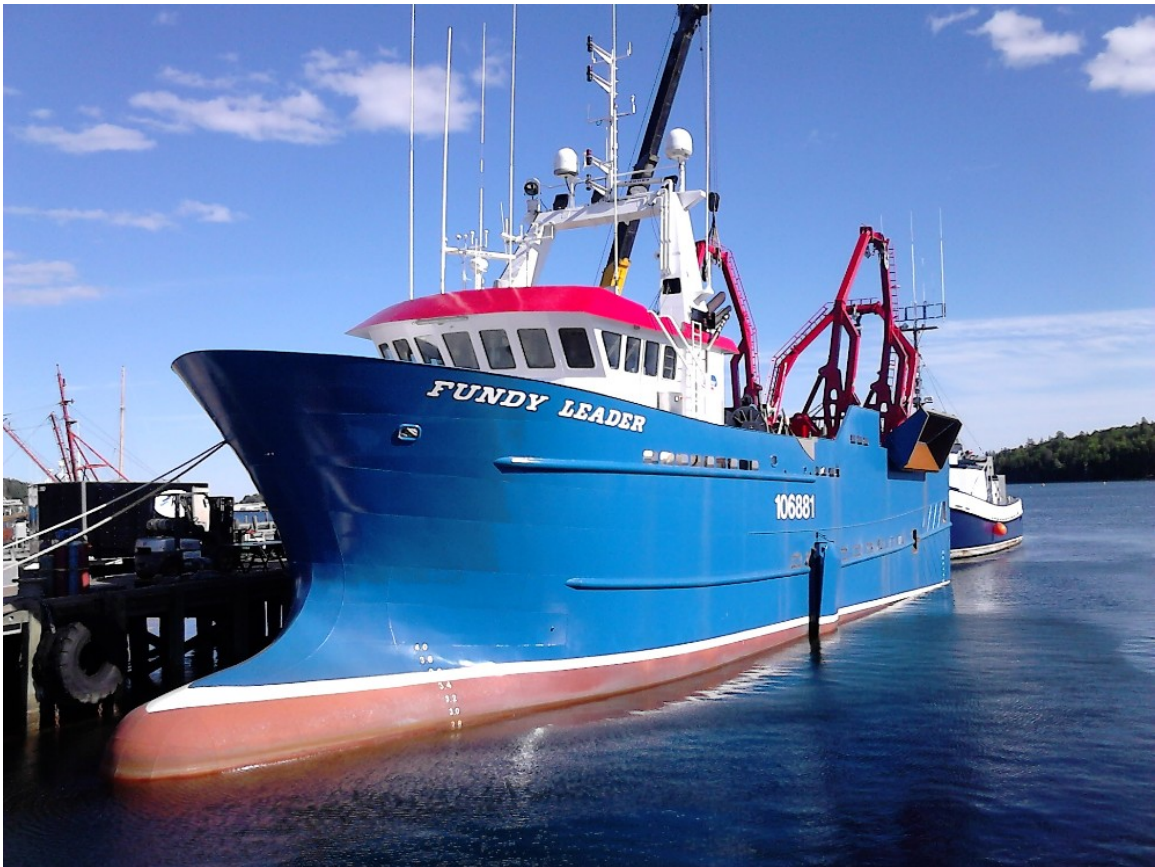
Figure 1. The *Fundy Leader* (Source: Clearwater Seafoods)

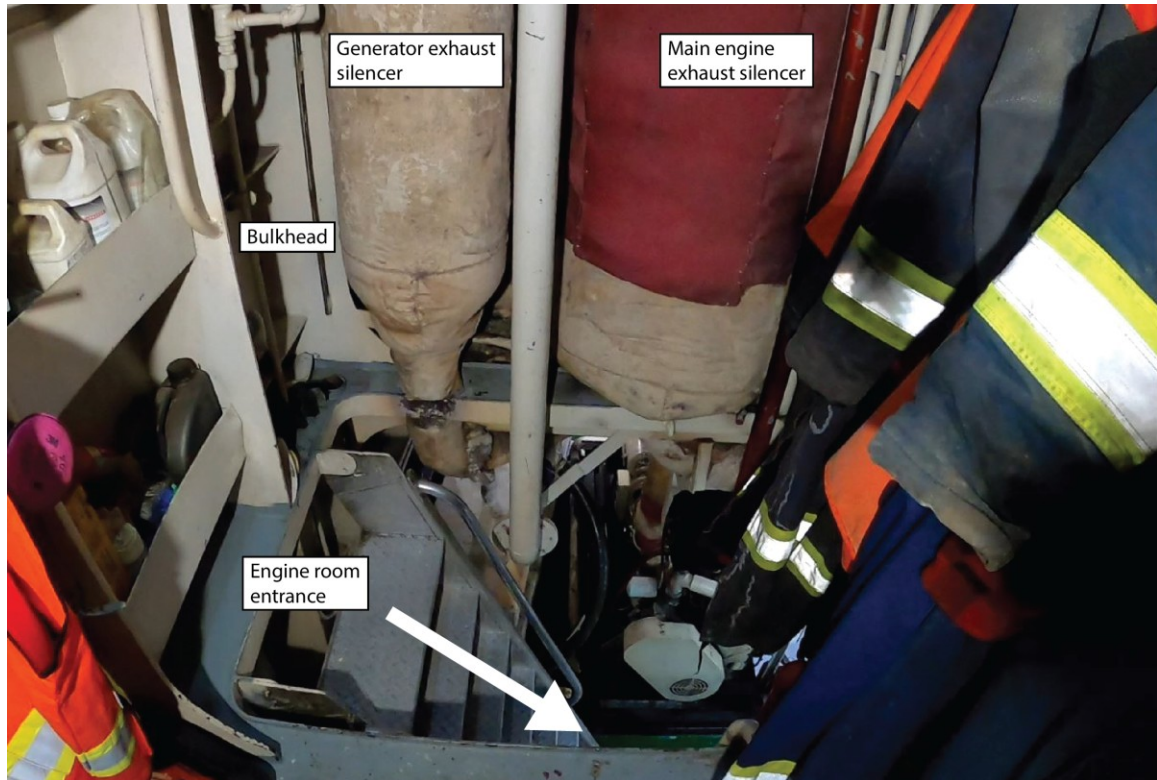
The main engine exhaust pipe is fitted with an exhaust silencer, which is essentially a muffler designed to reduce the noise of the main engine. The silencer is cylindrical in shape and is larger in circumference than the rest of the pipe. It is fitted into a section of the pipe using flanges. The exhaust pipe and silencer are covered with non-combustible thermal insulation (lagging) that reduces the transfer of heat to the surrounding area and prevents people and objects from making contact with the hot pipe.<sup>2</sup> On the *Fundy Leader*, the main engine exhaust silencer is

within 10 cm of the steel bulkhead that separates the exhaust trunking from the accommodations (Figure 2).

**Figure 2.** View of the exhaust trunking showing the location of the main engine exhaust silencer and a generator exhaust silencer. Note that this photo was taken after repairs following the fire. (Source: TSB)

The sections of exhaust lagging damaged in the fire were replaced with a type of lagging that can be removed for inspections by vessel crew and regulators.

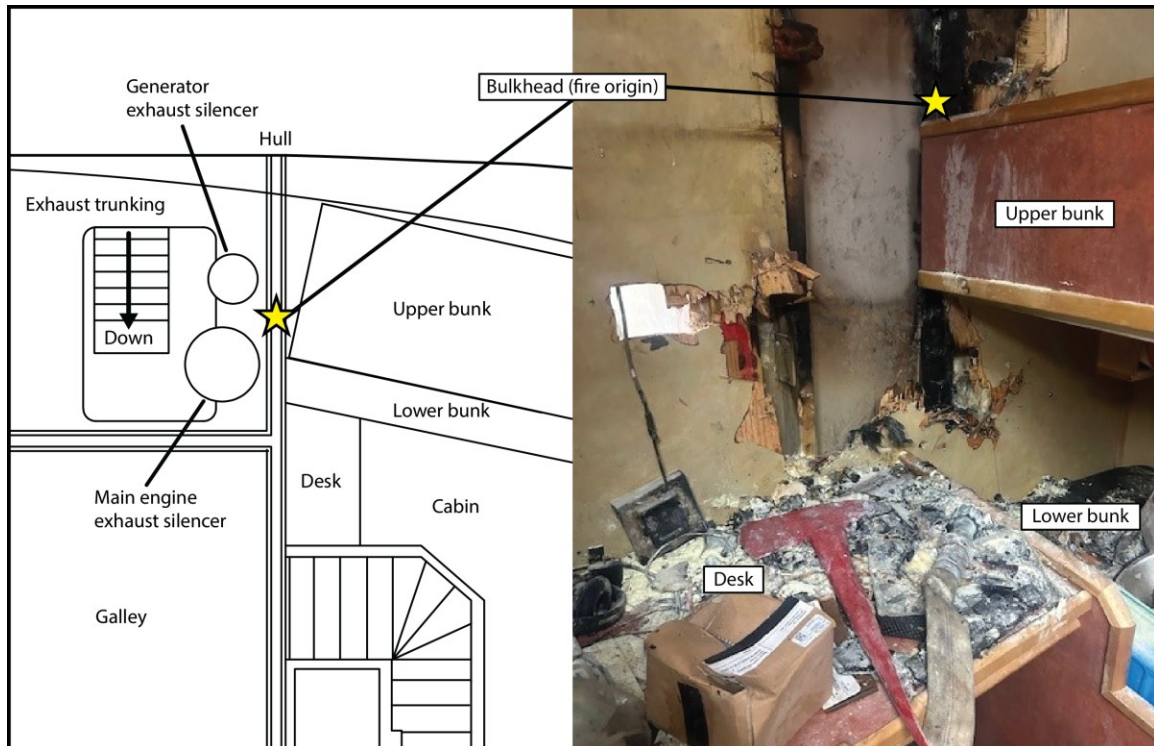
Data collected post-occurrence indicated that the source of ignition originated from a crack in the main engine exhaust silencer. The crack was approximately 30 cm in length and near the top of the silencer, on the side that faced the bulkhead separating the exhaust trunking from the cabin. Low-flame-spread<sup>5</sup> wall panelling was attached to the wood framing on the side of the bulkhead facing the cabin.

In this occurrence, hot exhaust gases were escaping from the cracked silencer and heating up the steel on the bulkhead, which was less than 10 cm away. By conduction, the heated steel ignited the wood framing and caused the fire (Figure 4).

Figure 4. Fire origin shown on the vessel layout (left) and on a photograph of the cabin (right) (Source of left image: TSB, based on the vessel's arrangement; source of right image: Clearwater Seafoods, with TSB annotations)

During vessel repairs post-occurrence, the company that owns and operates the *Fundy Leader* removed the remaining wood framing in the bulkheads separating the cabin and galley from the exhaust trunking. Metal framing was installed in its place. The wooden fire axe handles were replaced with fibreglass handles.
