# AIR TRANSPORTATION SAFETY INVESTIGATION REPORT A25P0149

## COLLISION WITH TERRAIN

Privately registered  
Bushmaster Super 22 (amateur-built aircraft), C-GWNQ  
Lillooet Aerodrome (CYLI), British Columbia  
24 September 2025

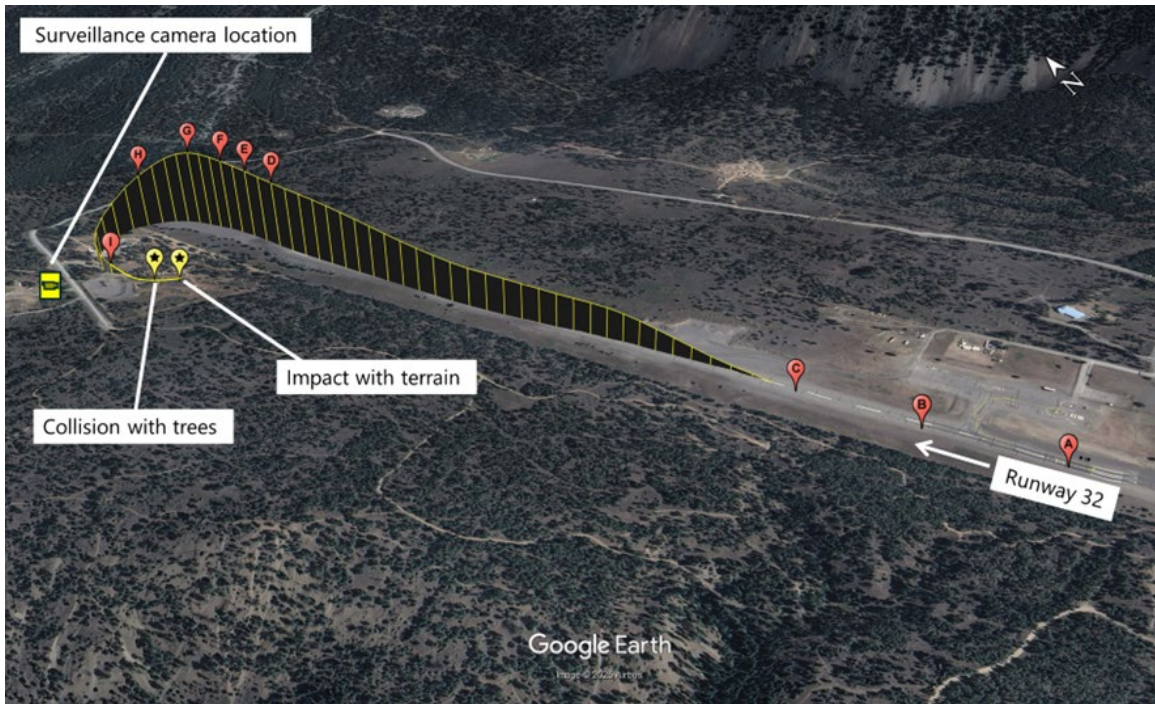
During the take-off roll, the aircraft's fuel pressure and engine rpm decreased momentarily and then recovered just before takeoff (Figure 1, points A to C).<sup>3</sup> About 30 seconds after the aircraft lifted off, and while it was climbing through approximately 345 feet above ground level (AGL), the fuel pressure and engine rpm started to decrease again (Figure 1, points D to F). The fuel pressure

and engine rpm continued to decrease. The engine lost power and, when the aircraft was at approximately 400 feet AGL, it levelled off (Figure 1, point G). At that point, the terrain directly ahead of the aircraft was flat and forested, and the pilot initiated a 180° left turnback toward CYLI. The fuel pressure and engine rpm continued to decrease, and the aircraft started to lose height. Throughout the turnback, the indicated airspeed ranged from 48 knots to 61.5 knots, the vertical speed reached a maximum of approximately 2300 fpm, and the bank angle ranged from about 29° to 37.5°. The last recorded data point (Figure 1, point I) showed that the fuel pressure had decreased to a very low value.

Figure 1. Occurrence aircraft’s flight path with referenced data points (see Table 1) and the location of the surveillance cameras, the collision with trees, and the impact with terrain (Source: Google Earth, with TSB annotations)

Reference point	Fuel pressure (psi)	Engine speed (rpm)
A	48.2	2530
B	20.7	1940
C	50.9	2750
D	49.8	2710
E	28.5	2640
F	16	1360
G	10.3	840
H	6.9	710
I	1.7	1070

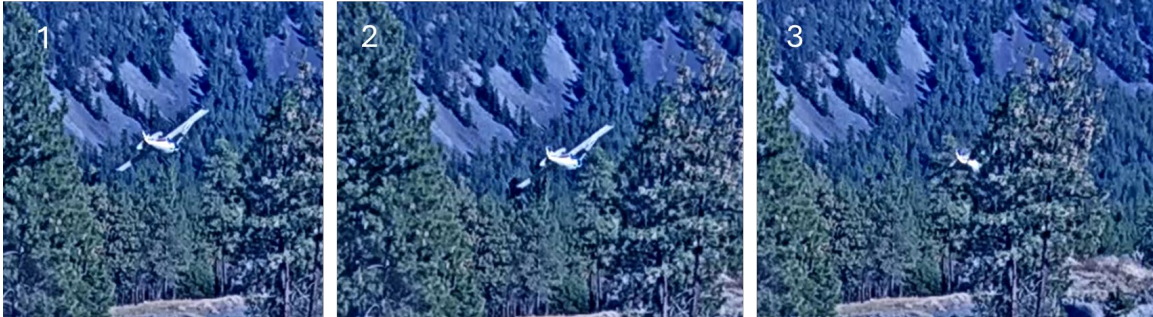
When the aircraft was at a height of approximately 35 feet AGL and banking left to turn back toward the aerodrome, it struck trees and then impacted terrain adjacent to CYLI. Surveillance cameras at a neighbouring property captured the impact (Figure 2) and indicated that the aircraft did not stall. A person at CYLI who had been accompanying the pilot on the hunting excursion and local first responders attended the scene and provided medical assistance; however, the pilot was fatally injured. There was no post-impact fire and the aircraft was destroyed.

Figure 2. Still images showing the occurrence aircraft's collision with trees (Source: Third party, with permission and with TSB annotations)

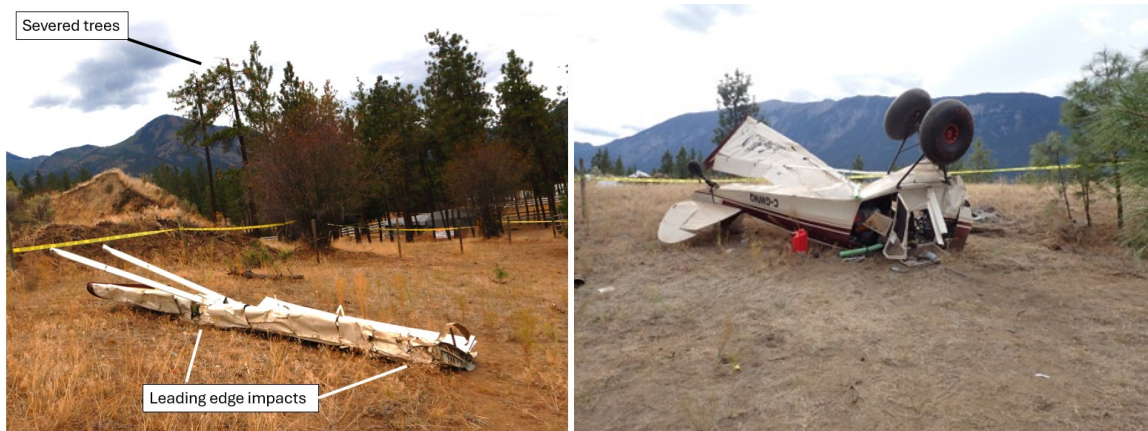
The collision with the trees tore the aircraft's left wing from the fuselage at the wing root. The left wing exhibited signs of impact with the trees on 2 areas of the leading edge (Figure 3). The remainder of the aircraft came to rest inverted and facing predominantly south, approximately 145 feet from the trees (Figure 4) and approximately 650 feet west of the end of the runway.

The occupiable space in the cockpit of the aircraft was compromised. The accident was not survivable.

Figure 3. Left wing with leading edge impacts and severed trees (Source: TSB)      Figure 4. Wreckage at accident site (Source: TSB)

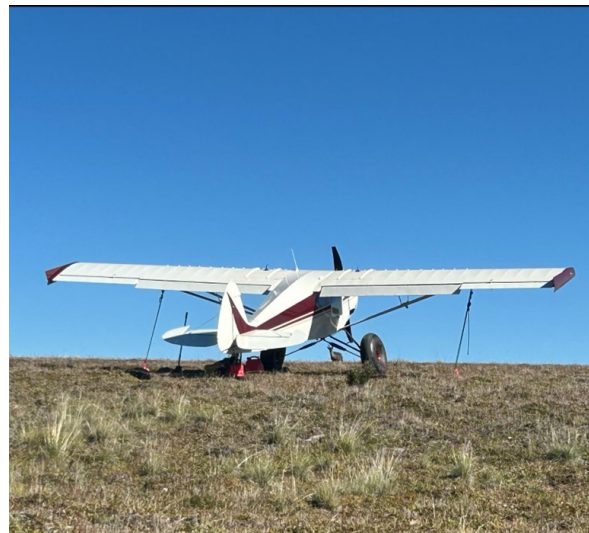
The pilot purchased the occurrence aircraft in July 2024, and approximately 2 months later it was reconfigured to a land plane with fixed landing gear (Figure 5).

Figure 5. Occurrence aircraft with fixed landing gear  
(Source: Third party, with permission)
