AVIATION INVESTIGATION REPORT

A0000214

ENGINE FAILURE—FORCED LANDING

DIAMOND DA 20-A1 C-GOAS

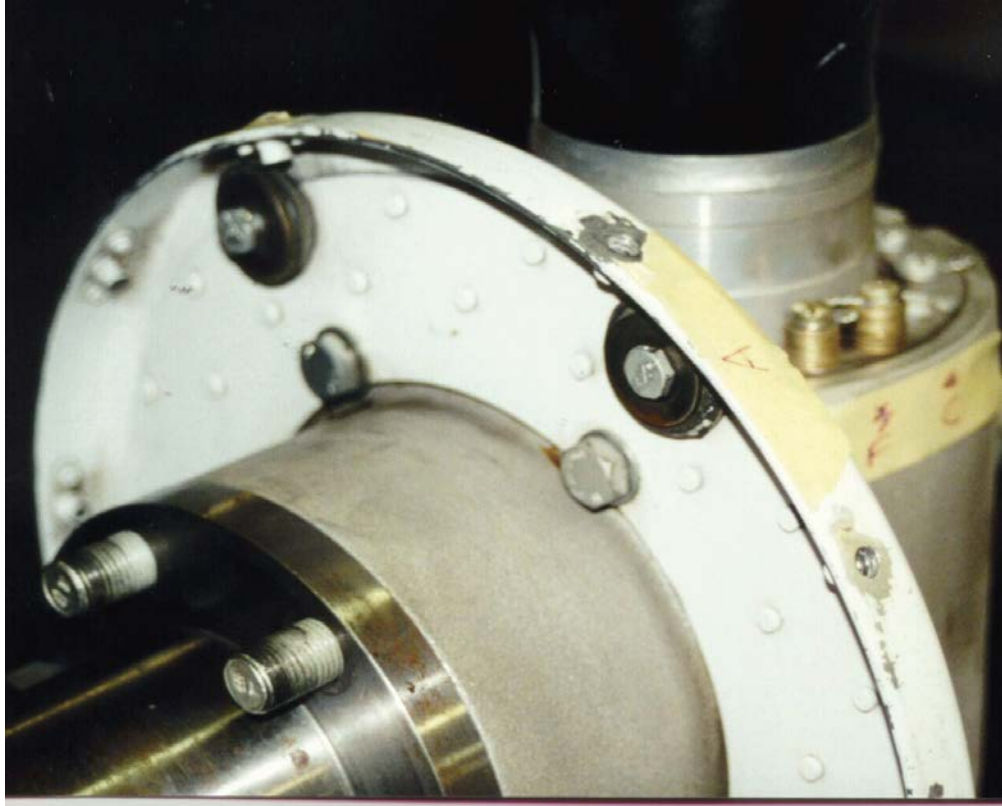
The propeller was a Hoffman HO-V352F/170FQ, S/N H427. It had accumulated 729 hours total time since overhaul. The propeller was examined and found to be undamaged; however, the propeller had a large amount of balance weight attached to the root of the No. 2 blade and on the engine side of the spinner bulkhead, behind this same blade. The propeller and the spinner were forwarded to the aircraft manufacturer's facilities in London, Ontario, to check the static and dynamic balance of the propeller.

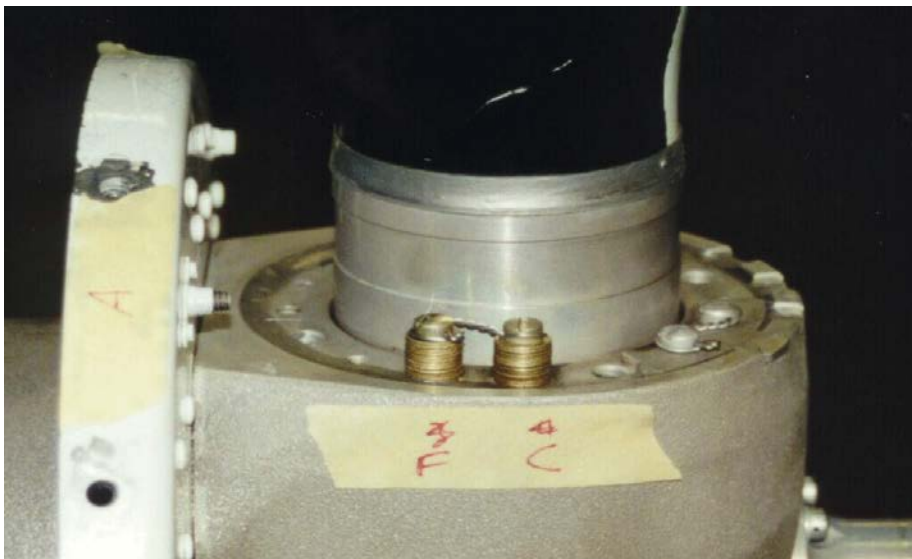
The propeller manufacturer's instructions for static and dynamic balancing call for the installation of AN 970-3 balancing shims mounted to the engine side of the spinner bulkhead. The total number of the balancing shims or total weight of the balancing shims in any one position was not to exceed six washers or 28 grams. The occurrence propeller had a combination of AN 970-3 balancing shims and lead washers installed on the spinner bulkhead behind the No. 2 blade (Figure 1). Additionally, there were four stacks of six AN 960-3 washers around the root of the No. 2 blade (Figure 2); this was not in accordance with the manufacturer's instructions.

The total weight of all the balancing weights attached to the No. 2 blade and the corresponding spinner bulkhead positions was 108 grams, whereas the maximum allowable weight was 56 grams. Furthermore, static and dynamic balancing of the propeller showed it to be 33 grams heavy on the No. 2 blade. Additionally, the dynamic balancing of the propeller should not exceed 0.2 inch per second at take-off rpm (revolutions per minute). When checked, the propeller was found to produce a vibration of 0.430 inch per second.

The propeller manufacturer recommends that the propellers be maintained by a Hoffman authorized service station to avoid incidents such as an unbalanced propeller.
