AVIATION INVESTIGATION REPORT

A00P0019

CONTROLLED FLIGHT ONTO ICE

PIPER NAVAJO CHIEFTAIN C-GBFZ

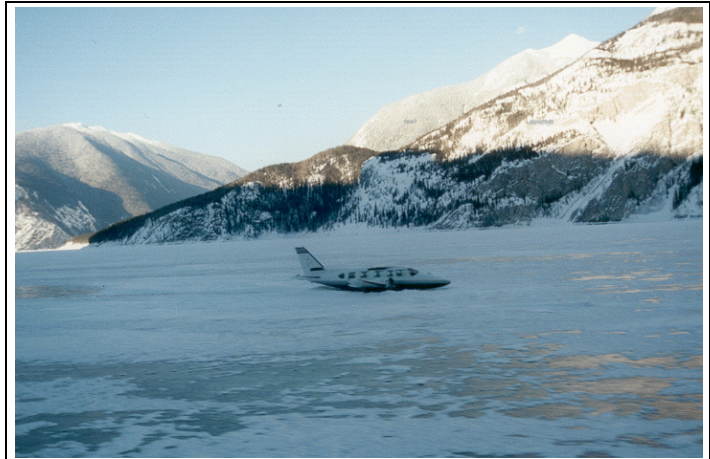
The pilot departed at about 1040 and proceeded westward. He soon encountered snow, but the visibility allowed visual contact with the lakeshore and the pilot elected to continue. The aircraft was configured in a cruise profile, flying at about 160 nm/hour (knots) with landing gear and flaps retracted. About 25 nm west of Bear Valley, visibility diminished to the point where the pilot was unable to maintain visual references. He turned the aircraft around and attempted to regain visual references for a return flight to Bear Valley. However, the aircraft descended, unnoticed by the pilot, and struck the ice. Turn performance calculations indicate that, at 160 knots, the pilot would have to maintain an angle of bank of about 40 degrees (steep turn) to complete a 180-degree turn within the confined valley. The loss of altitude and eventual contact with the ice are results consistent with similar accidents investigated by the TSB.³

The crash site is at latitude 56°02' N, longitude 123°38' W, in a narrow valley section of the lake that is steep-sided and oriented east/west. The valley walls are only about one mile apart at lake level and terrain rises over 4000 feet on either side. The snow storm was progressing from west to east, and wind speed generally increases in this section of the Peace Reach Arm because of the funnel effect.⁴ The pilot was navigating with reference to the north shoreline as he progressed westwards through the valley, and he biased his flight path to the northern side. When the pilot lost visual reference with the shoreline, the lateral distance within which to execute the 180° left turn was about one mile. By this time, the pilot had flown the aircraft down to an altitude of about 300 feet agl in an attempt to remain below the weather.
