AVIATION INVESTIGATION REPORT

A00P0206

RUNWAY INCURSION

25 OCTOBER 2000

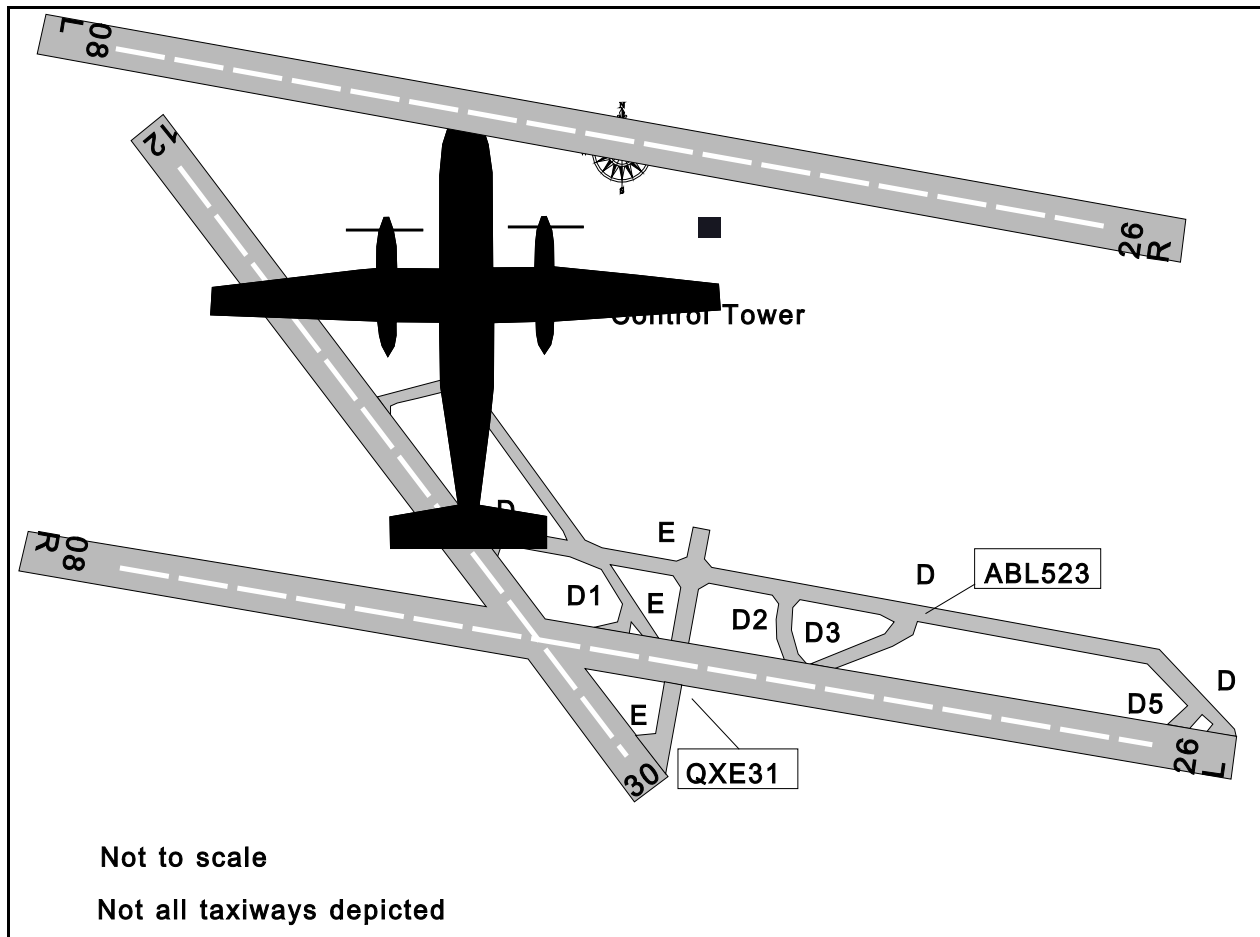
Vancouver International Airport is served by two parallel runways, 08R/26L and 08L/26R, and one crossing runway, 12/30. On the night of the occurrence, runway 26L was being used for departures. Runway 26L is an 11 000-foot, hard-surface runway that can be entered from the end or from a number of intersections along its length.
