AVIATION INVESTIGATION REPORT
A00Q0116

RISK OF COLLISION

AIRBUS INDUSTRIE A319-114 C-FYJB

CESSNA 152 C-GFBJ

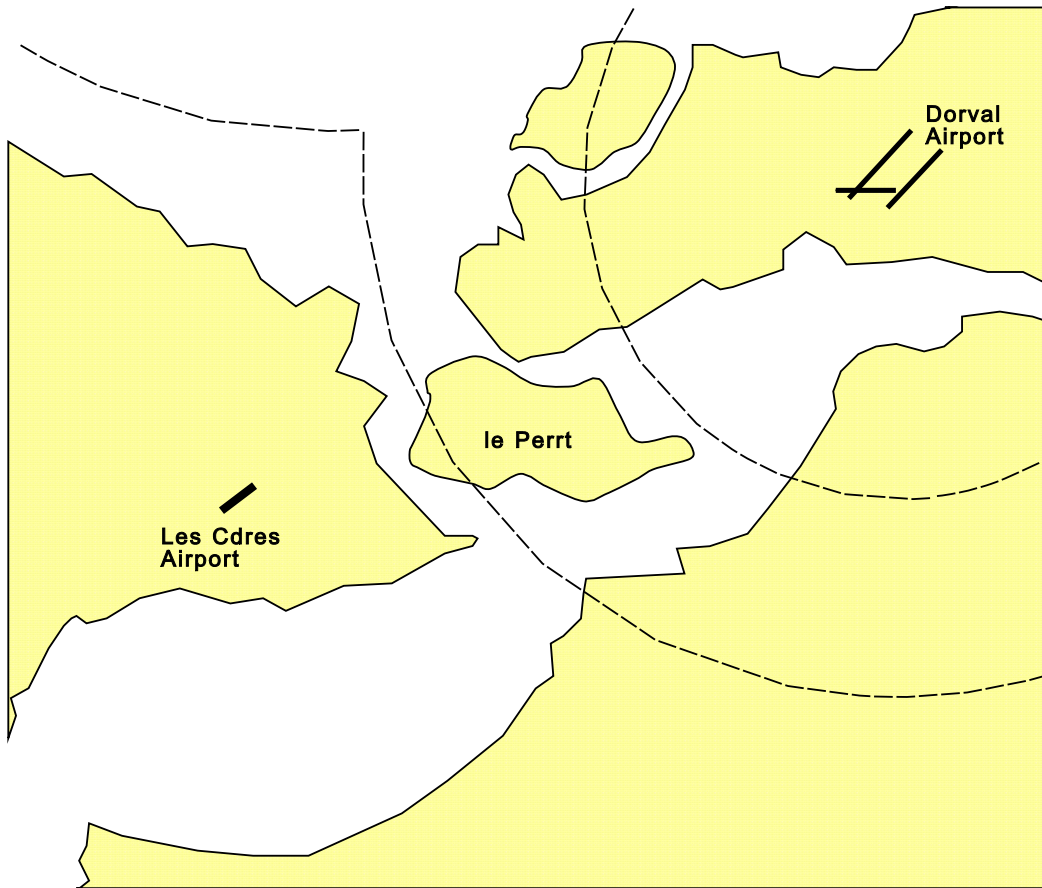
Appendix A—Cessna 152 Route of Flight

The Cessna pilot was aware of the airspace classification in the vicinity of Dorval. After take-off, the pilot established the aircraft altitude at 1100 feet asl to remain below the Class C airspace, which is based at 1300 feet asl and which overlies Île Perrôt and the western tip of the island of Montréal. The pilot planned to follow Highway 20 eastbound only as far as Sainte-Anne-de-Bellevue, 10 nm west southwest of Dorval and outside the Dorval control zone. She thought that the aircraft had not yet passed Pincourt on Île Perrôt when she saw Dorval airport directly ahead. She immediately recognized the navigation error, performed a general lookout, and then began an immediate right turn with the intention of returning to Les Cèdres. During the right turn, the Cessna passed in front of the Airbus. The occupants of the Cessna did not see the Airbus.
