AVIATION INVESTIGATION REPORT

A00W0215

POWER LOSS—MECHANICAL MALFUNCTION

EUROCOPTER AS 350BA C-GATX

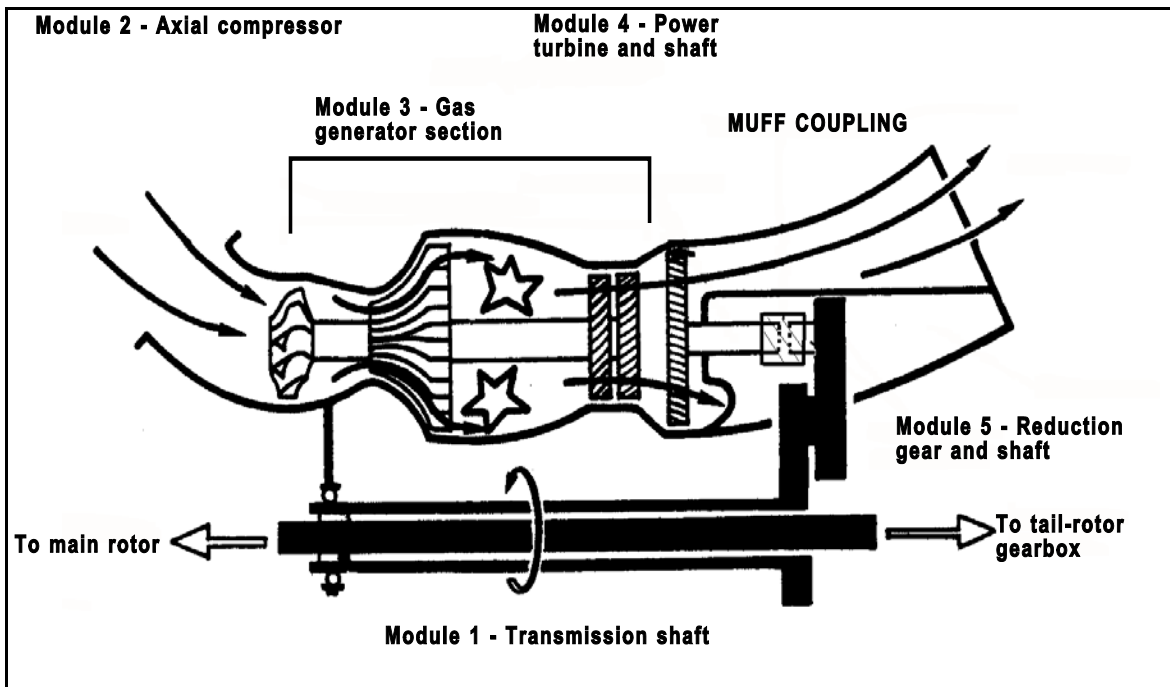
The engine is an assembly of five major modules (Figure 1). Modules 2, 3, and 5 had been exchanged with overhauled units from the engine manufacturer about 37 hours before the occurrence. Module 4, the power

(free) turbine section, had been in service for about 1200 hours since overhaul.

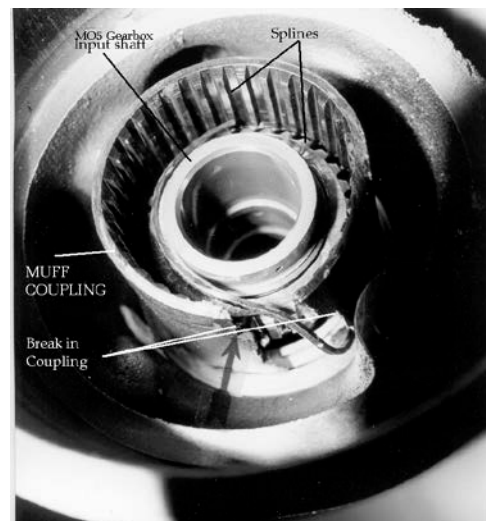
Metallurgical examination of the muff coupling at the TSB Engineering Laboratory established that the cause of the failure was the fatigue extension of a crack in the centre section of the coupling. The blocky, intergranular nature of the fracture surface suggests that the crack formed during the quench preceding the nitriding treatment, since a nitride layer was present on the crack surfaces. The manufacturer has advised that the overall nitride

layer would mask any existing cracks when checked by magnetic particle inspection (MPI) as the final step of the manufacturing process. The nitride layer would also have resulted in the crack not being detected by MPI during subsequent overhaul inspections since the coupling was placed in service.

Evidence of the nitriding layer through the crack surfaces was an indication that the crack was formed during the manufacturing process, before the final nitriding process and the MPI. Fatigue progression of the crack weakened the coupling until it failed. The nitride layer prevented discovery of the crack by the MPI process.

- The bar stock (billets) to be manufactured into couplings now undergo magnetic particle inspection (MPI) for any defects when received, before processing.
- The couplings undergo MPI and eddy current inspection after manufacture and heat treatment, but before nitriding.
- The couplings will now be serial numbered from manufacture.

- replace in-service couplings with new ones at overhaul or repair; and
- ensure that replacement couplings, if not serialized from the factory, are etched with the serial number of the reduction gearbox at installation and recorded on the reduction-gearbox log cards.
