AVIATION INVESTIGATION REPORT

A01H0003

ENGINE POWER LOSS - FORCED LANDING

PILATUS PC-6T C-GROO

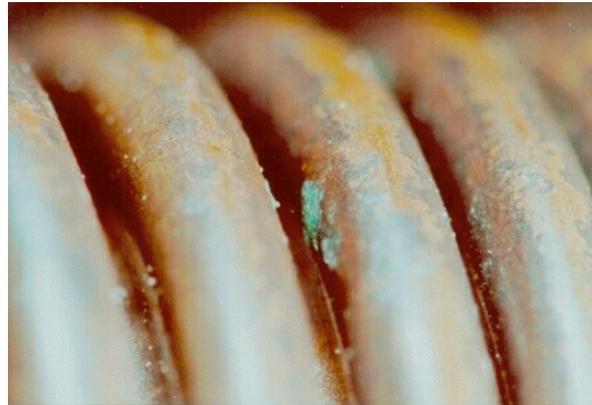
The FCU was initially shipped to the PWC Plant 12 accessories facility, where it underwent initial bench testing, followed by disassembly. The initial bench tests, using the PWC test equipment showed abnormal behaviour of the FCU, in that the unit restricted fuel flows to lower than normal values. Some adjustments, including those not allowed in field operation, were made on the FCU, and the unit would produce near normal fuel flows, but with hysteresis characteristics. The FCU was then disassembled. During disassembly, it was confirmed, by observing which parts had been marked by the operator, that the field adjustments made in June 2001 were allowable. After disassembly of the FCU, it was noted the FCU acceleration bellows had extended from its scribed height of 1.0156 inches to an atmospheric-corrected height 1.0952 inches. This represented a difference in the bellows length of 0.0796 inches, which was much greater than the 0.007 inches allowed. The increased length was indicative of a loss of vacuum in the acceleration bellows. Also, there were a few portions of the bellows with very small patches of greenish-blue discolourations. These discoloured patches could be seen with the naked eye (see Figure 1). Thus, further technical investigation was carried out on the bellows.

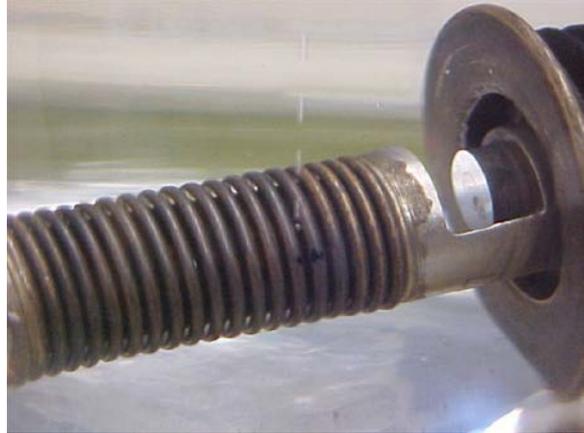
Leak testing of the bellows assembly at the time of the field investigation was conducted at the Honeywell facility in Montreal by immersion in a kerosene-base liquid in an evacuated chamber. The leakage of air shown by a stream of air bubbles is shown in Figure 2. The apparent site of the leak was identified as the side wall of the fifth convolution from the anvil end of the bellows. The location of the leak was at an area coincident with a corrosion deposit. It was decided that the examination of the failed bellows would be undertaken by the TSB Engineering Branch Laboratory. Examination was completed with representatives from the FCU manufacturer and Transport Canada, Continuing Airworthiness Directorate, in attendance.

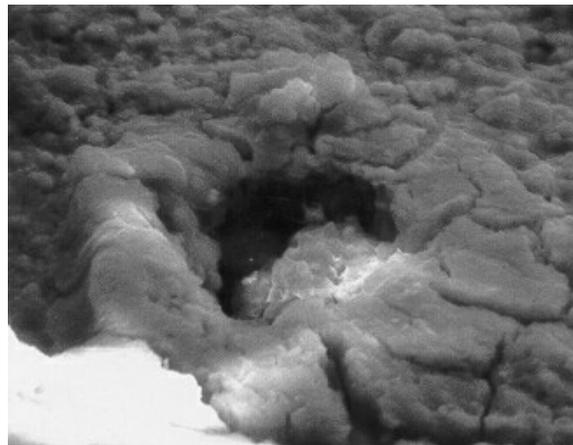
At the time of the testing, the presence of greenish blue coloured corrosion deposits was noted. Besides the deposit at the location of the leak, a second major deposit of the same corrosion product was noted on the side wall of the third convolution. Because of the location of the leak, it was difficult to examine the site using scanning electron microscope (SEM) images. Figure 3 shows a possible corrosion pit coincident with a region relatively clear of corrosion product deposits. The pit was measured to be some 50 microns or approximately 0.002 inches in diameter and it appeared from the SEM images to have significant depth. The presence of other pits underneath the heavier corrosion product deposits was considered a strong possibility. Energy dispersive X-ray analysis of the corrosion deposits indicated copper base corrosion products with a strong chloride and lesser sulphur presence. Both copper chloride and sulphate have the characteristic greenish-blue colour observed from the visual examinations and would be typically formed in the exposure of copper to moist marine or industrial atmospheres.

The bellows are a double-wall design, and perforation of the outer ply should not have necessarily compromised the integrity of the contained vacuum. However, an examination of the braze joints at either end of the bellows suggested a possible leakage path, with the joint at the threaded end of the bellows being the more likely area. The interior of the sectioned bellows shows a deep depression in the braze adjacent to the inner ply. A corresponding microsection of this region showed an inadequate fill, extensive porosity, and all likelihood of a leakage path from the airspace between the plies and the normally evacuated interior of the bellows. The porosity, according to the manufacturer's representative, may have resulted from the thermal expansion of air contained between the plies being forced through the molten braze metal during the brazing operation.
