AVIATION INVESTIGATION REPORT

A0100165

IN-FLIGHT BREAK-UP

CESSNA 210L CENTURION C-GPMC

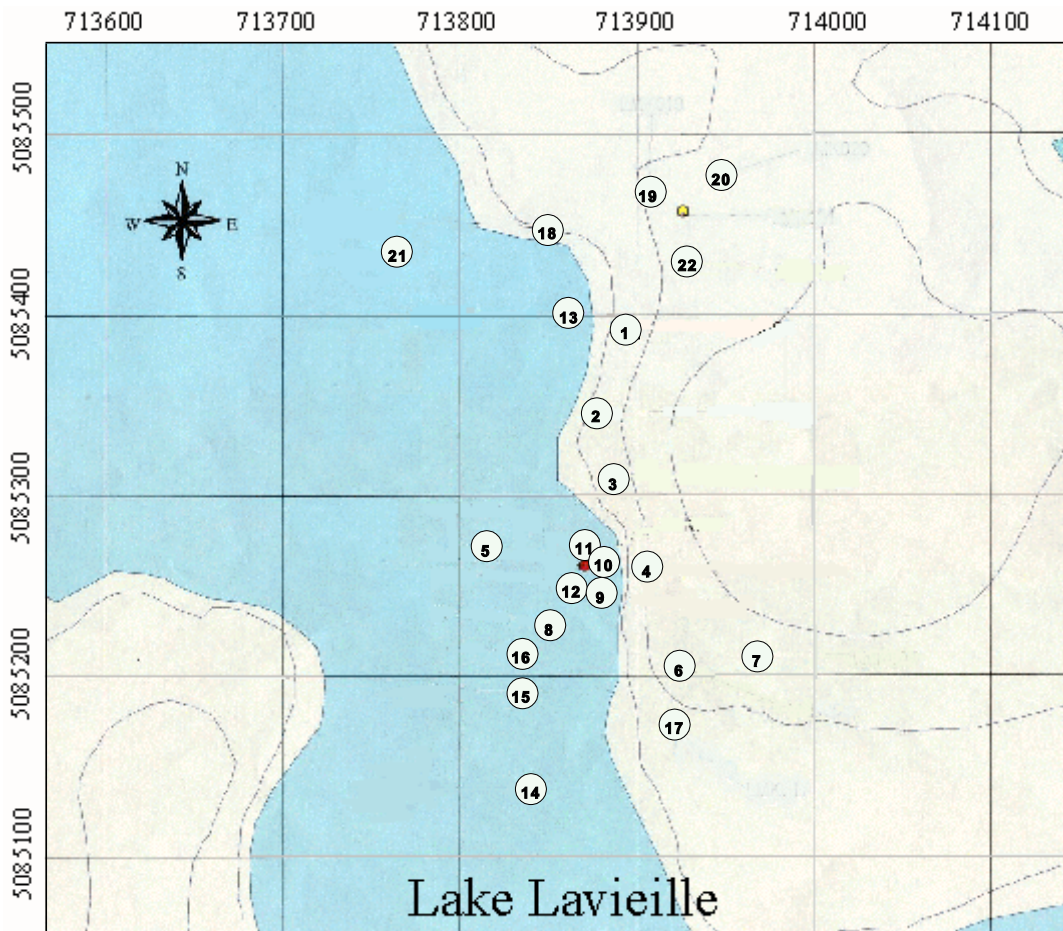
## Appendix A—Wreckage Diagram

Lake Lavieille is a large, remote lake in the interior of Algonquin Provincial Park. The forest surrounding the lake is very dense. The main wreckage was found approximately 15 feet from shore in 3 feet of water. The remaining portions of the aircraft and personal effects were found scattered up to 1000 feet away, both in the water and on the land. (See wreckage diagram in Appendix A.) The aircraft landed on the left side of the fuselage, severely deforming the fuselage along its entire length; however, the right side of the fuselage was relatively undamaged. The flaps and the landing gear were found in the retracted position.

The empennage separated just forward of the vertical stabilizer and was found in the water southeast of the main wreckage. All of the associated control cables and electrical wiring failed in overload. The horizontal stabilizers and the elevators separated from the empennage and were found in the water and on the land. The leading edges of the vertical and horizontal stabilizers showed signs of paint transfer and severe impact damage.

Notes: Small pieces of aluminum, plastic, plexiglass, and fibreglass were found throughout the entire forested debris field as defined by the landmarks. Although large pieces of wing, stabilizers, and flight controls were found in the water, very little small debris was found in the water, except at the main wreckage site.

The area around 21 and 22 was littered with small debris, that is, small pieces of aluminum, plastic, plexiglass, fibreglass, pieces of map, a magazine, and two sponge mitts that were used as intake plugs.
