AVIATION INVESTIGATION REPORT

A01P0061

MAIN-ROTOR BLADE FAILURE

MD HELICOPTERS 369D C-GHFL

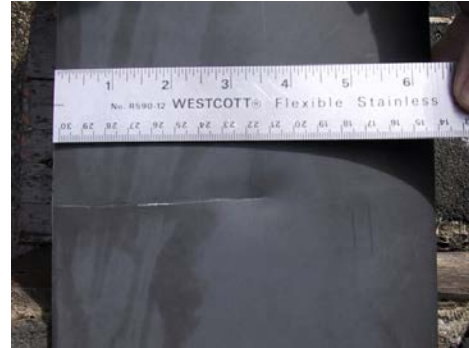
After the occurrence, company maintenance personnel inspected the blades and found that one of the five blades—part number 369D21100-523, serial number 009999-K077, the blade colour-coded yellow—had cracked at the upper and lower skins, from the trailing edge to the spar.

1. The main-rotor blade failed because its structural integrity was compromised by a manufacturing defect at the edge of a lightening hole in the C-channel, internal to the blade, located about three inches inboard of the data plate.

2. The defect at the lightening hole resulted in a fatigue crack that propagated to the lower skin, rearward to the trailing edge, and around to the top skin going forward in the direction of the blade spar.

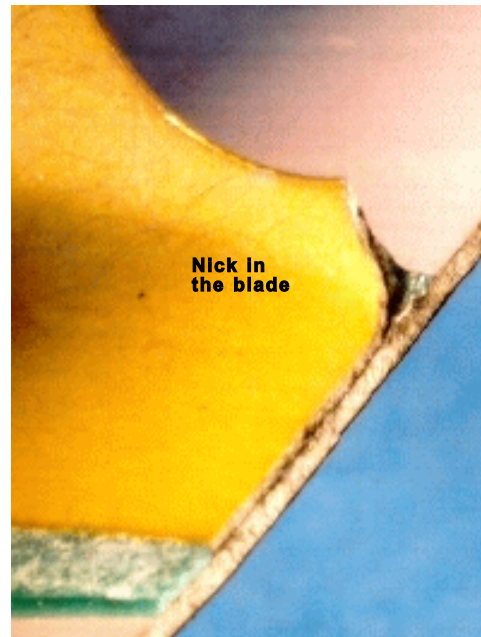
The failed blade was examined visually and using X-rays, photography, scanning electron microscope, and optical microscope. The examination revealed a fatigue failure and crack that started from a nick or rough radius on the edge of a lightning hole on the C-channel structure of the blade, about three inches inboard of the data plate. The fracture propagated to the top and bottom skins of the blade and subsequently across the cord of the blade, causing a separation at the trailing edge. The fractures stopped at or near the 'D' spar structure near the leading edge of the blade.

A nick or inclusion, in the radius of a lightening hole on the C-channel, was introduced at manufacture and compromised the structural integrity of the main rotor blade. This nick caused a stress riser and was the origin of a crack that propagated to the blade's lower skin, trailing edge, and onto the top skin perpendicular to the span of the blade, where the crack stopped near the blade spar. A recent inspection of the blade by company maintenance failed to detect any damage or crack; this suggests that crack propagation may develop rapidly and be difficult to detect.
