AVIATION INVESTIGATION REPORT

A01P0282

INPUT FREEWHEEL UNIT FAILURE

EUROCOPTER SA315B LAMA C-GXYM

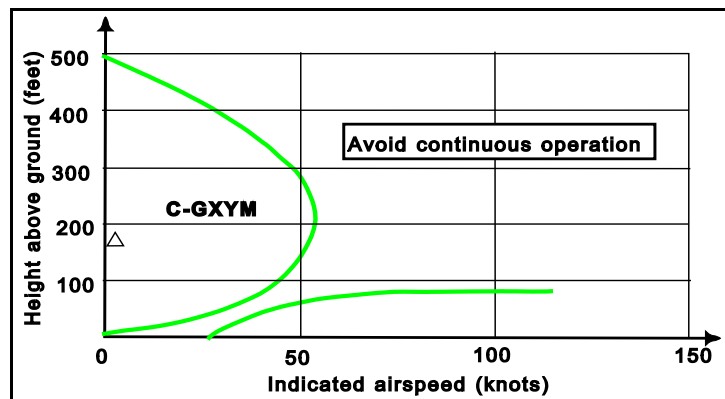
Section 4 (Performance) of the Transport Canada-approved rotorcraft flight manual (RFM) contains a speed-altitude graph outlining the in-flight parameters where pilots should avoid continuous operation (see Figure 1). The accident helicopter was used for repetitive heavy-lift (RHL) operations at about 165 feet above ground level and was being operated at a height and airspeed combination that had not been demonstrated to permit a successful emergency landing in the event of an engine power loss.

4. The helicopter was operated repeatedly in a hover about 165 feet above ground level, placing the helicopter in the "Avoid Continuous Operation" section of the speed altitude envelope chart. In this area of the chart, an emergency landing is unlikely in the event of an engine power loss.
