AVIATION INVESTIGATION REPORT

A01P0296

CESSNA 152 C-GJKE

BOUNDARY BAY AIRPORT, BRITISH COLUMBIA

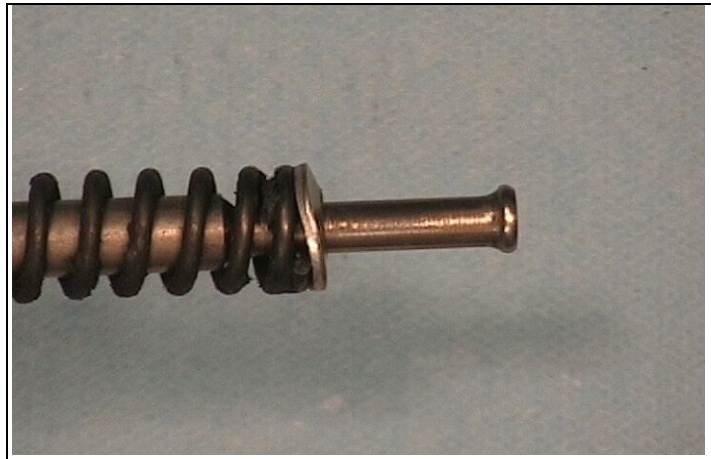
It was noted that the RH assembly could not be extended against the internal spring pre-load pressure, an action necessary to apply right rudder when airborne with the nosewheel in the normal centred and locked position. Dissection of both nosewheel

steering tube assemblies revealed that the inner spring retainer washer on the end of the rod section in the RH assembly was saucer shaped and positioned on the opposite side of an annular crimp in the outer tube section when compared to the same part in the LH assembly (see Figure 1). From this position, it could not return to its normal position and operation. If this condition pre-existed, it would not prevent steering action on the ground, yet it would mechanically prevent the application of right rudder when the nose oleo extended at lift-off and engaged the nosewheel centring and locking cam. The left rudder would operate normally since the RH nosewheel steering tube assembly could still operate in the compression mode. Furthermore, in this condition, the automatic centring action of the nose gear as the aircraft lifted off would have resulted in the application of two to four degrees of left rudder deflection. This is due to the left hand rudder centring spring taking up the slack introduced in the right hand rudder cable by the right hand rudder pedal being moved aft of its normal position due to the shortened length of the RH nosewheel steering tube assembly.

1. Even in the damaged condition as found, the washer in the RH nosewheel steering tube assembly withstood design loads during testing.
2. It could not be determined whether the anomaly in the RH nose gear steering tube assembly was the result of impact damage or whether the condition was pre-existing. If it was pre-existing, an explanation for the development of this anomaly could not be determined.
