AVIATION INVESTIGATION REPORT

A0200287

LOSS OF CONTROL AND COLLISION WITH TERRAIN

CESSNA 172P C-GNRJ

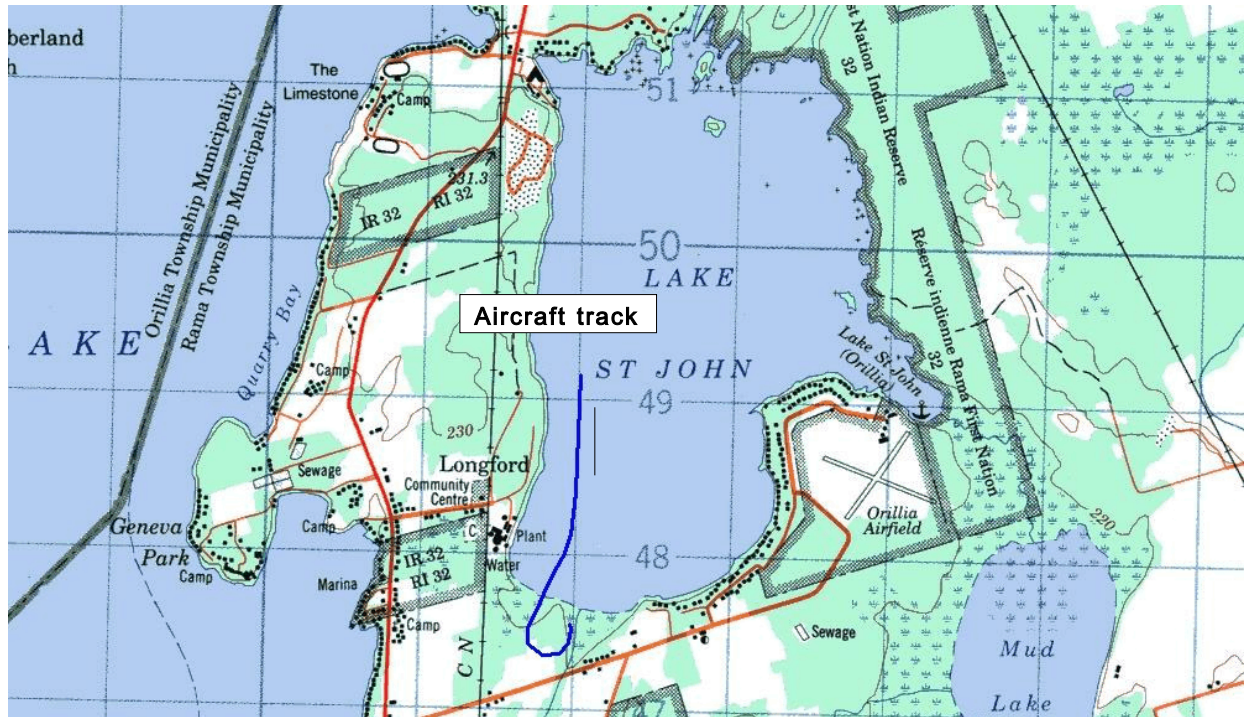
Appendix A - Lake St. John and Aircraft Track

Lake St. John is approximately 3.4 kilometres long and 2 kilometres wide and is oriented in a north/south direction (see Appendix A). Orillia Aviation Limited's float plane base is located on a bay on the south-eastern side of the lake. At the south end of the lake, where the occurrence took place, there is approximately 300 to 500 metres of swampy shoreline extending south to a tree line. The tree line marks the beginning of a forested area, with trees 20 to 30 feet tall.
