AVIATION INVESTIGATION REPORT

A02P0261

ENGINE POWER LOSS IN FLIGHT

Cathay Pacific Airways
Airbus A340-300 B-HXN
Timmins, Ontario 40 nm W
20 October 2002

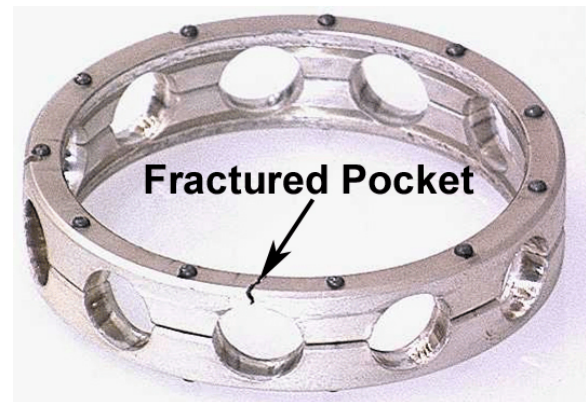
When the replacement PMA was removed and inspected, it showed scoring and burning similar to the original PMA. The entire PMA drive shaft assembly—comprising PMA rotor, roller bearing, drive shaft, ball bearing support, and ball bearing—was removed and examined. A visible crack was found in the ball bearing cage that supports the drive shaft where it exits the gearbox (see Photo 1). The crack could not be seen with the drive shaft assembly in place in the gearbox. A new drive shaft assembly and a third PMA were then installed, and another engine run was performed, this time without anomaly.

Photo 1. Ball bearing cage

The PMA drive shaft assembly was sent to CFM for examination and analysis. The CFM analysis of the failed ball bearing (part number 305-100-410-0, serial number UR06967) indicated that there was generalized spalling³ of the balls, wear on the cage pockets (including a fractured pocket), and sectorial spalling on 90° of the inner race (see photos 1 and 2). The ball bearing at this particular location is subject to temperatures as high as 160°C, and it rotates at about 20 000 rpm. There was no indication of corrosion. The roller bearing (part number 301-480-926-0) had two separate serial numbers on the races (inner race: UR31008, outer race: UR28466). No other anomalies were found on the remainder of the drive shaft components. The root cause of the spalling was not determined by CFM.

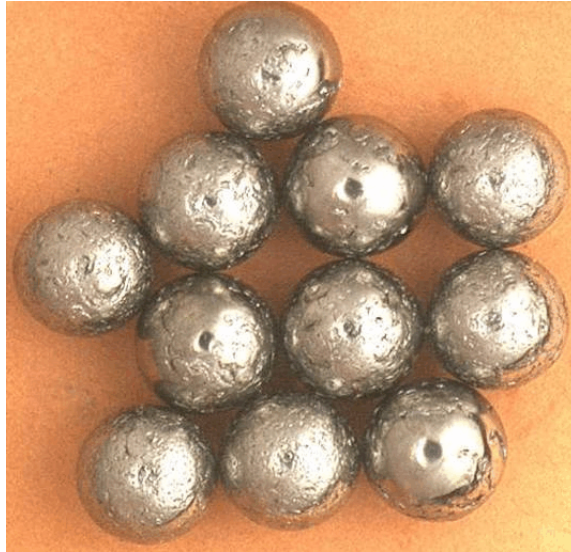
Photo 2. Spalled balls

CFM concluded that the incident ball bearing failed as a result of radial overload stress, which induced inner race spalling, the origin of which occurred 50 to 70 μm in depth. Radial overload stress, also known as “contact fatigue,” results from two curved surfaces moving over each other in a rolling motion, as seen in a ball bearing over a raceway.⁵ The contact geometry and the motion of the rolling elements produce alternating subsurface shear stress, which generates and accumulates cracking. The cracking then propagates until a surface pit is formed and spalling results. If this degeneration continues, complete bearing failure occurs. Rolling contact components have a fatigue life, that is, a number of cycles to develop a noticeable fatigue spall.

1. As a result of radial overload stress (contact fatigue), spalling damage occurred to the balls in the inner race of the ball bearing on the drive shaft of the permanent magnet alternator (PMA) on the number 1 engine, resulting in bearing failure.
