AVIATION INVESTIGATION REPORT
A03A0002

COLLISION WITH WINDROW

LABRADOR AIRWAYS LTD.
BEECH 1900D C-GLHO
ST. JOHN'S INTERNATIONAL AIRPORT
NEWFOUNDLAND AND LABRADOR
11 JANUARY 2003

Report Number A03A0002

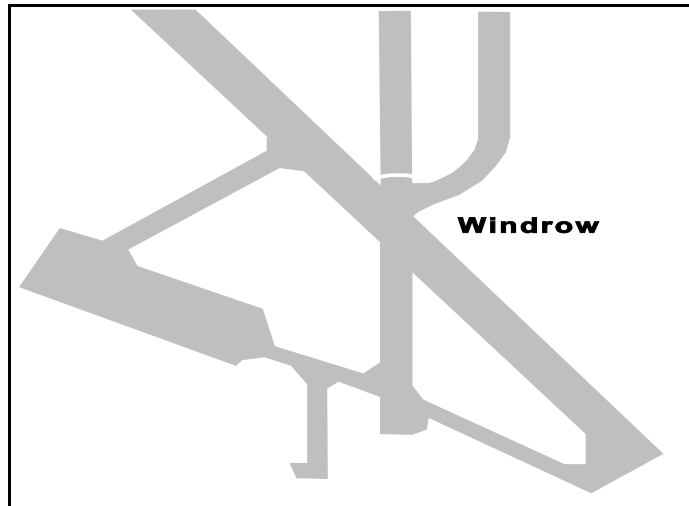
At 0841, Lab Air Flight 8333 was cleared to taxi via Foxtrot, Runway 02, and to hold short of Runway 29 (see Figure 2). An analysis of the flight data recorder (FDR) information showed that the aircraft was travelling at about eight knots and was accelerating when it rolled out on the runway, heading on Runway 02. As the aircraft approached the intersection of runways 02 and 34 there were several snow removal vehicles on Runway 34 east of the intersection. After confirming that the vehicles were holding short, the crew proceeded through the intersection, initiating the "instruments" portion of the taxi check nine seconds prior to striking the windrow. According to the operator's standard operating procedures for the instrument cross-check, the captain (pilot flying), must look inside the cockpit to call out indications from the aircraft's flight instruments. Meanwhile, the first officer (pilot not flying) is supposed to also monitor the instruments and when found correct will respond "Checked and Set Left/Right."

As the crew were conducting this check, the windrow was spotted. The aircraft was now 3.5 seconds and 146 feet² from the windrow and travelling at 24 knots. The captain attempted to stop with wheel braking, approximately two seconds later and 60 feet short of the windrow. When the wheel brakes were applied, the aircraft started to skid on the slippery runway surface. The captain attempted to apply reverse thrust, but there was insufficient time for it to be selected before the nosewheel struck the windrow, at 23.5 knots. The propellers struck the windrow next, followed one quarter of a second later by the main gear, which struck the windrow at approximately 20 knots.
