AVIATION INVESTIGATION REPORT

A03H0001

COMMUNICATIONS FAILURE AND LOSS OF SEPARATION

GANDER AREA CONTROL CENTRE

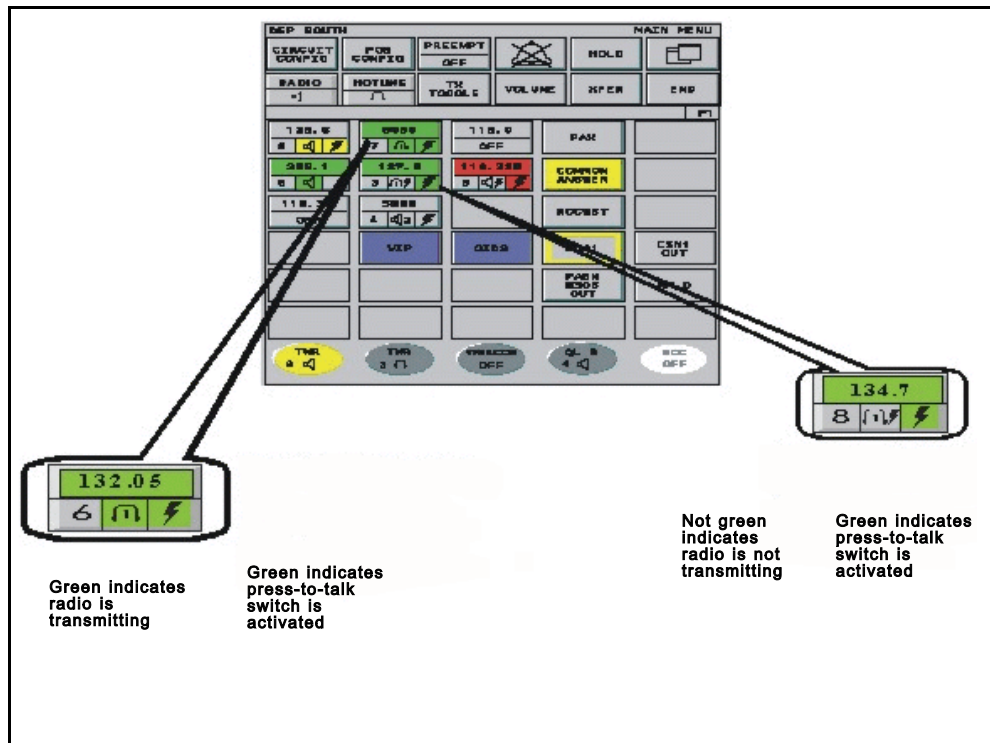
The VSCS is the primary interface for controllers to access the radios and landlines. The VSCS CCP is a display module (see Figure 1) located at each control position. The CCP is a touch sensitive screen which displays all the air/ground frequencies and landlines available to controllers. Each frequency is displayed separately on the screen by a rectangular icon. Different sections of the frequency icon show green depending on what the controller is doing: receiving, transmitting or has pressed the ‘press to talk’ switch but no transmission occurs (this indicates that there is a fault).

The VSCS training provided to controllers included both classroom instruction and hands-on practice. The controller involved in this incident was not aware that the specific green pattern in the frequency icon for 134.7 MHz indicated that he was not actually transmitting on that frequency, even though he had depressed the ‘press-to-talk’ switch. This was the only direct indication to the controller that there was an air traffic control (ATC) communications equipment failure. During the investigation it was determined that some other controllers were also not aware of the significance of the various green light indications on the CCP.

The VSCS CCP display provided one clue that the loss of communications was caused by a failure in the ATC communications system and not by the aircraft; however, the differences in the display indications on the VSCS CCP was not obvious to the controller. A glance at the frequency icon would have shown what the controller expected to see whenever he attempted to activate the frequency, that is, an overall green indication. However,

only a close look and detailed familiarity with the meaning of the different types of display patterns on the frequency icon would have alerted the controller that he was not getting out on the frequency. Although the controller had received instruction on the operation of the VSCS during training, and had used this equipment for a number of months, he was not aware of the variety of display patterns nor of their exact meaning. The controller involved in the incident was not alone in not knowing the meaning of the presentation on the VSCS CCP frequency icon. The supervisor, on looking at the VSCS CPP, did recognize that the controller was not transmitting on 134.7 MHz.

It was not common knowledge among technicians and controllers that an anomaly in the communications control panel (CCP) of the voice switch communication system (VSCS) existed that allowed a green transmitter light on the CCP to indicate that the transmitter has been keyed and should be transmitting when in fact it was not. This deficiency has been identified to NAV CANADA's Operational System Requirements Branch for resolution.
