AVIATION INVESTIGATION REPORT

A03H0002

COLLISION WITH TERRAIN

CESSNA 208B CARAVAN C-FKAB

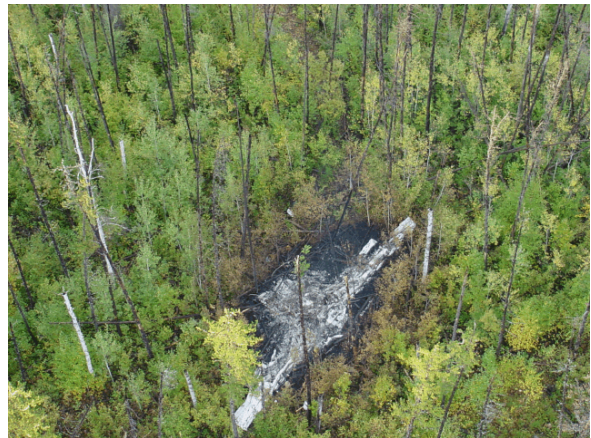
Examination of the wreckage revealed that the aircraft struck heavily wooded terrain in a near vertical attitude with the wings level. The site was located 3.1 nm from Summer Beaver on a 295° M bearing from the threshold of Runway 17. The aircraft knocked down several trees that had occupied the ground where the aircraft came to rest, and there were signs of tree impact to the leading edges of both wings. The aircraft came to rest facing 200° M, with the remains of the wings nearly perpendicular to the fuselage. Fire consumed some trees and most of the aircraft, with the exception of portions of the fuselage, wings, engine, and propeller. The remains of the landing gear, seats, door latches, and cargo pod were identified. No evidence of pre-impact structural failure was identified.

All major components of the aircraft were located at the accident site. No discrepancies were found with the portions of the aircraft that could be examined. Only small fragments of the windshield were found within and immediately outside of the site perimeter.
