## AVIATION INVESTIGATION REPORT

### RUNWAY EXCURSION

GULFSTREAM AEROSPACE LP ASTRA SPX C-GSSS

Report Number A03O0273

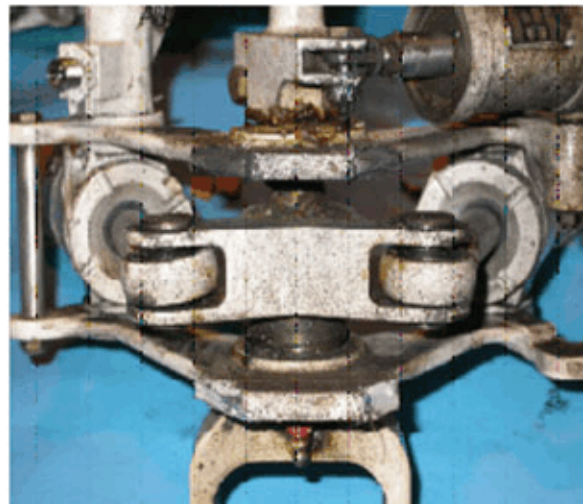
Examination of the aircraft revealed that the nose landing gear steering assembly upper and lower attachment brackets had failed near the attachment to the aircraft bulkhead. The left steering actuator was found fully extended and the right steering actuator was found fully retracted; this corresponds to a full-left steering input. The entire steering assembly was rotated and jammed against the right side of the nose landing gear bay, beyond the normal steering range for the nose landing gear.

The steering assembly (see Photo 1) comprises an upper and lower attachment bracket, a left and right steering actuator, and a shaft with a universal joint to mate to the nose landing gear. The brackets are bolted together at four points using nuts and bolts with a spacer to maintain separation. The entire steering assembly is then bolted to the aircraft at the nose landing gear bay aft bulkhead.

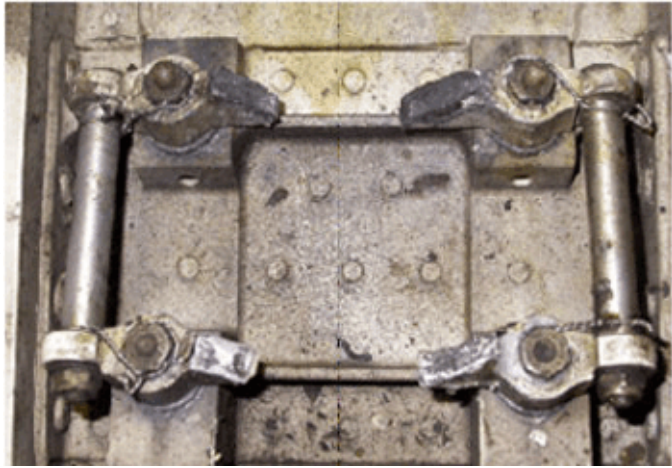
There was fretting<sup>2</sup> found on the mating surfaces of the upper and lower brackets at the attachment to the aircraft bulkhead (see Photo 2). The upper bracket fracture surfaces were heavily contaminated with blackened Skydrol hydraulic fluid, and had a polished appearance. As well, the paint around the fracture surfaces was softened and blistered in much the same manner as a painted surface with paint stripper applied. By comparison, the lower bracket fracture surfaces were clean and dull in appearance, and the paint showed no signs of softening or blistering. Both the upper and lower bracket fracture surfaces had smearing damage from the fracture surfaces impacting each other. The entire steering assembly was forwarded to the Transportation Safety Board (TSB) Engineering Branch Laboratory for further examination.

Laboratory examination showed there was no indication of fatigue cracking on any of the fractured surfaces and all of the fracture surfaces were representative of overstress failures. A test was conducted to see how long it would take for the paint to start blistering if contaminated with Skydrol hydraulic fluid. This consisted of scratching through the paint to the metal on a cleaned portion of the attachment bracket. This would be representative of a typical crack in the paint at a fracture site. The area was then contaminated with Skydrol hydraulic fluid; it took approximately three weeks for the test area to show any signs of paint blistering.

It was concluded that the top attachment bracket was overstressed and failed at sometime prior to the occurrence. It was not possible to determine when the top attachment bracket failed; however, the combination of the polished fracture surfaces, the blackened Skydrol contamination on these surfaces, and the softened paint around the fractures are indicative of an old failure that had been working or rubbing together for sometime. Additionally, the fretting found on the mating surfaces of the upper and lower attachment brackets supports this analysis. The fretting indicates that the attachments to the aircraft were moving due to the transfer of steering loads to the lower brackets. The clean, dull fracture surfaces of the lower bracket were overload failures at the time of the occurrence.
