AVIATION INVESTIGATION REPORT

A03P0054

IN-FLIGHT ENGINE FAILURE

BOEING 737-200 C-FTWJ

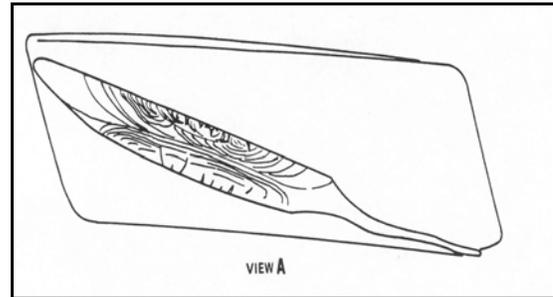
Figure 1. Fracture surface profile

All of the LPC and HPC stages, with the exception of the 1st and 2nd stages, suffered some form of mechanical distress or failure. The TSB Engineering Laboratory examined the full rotor airfoil set from the 3rd stage, using a low- to medium-power stereo microscope. Results from this examination indicated that 13 airfoils had broken in fatigue; the fatigue fracture topography varied from 40 per cent to 85 per cent of the total cross-section. In addition, 14 other airfoils exhibited advanced fatigue cracking. The fatigue cracks propagated from multiple origins on both the convex and concave sides of the airfoils, indicating cyclic loading in reverse bending.

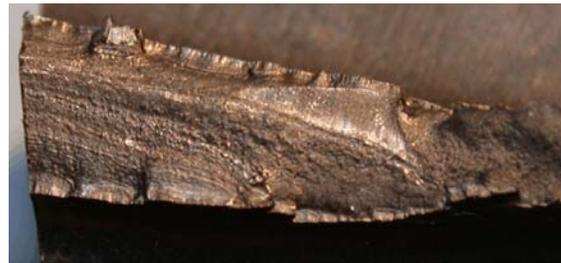
Photo 1. Fractured 3rd stage compressor airfoil
