**AVIATION INVESTIGATION REPORT  
A03P0136**

**ENGINE POWER LOSS – HARD LANDING AND ROLLOVER**

**BELL 206B C-GPOS**

**06 JUNE 2003**

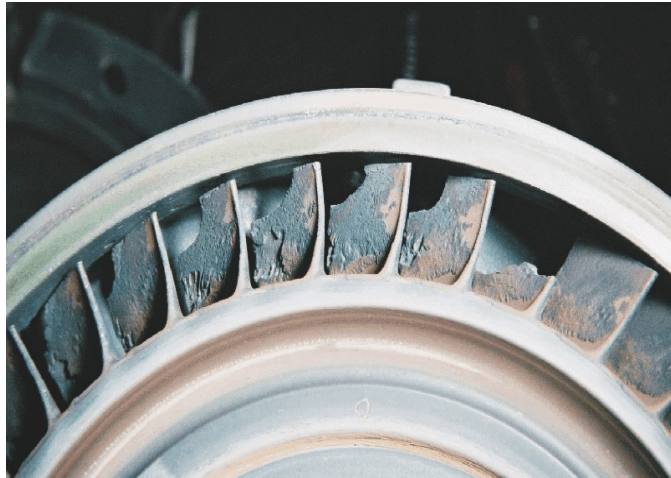
Examination of the remaining fracture surface of the blade that broke close to its root showed indications of a progressive failure (fatigue crack). The other fracture surfaces showed failure by overload. More detailed examination of the GP turbine blades showed extensive sulfidation corrosion<sup>1</sup> (see Photo 1). The blade surfaces were flaking and there were fatigue cracks in many of the blades. The turbine first-stage nozzle labyrinth seal was damaged and the outer fibreglass packing was partially missing. There was soot at the joint between the turbine nozzle and number 1 GP turbine and thick, black, wet soot around the labyrinth seal and on the turbine coupling.

**Photo 1.** Sulfidation of number 1 GP turbine. Engine compressor washing is recommended in corrosive and dirty environments. It is also prescribed when engine performance has depreciated, as noted from power assurance checks. However, there has been concern that some tap water can in itself be corrosive. Operators rarely do compressor washes when their helicopters are operating away from a salt environment. They will wash compressors when they can see dirt building up at the air intake, or when an engine is performing below specifications. It is not clear if compressor washing effectively cleans the GP turbine wheel.

There were no periodic power checks carried out, or required, by the operator to detect a power loss, nor maintenance inspections required by the manufacturer or the operator for sulfidation corrosion. It is suggested that either power checks or maintenance inspections would have led to the discovery of the corroded turbine components. The identified sulfidation weakened the GP turbine blades, fatigue cracks occurred on many of the blades, and one of the blades separated. Parts of other GP turbine blades broke off and engine power was lost.

1. Periodic power checks or inspections for sulfidation corrosion, which most likely would also have detected a power loss and the corroded turbine components, were not undertaken, nor were they required.
2. A blade in the number 1 GP turbine failed as a result of fatigue, which resulted from sulfidation corrosion; the engine lost power as a result of the blade failure.
3. The helicopter was operating in a high hover when the engine lost power. The ensuing forced landing was hard, the landing gear broke, and the helicopter rolled over.

On 03 October 2003, the TSB sent a Safety Advisory (A030018) to TC, with copies to Rolls-Royce, Bell Helicopter Textron, and Cariboo Chilcotin Helicopters Ltd., drawing attention to the predominant cause for the engine power loss – sulfidation corrosion. Because periodic inspections are not required, the risk of this corrosion going undetected in other aircraft powered by Rolls-Royce 250 engines remains. The letter stated that TC may wish to consider whether periodic inspections should be carried out to help detect damage caused by sulfidation corrosion.

Subsequent to TC's first response, the TSB Engineering Branch conducted a further examination and testing, and documented its findings in report LP 037/04. On reading that report, TC provided a second response, dated 15 April 2004, in which it concluded that sulfidation was indeed the process by which the turbine blades deteriorated and eventually failed due to fatigue. TC will recommend to the engine manufacturer that an inspection for sulfidation on the turbine blades of this engine be implemented, and that this recommendation will be tracked in TC's Civil Aviation database.
