AVIATION INVESTIGATION REPORT

A04O0016

NOSEWHEEL AXLE FAILURE

AIRBUS A321-211, C-GJWI

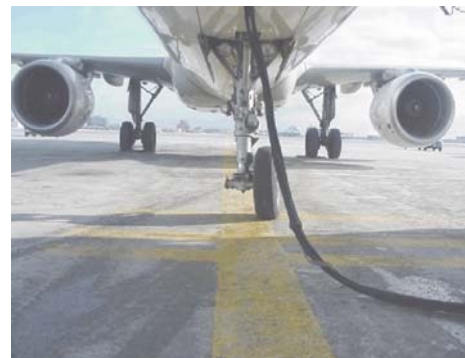
Photo 1. Aircraft at gate shortly after arrival

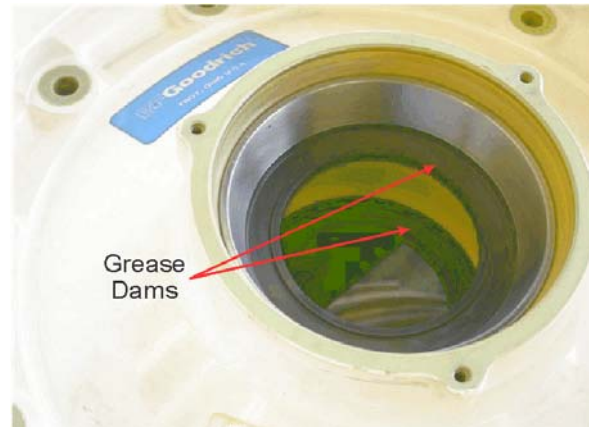
The inner wheel assembly was found to be covered with discoloured grease. The inner bearing grease dam, normally positioned next to the bearing to reduce grease migration and subsequent bearing damage or failure, was found dislodged and sitting against the outer bearing grease dam. The two contacting surfaces were clean and free of grease. The grease dams (see Photo 2) are rubber-like and are held in place by a protruding ridge moulded on the circumference of the dam. When installed, the ridge fits into a channel in the wheel assembly. The dam can be displaced during wheel installation as the wheel is being slid onto the nose landing gear axle. If this happens, the displacement may go undetected since the dam is not visible to the installer because of its location within the wheel assembly.

Photo 2. Dam location in wheel assembly

1. The dislodged inner-bearing grease dam allowed grease to migrate from the inboard roller bearing of the right nosewheel to the inside of the nosewheel assembly. A reduction in lubrication increases the cage loads and may lead to bearing failures.

Air Canada has also issued a maintenance alert and revised its wheel installation job card to stress the importance of a wheel inspection prior to installation and to ensure the recommended wheel installation tools and torques are used in accordance with the *Aircraft Maintenance Manual*. The Air Canada wheel shop manuals were revised to raise the awareness of the importance of grease dams and seal installations.

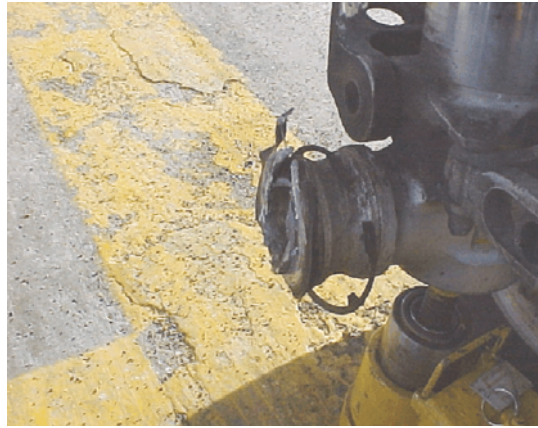
The nose landing gear wheel axle was examined and found to be fractured circumferentially in the vicinity of the collar (see Photo 3 and Appendix A). Both of the fracture surfaces appeared rugged with stains radiating from the inside diameter surface. In addition, the fracture was covered with a carbonaceous residue. There were indications that the axle had been subjected to high temperatures as the paint on both the inner and outer surfaces was blistered, flaking and discoloured, and the cadmium plating had melted and resolidified to form beads. The fracture originated on the inside diameter surface of the axle. The inner and outer diameters of the axle are cadmium plated for corrosion protection.

Photo 3. Close-up view of axle

A scanning electron microscope was used to examine the fractured surface of the axle. The stained portion of the surface was a blocky, intergranular fracture typical of embrittled steels. The remaining surface was ductile in appearance.

The energy dispersive x-ray spectrum of the intergranular surface revealed the presence of cadmium, confirming that the mode of failure of the axle was a result of liquid metal (cadmium plating) embrittlement. The microstructures of the axle material conformed to a typical high-strength steel, as specified for this application.

The heat generated from the friction of the failed bearing raised the temperature of the axle beyond the melting point of cadmium, which is greater than 321°C. There were also indications that the aluminum alloy sleeve had partially melted, which would require a temperature greater than 660°C.

1. The nosewheel right inboard roller bearing failed. It is likely that the lack of lubrication as a result of the grease dam being dislodged from its normal position was a contributing factor.
2. The friction temperatures created by the failed roller bearing exceeded the cadmium melting point. Cadmium penetrated and weakened the intergranular structure of the nose landing gear axle, causing it to fail due to liquid metal embrittlement.

Air Canada has taken steps to have the axles for its nose landing gears coated with SermeTel® to reduce the likelihood of axle failures from cadmium infusion as a result of high friction heat generated from bearing failures. SermeTel® is an anti-corrosive and chemical-resistant base applied as an initial coating prior to decorative coatings of epoxy resin and polyurethane paints.
