AVIATION INVESTIGATION REPORT
A05P0227

ENGINE POWER LOSS LEADING TO LOSS OF CONTROL

ENSTROM 280C (HELICOPTER) C-FKEO
DUNCAN, BRITISH COLUMBIA
17 SEPTEMBER 2005

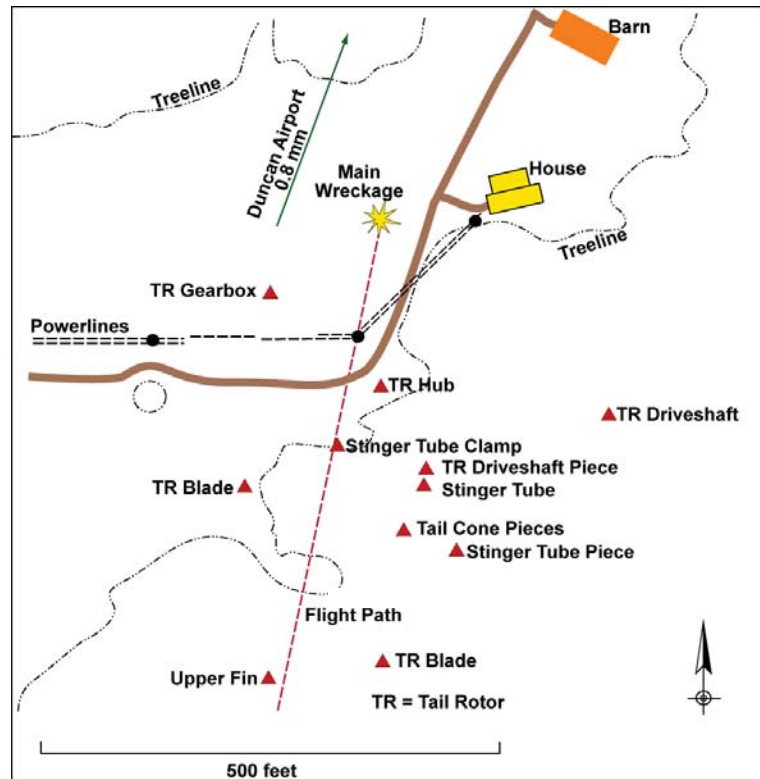
Figure 1. Diagram of wreckage site

During the last 300 feet of the flight path, the tail rotor assembly broke away from the helicopter. The helicopter climbed steeply then descended rapidly to the ground. An explosion and fireball occurred at ground impact, and the helicopter came to rest on its left side. Both occupants were fatally injured at impact, and the cabin and pylon areas were destroyed by impact forces and fire. The wreckage distribution patterns and the dimensions of the debris trail are characteristic of an in-flight break-up event (see Figure 1).

The aft end of the tail cone exhibited main rotor strike damage. Tail section parts found along the flight path as far back as 500 feet from the main wreckage site also exhibited main rotor strike damage. The orientation of the strike marks on the tail components indicates that the main rotor blades contacted the tail cone. Subsequent strikes to components located aft of the tail cone (such as the tail rotor blades) occurred when those components moved into the main rotor path.

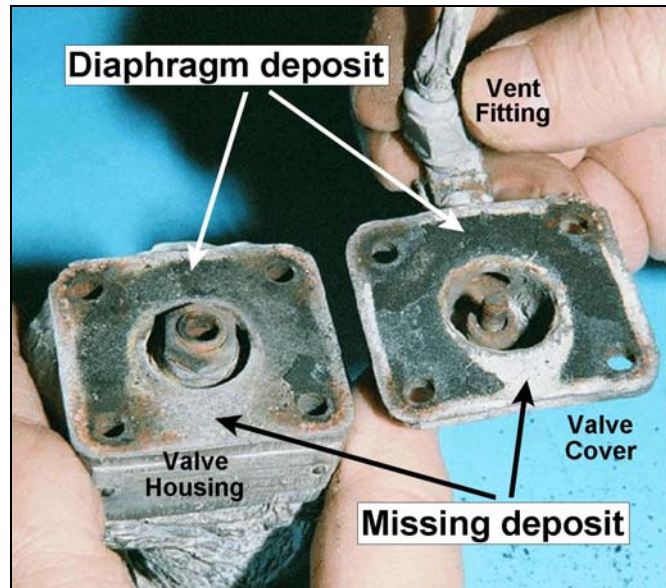
The engine was equipped with a Crane (Lear Romec Division) engine-driven rotary fuel pump, part number RG17980K, serial number B 8714. The fuel pump examination found that the diaphragm (part number RA-7434), located between the relief valve housing and relief valve assembly cover, had been reduced by fire to an ash deposit. An area between the two relief valve attaching screws opposite the vent fitting (see Photo 1) was free of ash deposit. This ash-free area would be adjacent to the magnetos when the pump was installed on the engine. The gasket between the relief valve housing and the fuel pump housing had also been reduced

to an ash deposit. However, the ash pattern resembled the complete gasket shape. The installation torque on the four relief valve-to-pump-housing attachment screws could not be determined due to fire damage. No additional anomalies were observed regarding the fuel pump.

Photo 1. Valve housing and cover with gap in diaphragm

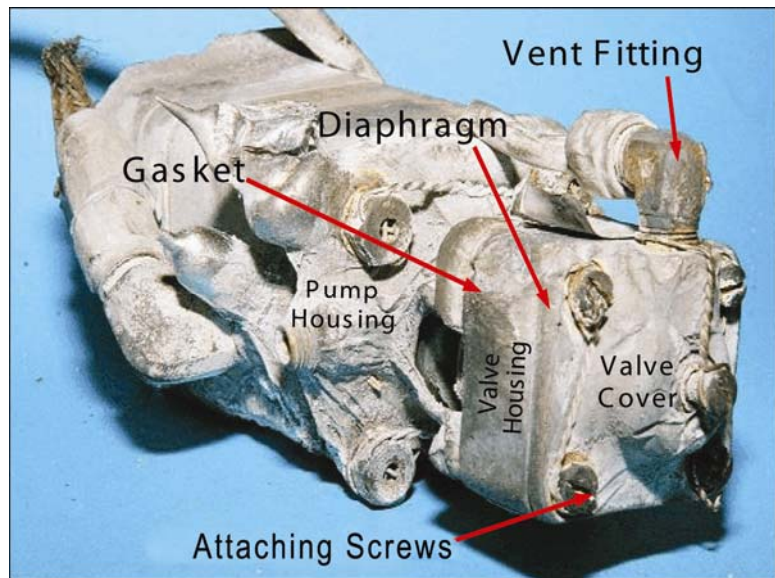
Photo 2. Engine-driven fuel pump

AD 2003-14-03, which supersedes AD 98-18-12, requires a torque check inspection of the four fuel pump relief valve attaching screws (part number AN500A10-22) for the prescribed torque of 23 to 25 inch-pounds. This inspection is to be completed every 50 hours time in service or every six calendar months, whichever comes first. These screws secure the assembly of the valve cover, diaphragm, valve housing, and gasket to the fuel pump. It has been determined that loss of torque on these screws allows the extrusion of the gasket (part number RA-15981) between the

valve housing and the pump housing and the extrusion of the diaphragm between the valve housing and the valve cover (see Photo 2). According to the information in the ADs, extrusion of the gasket and/or the diaphragm is known to have caused serious fuel leakage, which in turn can lead to engine failure, engine fire, and damage to, or loss of, various aircraft. The most likely source of ignition from an external fuel pump leak is the extremely hot turbocharger and exhaust system.

Technical information confirms that the engine-driven fuel pump diaphragm is a known vulnerability. As the helicopter maintenance records indicated that the torque check on the relief valve retaining screws had not been repeated as required by the AD and because a portion of the diaphragm residue was found missing, a fuel leak most likely developed at the split line between the relief valve housing and the relief valve cover. This concurrently allowed the fuel to leak externally from the pump into the engine cowl where sources of ignition were abundant and, due to the lack of the required restricted fuel pump vent fitting, to leak internally into the intake manifold causing an over-rich fuel mixture. Either the over-rich mixture or the loss of fuel pressure or a combination of both would result in a rough running engine and loss of engine power. As the magnetos were among the most heavily damaged of the engine accessories, and as the leak was adjacent to the magnetos, the fire may also have affected the ignition system in flight and further contributed to the power loss.

AD 2003-14-03 further allows a terminating action (replacement of the pump with one having a new design valve housing) to be performed once in lieu of the repetitive maintenance action. The pump in C-FKEO did not incorporate the redesigned valve housing, nor was there any
