AVIATION INVESTIGATION REPORT A06O0180

COLLISION WITH WATER

**CESSNA 172M C-FKWP
WILCOX LAKE, RICHMOND HILL, ONTARIO
16 JULY 2006**

Report Number A06O0180

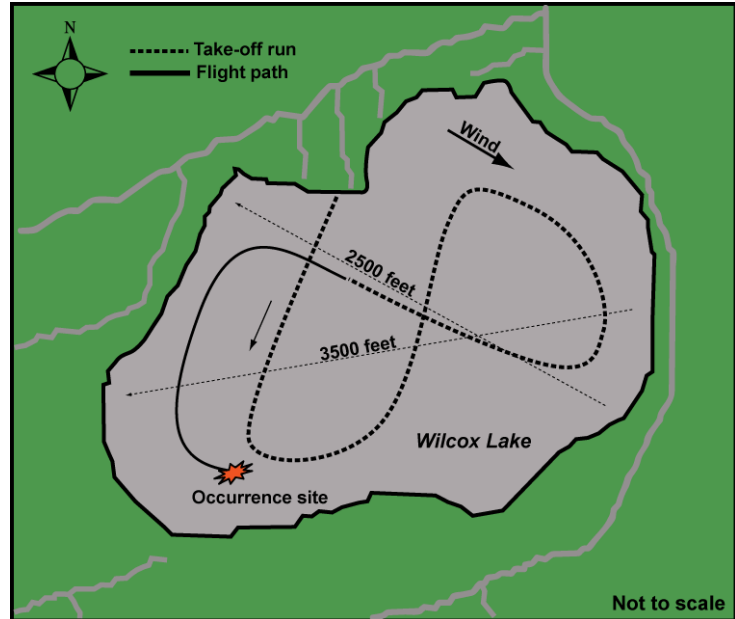
Figure 1. Wilcox Lake take-off diagram

Wilcox Lake is a small lake in a residential area of Richmond Hill. The shoreline is surrounded by residential buildings, and beyond that, numerous subdivisions. The lake is popular for recreational activities such as swimming, boating, and canoeing; during the occurrence, it was being used extensively. The longest section of the lake is approximately 3500 feet in an east-west direction. The direction the aircraft was traveling during the final take-off run was northwest. The total distance available from the southeast shoreline to the northwest shoreline for the take-off run was about 2500 feet. (See Figure 1)

During the take-off of a floatplane, it is necessary to get the floats in a planing condition so the aircraft can accelerate. This is commonly referred to as getting the aircraft "on step." When there is sufficient room for take-off and the lake is free of obstacles, this procedure is normally executed straight ahead. If it is necessary for the aircraft to change direction while on step (step taxiing), it requires a larger turning radius than while taxiing at a slow speed. The figure-eight manoeuvre that was used during the take-off entailed changing direction twice and, because of the speed of the aircraft, a large radius turn could be expected. The aircraft was approximately 200 feet from the east-southeast shoreline before turning to a northwest direction for the final take-off run.

The distance available for take-off into wind, in a northwest direction, was insufficient. While there was enough distance to get airborne, the aircraft would not have been able to climb safely to an obstacle clearance altitude of 50 feet. However, even with the 60° crosswind, the lake was long enough in an east-west direction for a take-off and climb to an obstacle clearance altitude of 50 feet. Although taking off directly into a headwind is the preferred procedure for optimal performance, in this instance, the performance degradation from the crosswind component would have been minor. The pilot elected to use a step-taxi turn in an attempt to shorten the take-off run. However, this had a negligible effect because the turn radius of the aircraft was increased during the final turn, thereby shortening the into-wind take-off distance available. After lift-off, the slow speed of the aircraft did not provide much margin above the stall speed for manoeuvring. As the aircraft banked to avoid obstacles, the stall speed increased, and the aircraft stalled.
