AVIATION INVESTIGATION REPORT

A06Q0114

LOSS OF CONTROL AND COLLISION WITH TERRAIN

AVIATION MAURICIE
CESSNA U206F (FLOATPLANE) C-FMGP
PASTEUR LAKE, QUEBEC
08 JULY 2006

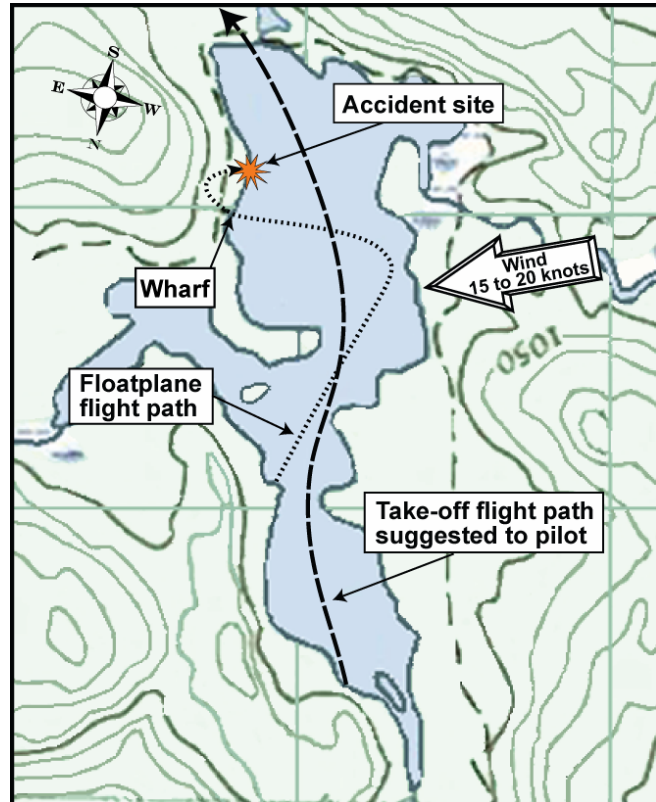
Figure 1. Topographic map of Pasteur Lake

The owner of the wharf had a floatplane that he used regularly to travel between Tortue Lake and Pasteur Lake. Before departure, he informed the occurrence pilot of the take-off flight path preferred by other pilots familiar with Pasteur Lake. It consisted in starting the take-off run from the far north end of the lake heading in a southwesterly direction, and after lift off, it was necessary to make a slight turn to the left to continue to climb in the saddle between the two mountains bordering the southern section of the lake (see Figure 1).

At about 1100, the pilot got into the right front seat, the student pilot got into the left front seat and the passenger sat in the right back seat. At approximately 1112, the aircraft left the wharf and taxied on the water towards the northern section of the lake. The floatplane disappeared behind a peninsula (see Figure 1) and shortly after started its take-off run towards the southwest.

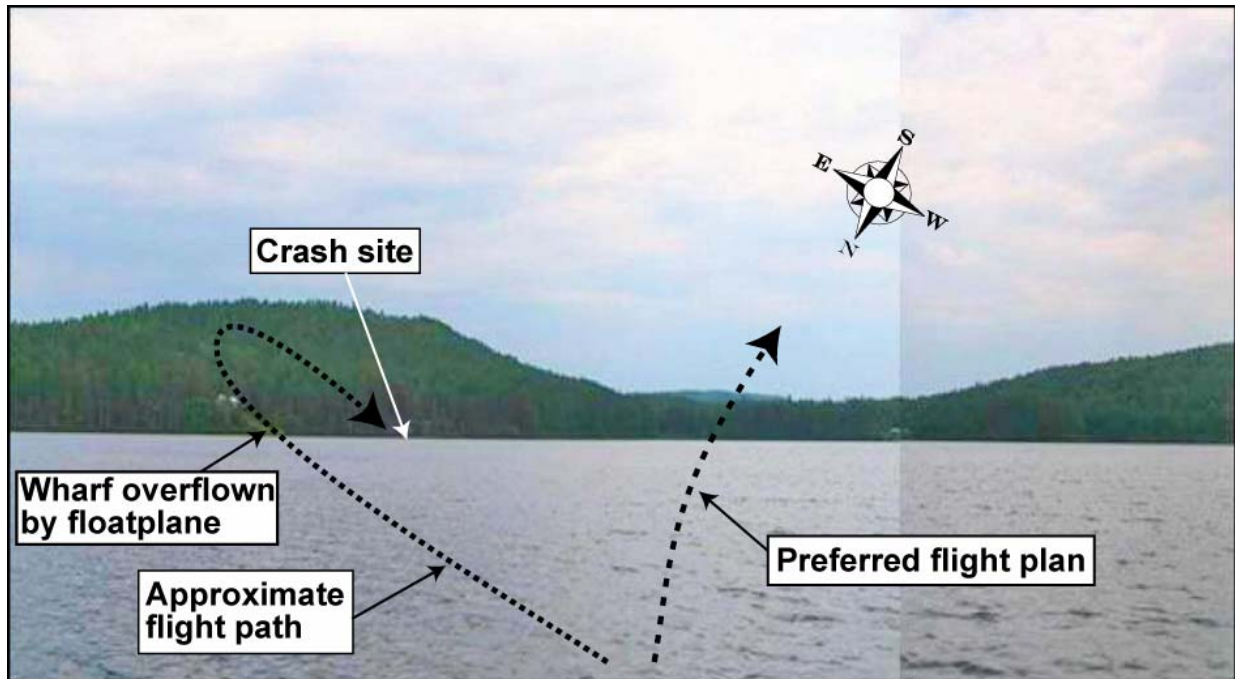
Rather than following the suggested flight path, the aircraft took off more or less into the wind in a southwesterly direction. Shortly after becoming airborne near the western shore of the lake, the aircraft turned left heading east with a tailwind, and headed directly towards the departure wharf (see Photo 1). About 1700 feet separated the two shores of the lake where the turn was made. After flying over the wharf, the aircraft stalled and crashed 300 feet to the south. The engine continued to operate for a short time.

Photo 1. View of the location where the floatplane turned towards the wharf after becoming airborne

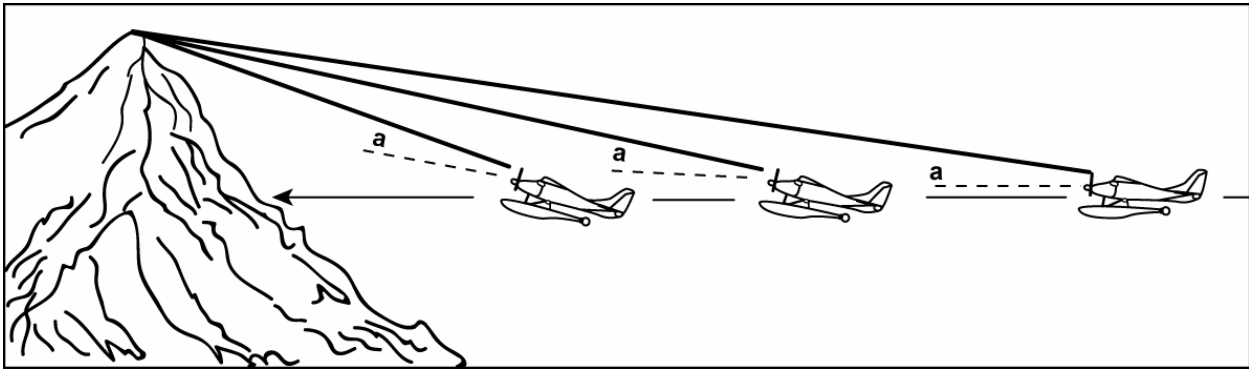
In some situations, a pilot's ability to estimate speed, size, distance, the direction to a slope, or even to identify objects can be seriously diminished. Pilots can be subjected to optical illusions when approaching a rising slope at right angles. When getting close to the ridge, the pilot may tend to maintain a constant angle between the extended cowl and the mountain peak; as a result, the pitch attitude of the aircraft increases and speed decreases (see Figure 2). Consequently, aircraft performance decreases and vertical separation with the terrain decreases.

Figure 2. Possible optical illusion when approaching a rising slope
