AVIATION INVESTIGATION REPORT
A06Q0157

ENGINE FAILURE

CESSNA 172M C-FFRV
MONTRÉAL, QUEBEC
10 SEPTEMBER 2006

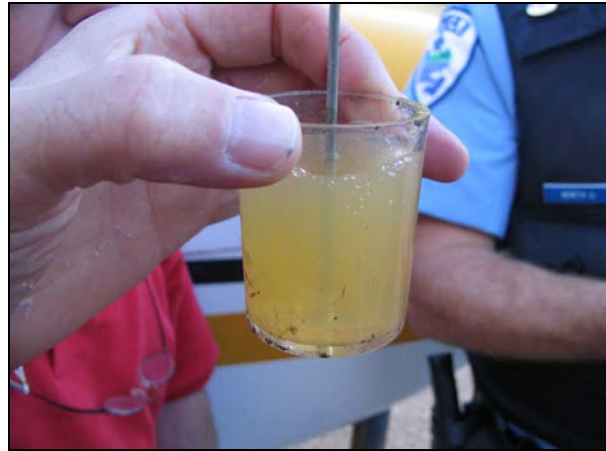
The aircraft was examined at the accident site, and a few water droplets were initially collected from the right wing tank drain valve. The left tank could not be drained because the dented wing skin obstructed the access to the drain valve. The gascolator bowl in the engine compartment was drained, and 5 to 6 ounces of yellowish water was collected (see Photo 1).

Photo 1. Water from gascolator

Analysis of the gascolator bowl showed that it had been in contact with water for a considerable period of time, probably several years. Since the aircraft was parked in the same place with a right bank angle most of the time, the quantity of water in the right fuel tank was undetectable. It is possible that a small quantity of residual water that was not drained from the fuel tanks made its way from the right fuel tank to the gascolator bowl in flight and stayed there until the next draining. The accumulated quantity of water that migrated during the occurrence flight saturated the gascolator bowl, causing the engine to stop.

1. The aircraft was not on level ground when the draining was done before the flight. Consequently, the water in the fuel tank was lower than the drain valve and could not be removed with the pipette.
2. The water accumulated in the right fuel tank migrated to the gascolator bowl, saturating it, and causing the engine to stop.

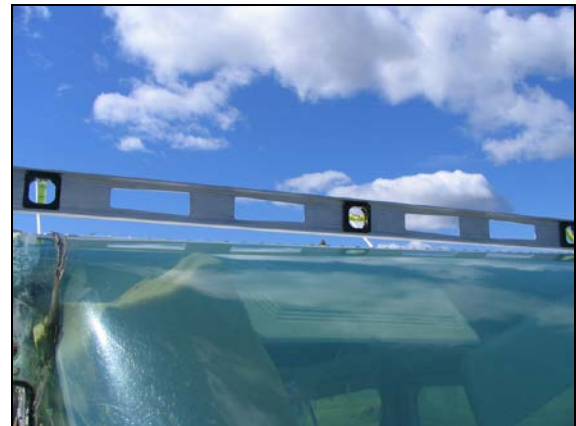
- the seals on the two fuel filler caps showed no defects;
- the left wing tank showed no evidence of water and the fuel filler cap installation was in accordance with manufacturer specifications;
- the chain used to tether the cap to the right fuel tank filler pipe was found at the bottom of the fuel tank;
- the two S-hooks on the chain showed signs of corrosion;
- debris was observed on the surface of the gascolator filter screen;
- the bottom of the gascolator bowl had stains from yellowish water;
- debris was observed on the surface of the carburetor filter screen;
- the area where the aircraft was usually parked was not level. The aircraft was always parked with a right bank angle. The right wing was about 1.5 inches lower over a distance of about 48 inches (see Photo 2).

Photo 2. Aircraft out of level

Before take-off, the pilot did a full preflight inspection. Because the left tank fuel quantity indicator was defective, the pilot visually checked the fuel quantity in both tanks, and estimated that there was sufficient fuel for the flight planned. However, the aircraft was not level when the fuel tanks were drained, which is contrary to the manufacturer's recommendations. Since the aircraft had a right bank angle, it was impossible for the pilot to drain the water accumulated in the right fuel tank because the water was lower than the drain point. Without a level, it is hard to verify visually the aircraft bank angle. Also, it is hard to easily catch the fuel drained from the gascolator to examine it. As a result, the pilot drained the contents of the gascolator onto the ground without properly examining it.
