**AVIATION INVESTIGATION REPORT
A07A0029**

RUNWAY EXCURSION

**VOLGA-DNEPR AIRLINES
ANTONOV AN 124-100 RA-82078
GANDER, NEWFOUNDLAND AND LABRADOR
31 MARCH 2007**

Report Number A07A0029

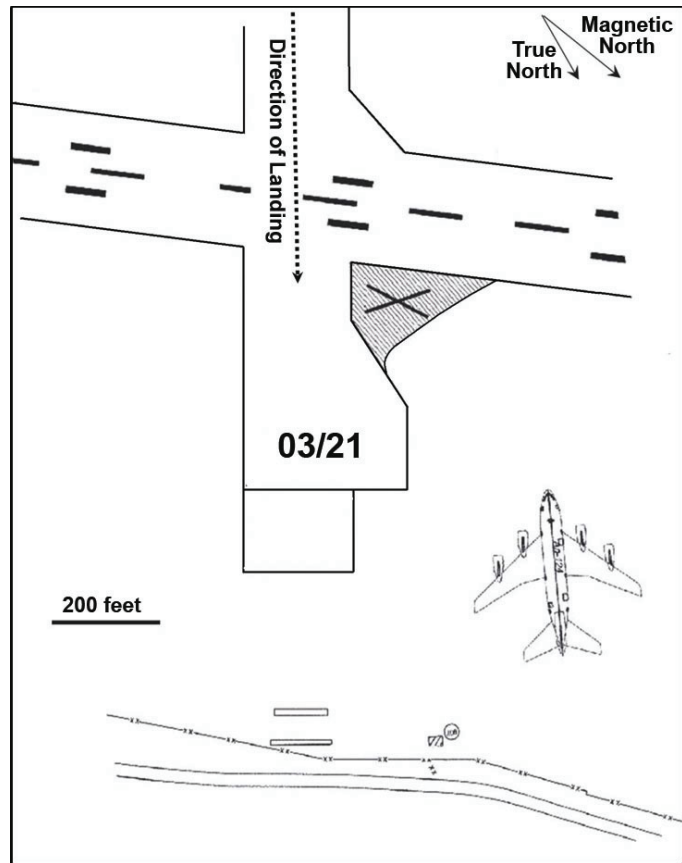
Figure 1. Final position of aircraft

During the latter part of the landing rollout, it became apparent that the aircraft would not stop on the runway. The aircraft was intentionally steered toward the left side of the runway to avoid colliding with ILS equipment located off the departure end of the runway. The aircraft departed the left edge of Runway 03/21, near the runway end at about 35 knots. The aircraft rotated to the left and came to rest approximately 480 feet from the runway end with the aircraft oriented nearly opposite to the direction of landing. The crew conducted an emergency shutdown during which they assessed that an immediate evacuation was not necessary.

1. The aircraft touched down approximately 2400 feet past the normal touchdown point; this greatly reduced the available stopping distance.
2. The contaminated runway surface condition increased the distance required to stop the aircraft.
3. The delay in the application of wheel brakes combined with the failure to maintain maximum available reverse thrust until it was ensured that the aircraft would stop on the remaining runway contributed to the overrun.

Volga-Dnepr Airlines has made arrangements with the Gander International Airport Authority to have, upon request, Canadian runway friction index (CRFI) reporting for each third of the runway.
