AVIATION INVESTIGATION REPORT

A07A0066

COLLISION WITH TERRAIN DURING TAKE-OFF

**PORTLAND CREEK AVIATION LIMITED
DE HAVILLAND DHC-2 BEAVER C-GBZS
BRYANTS RAFT POND,
NEWFOUNDLAND AND LABRADOR
26 JUNE 2007**

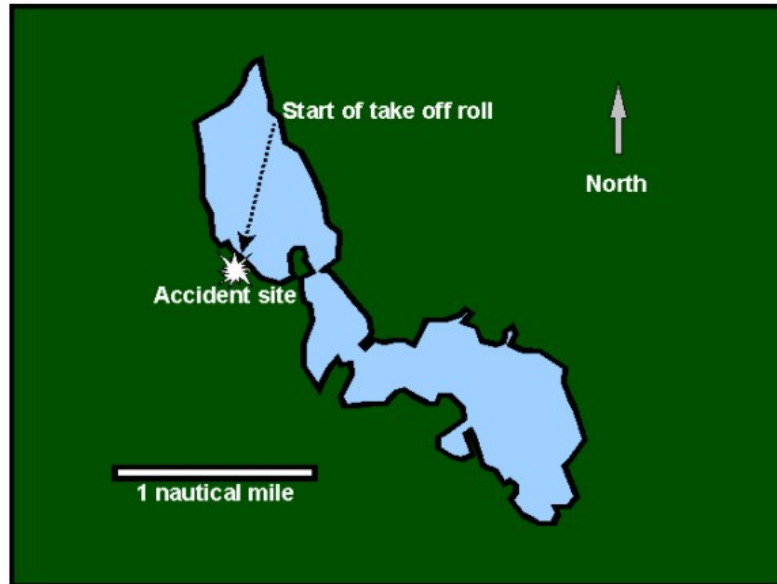
Figure 1. Area diagram

Before the flight, the pilot ensured that there was no water in the floats. The pilot started and taxied the aircraft for approximately 10 minutes in order to check the aircraft and warm up the engine. The surface wind was approximately 10 knots from a direction across the pond; the pilot elected to conduct the take-off into the wind. The pilot had the option of taking off down the pond with a crosswind, which was a longer distance. The distance across the pond, from shoreline to shoreline, was approximately 2900 feet. The available distance for take-off was somewhat less because the aircraft could not taxi in the shallow water along the shoreline, and there were obstacles on the departure path.

The shoreline of Bryants Raft Pond in the direction of take-off consisted of a rocky bank approximately three feet above the water level after which there was soft, level forest floor with spruce trees and undergrowth. Beyond this, there was a low hill.

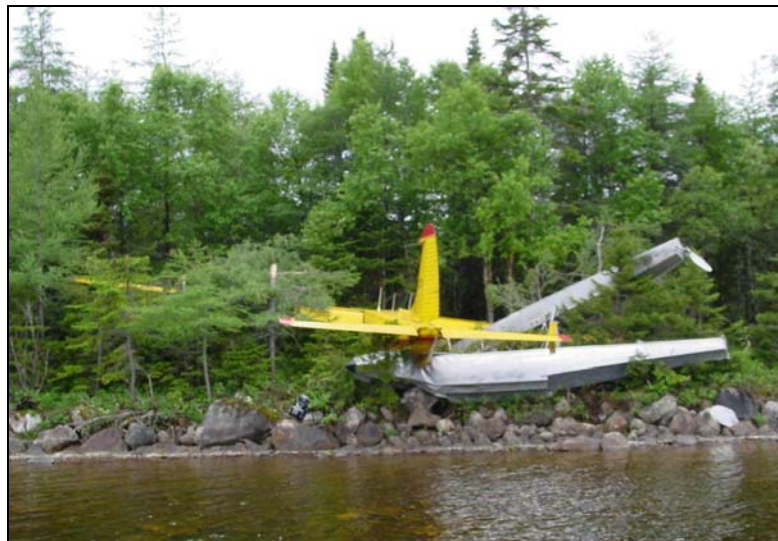
Photo 1. Aircraft wreckage viewed from the water

Wreckage examination revealed that the aircraft was substantially damaged. The propeller was bent, the lower, forward fuselage was damaged, the leading edge of both wings were damaged from tree impact, the right wing was bent forward from its normal position, and the floats and related support struts came to rest under the aircraft. The aircraft was removed from the site several days after the accident. Further inspection revealed that the rear attachment point for the left wing was damaged. The flaps were found in the take-off position, and the flap indicator showed the flaps at the take-off position. The carburetor heat selector was in the full cold position.
