AVIATION INVESTIGATION REPORT
A07C0001

COLLISION WITH TERRAIN

TRANSWEST AIR
BEECH A100 KING AIR C-GFFN
SANDY BAY, SASKATCHEWAN
07 JANUARY 2007

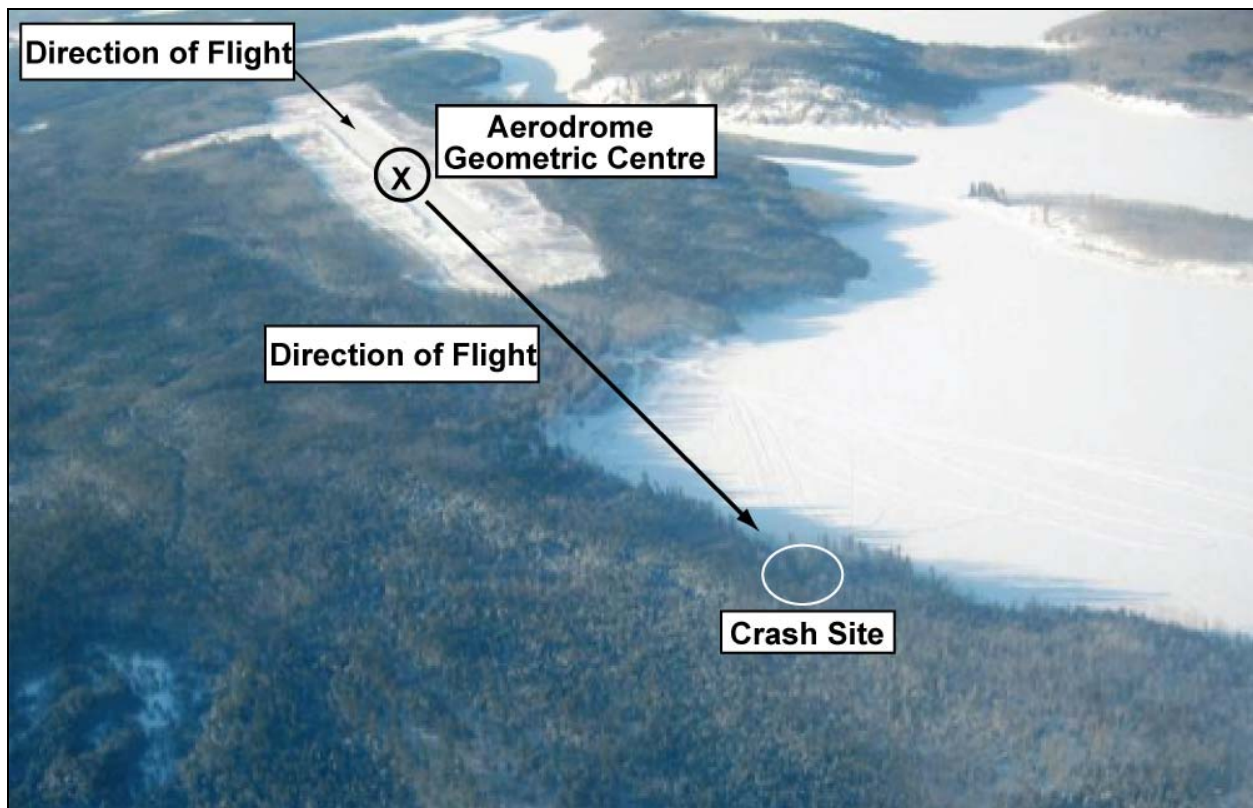
Photo 1. Sandy Bay aerodrome (CJY4) (Source: Transwest Air)
