AVIATION INVESTIGATION REPORT

A07C0106

IN-FLIGHT COCKPIT FIRE

BOEING 747-251B N632NW

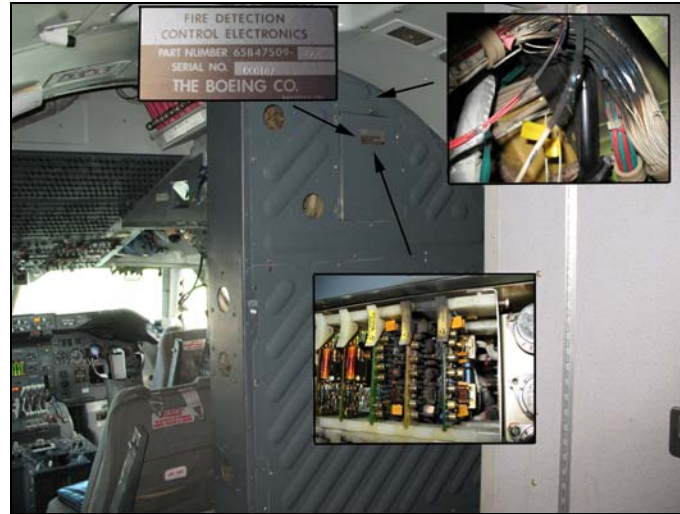
The aircraft was inspected and the fire was found to originate from within the number four engine loop "A" (A4) circuit board warning card mounted in the fire-detection control electronics box located on the aft side of the P6 circuit breaker panel (see Photo 1). The fire had spread to both the adjoining A3 and A5 circuit cards, as well as to a major aircraft wiring bundle located above the control box. Maintenance personnel replaced the control box and the circuit cards and repaired the damaged wiring bundle. The number four engine was started and the number four engine fire-detection loop "A" nacelle temperature indicator again began to fluctuate as in the original

Photo 1. P6 panel fire damage

The damaged fire-detection control electronics box along with the digital flight data recorder (DFDR) and the cockpit voice recorder (CVR) were forwarded to the TSB Engineering Laboratory in Ottawa, Ontario, for examination. The DFDR and CVR did not provide any valuable information. The DFDR only recorded a limited number of parameters, none of which related directly to the fire. The two-hour CVR recording had been overwritten by ground operations after the flight. The number four engine loop "A" (A4) circuit board warning card (part number 60B00023-96) in the fire-detection control electronics box was assessed as being the source of the fire. The power resistor (R11) on the side of the board had burnt and burst from internal overheating due to excessive current passing through the resistor.

The wires chafed to the conductor core, which allowed the generator PMG 60 VAC to transfer to the 28 VDC "A" loop fire-detection circuit and cause a current surge back through to the fire-detection control electronics box in the cockpit. The current surge was dissipated by resistors on the A4 circuit board warning card, causing a rise in temperature in the resistors to the point of ignition. There is no circuit breaker protection in the circuit between the circuit card and the engine fire loop; thus, the system would overheat until the short occurred.

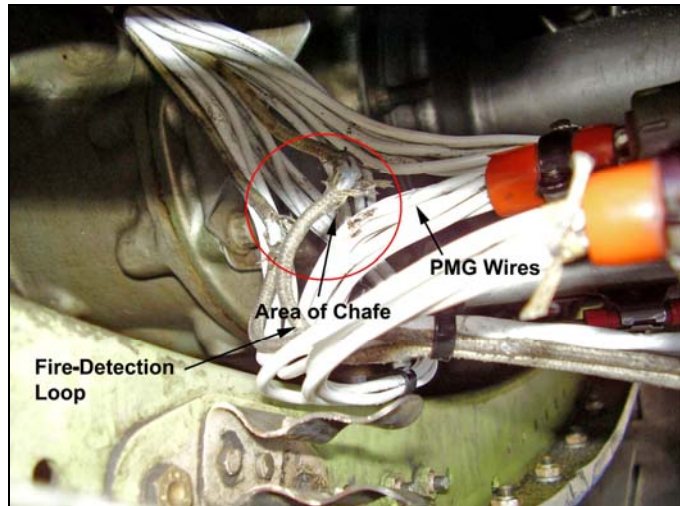
During troubleshooting in Minneapolis, alternating current voltage (VAC) was noted to be present on the number four engine loop "A" direct current (VDC) circuit. The voltage stopped when the generator constant speed drive (CSD) was disconnected. The wiring near the generator was inspected and four wires in a wire bundle were found to be chafed; three of the wires were chafed to the conductor core. Two of the wires chafed to the conductor core originated at pins 1 and 3 at connector DG1B on the permanent magnetic generator (PMG). With the CSD coupled and the engine running, the PMG produces approximately 60 VAC. The remaining wire was a 28 VDC voltage wire (W266-W13-16R), which is part of the engine fire-detection loop.

The chafed wires were bound together with plastic tie wraps. When the tie wrap was removed, it was noted that a slack portion of the engine fire-detection wire loop had been folded back and secured to the adjacent PMG wiring harness (see Photo 2).

Photo 2. Area of chafe

The wire chafing occurred as a result of relative movement between individual wires secured together in adjacent wire bundles in a non-standard way. The bundles are situated in an engine area identified as a high-vibration area. Excess wire length in the number 4 engine fire-detection loop was folded back and secured to the adjacent PMG wiring harness. The Boeing *Standard Wiring Practices* manual specifies in part that all wires must be parallel before a wire harness tie is assembled on the wire harness. The excess wire length in the number 4 engine fire-detection loop was not secured in this manner.

1. Adjacent wire bundles in a high-vibration area in the number four engine were secured in a non-standard way.

Northwest Airlines Inc. initiated a Boeing 747 fleet campaign to look for wire routing and chafing issues similar to those found on the occurrence aircraft. No similar discrepancies were found. Northwest Airlines Inc. also enhanced its maintenance program by adding a new step to the existing 600-hour "under-cowl check." The step was designed specifically to identify and correct poorly routed wiring in the area of the chafe as noted on the occurrence aircraft.

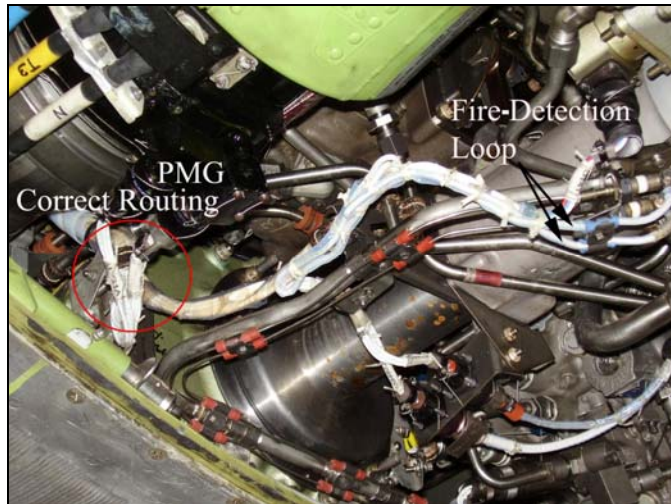
Northwest Airlines Inc. consulted technicians who had previously worked on the engine. The technicians indicated that the wire routing configuration and bundling was at variance with QEC shop procedures (see Photo 3).

Photo 3. Example of good wire lacing and routing
