**AVIATION INVESTIGATION REPORT
A07O0030**

**THE HELICOPTER COMPANY INC.
ROBINSON R44 II, C-FGTN
CAMBRIDGE, ONTARIO
02 FEBRUARY 2007**

Report Number A07O0030

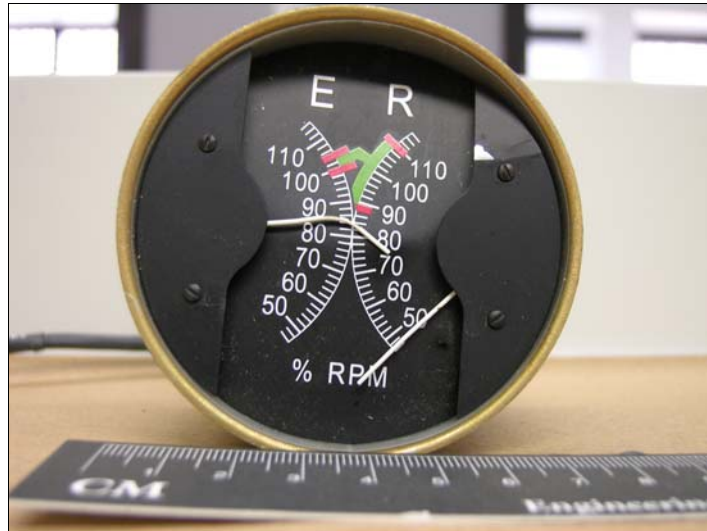
Photo 1. C-FGTN engine (E)/rotor (R) tachometer.

- The rotor RPM gauge was indicating 98per cent.
- The vertical speed indicator was indicating 800 ft/min down.
- The manifold pressure gauge had two indications. One was in the range of 18 to 19.3 inches of mercury ("hg.) and the other was in the range of 27.7 to 29.3 "hg.
- The Lowrance Airmap 2000c GPS did not record the occurrence flight track and the Garmin Apollo SL60 GPS does not retain flight track data in its non-volatile memory.

When the helicopter struck the ground, the rotor tachometer was indicating 98 per cent, the rate of descent was 800 feet per minute and the helicopter had very little forward speed. All of this indicates that although full throttle had been reapplied during descent, there was insufficient altitude and time to arrest the descent prior to impact.
