## AVIATION INVESTIGATION REPORT

A07P0345

### LOSS OF CONTROL - COLLISION WITH TERRAIN

CESSNA 172M C-GGVK

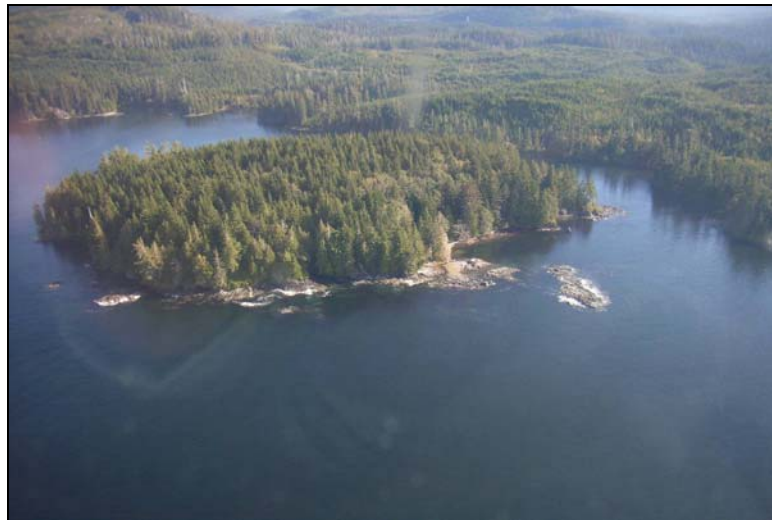
Photo 1. Taken from the aircraft showing conditions just before the accident

The conditions at the time of the accident were suitable for visual flight operations. The wind was calm, visibility more than 20 nm, and there was no cloud ceiling. These conditions were observed on a photograph taken from the accident aircraft minutes before the accident.

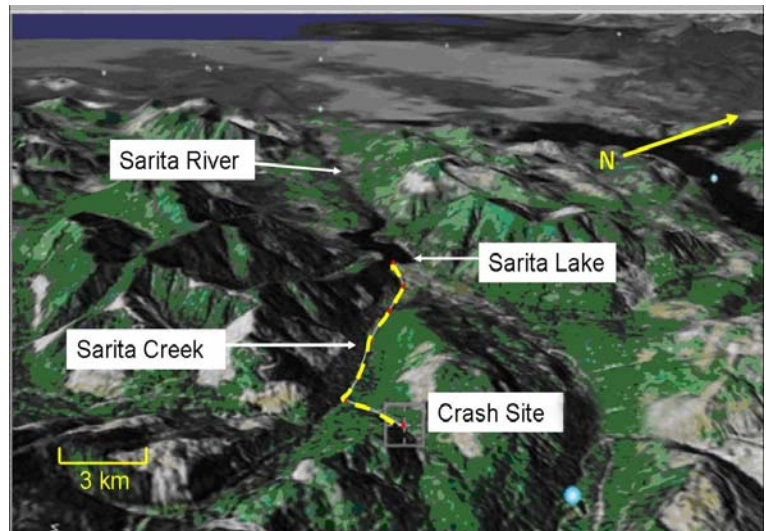
From that point on, the route is not known. However, based on the location of the crash site and the known destination, it is likely that the aircraft turned inland and followed the Sarita River towards Sarita Lake (see Figure 2). The lake is large enough to land a floatplane.

670 feet above Sarita Lake. This valley rises about 150 feet from the Sarita Creek valley to the accident site (0.5 nm) and a further 300 feet in 0.5 nm beyond the site. The peak elevation of this valley is about 0.75 nm past the accident site. Beyond this point the terrain drops into another valley. There is an elevation increase of 1100 feet in the 4 nm between Sarita Lake and the high point in the valley.

Figure 2. Likely track of aircraft from Sarita Lake.

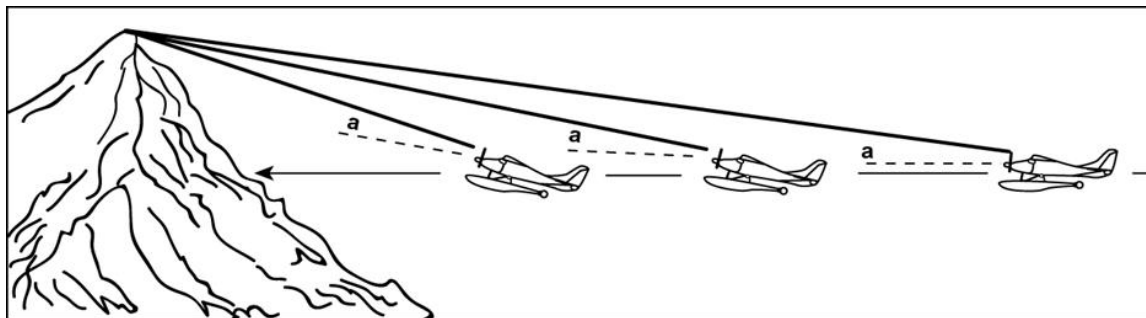
In some situations, pilots can be subjected to visual illusions when approaching rising terrain. As an aircraft approaches rising terrain, pilots tend to maintain a constant visual angle between the extended cowl of the aircraft and the crest of the terrain ahead. This tendency can result in a gradual increase in aircraft pitch attitude and a concurrent decrease in the aircraft's airspeed as the aircraft approaches the elevated terrain (see Figure 3). This often results in a delay to the pilot's realization of inadequate aircraft climb performance ("a" in Figure 3), the aircraft's separation with the terrain decreases and the aircraft gets closer to aerodynamic stall as the angle of attack increases.

**Figure 3.** Possible visual illusion when approaching rising terrain (exaggerated for demonstration)

The pilot non flying was trained in mountain flying techniques, but for unknown reasons, the aircraft was being flown close to terrain. It is possible that both pilots were lulled into a false sense of security due to visual illusions and the lack of a linear stall warning device. Also, the experience level of the pilot flying may have caused the pilot-in-command to be less vigilant.

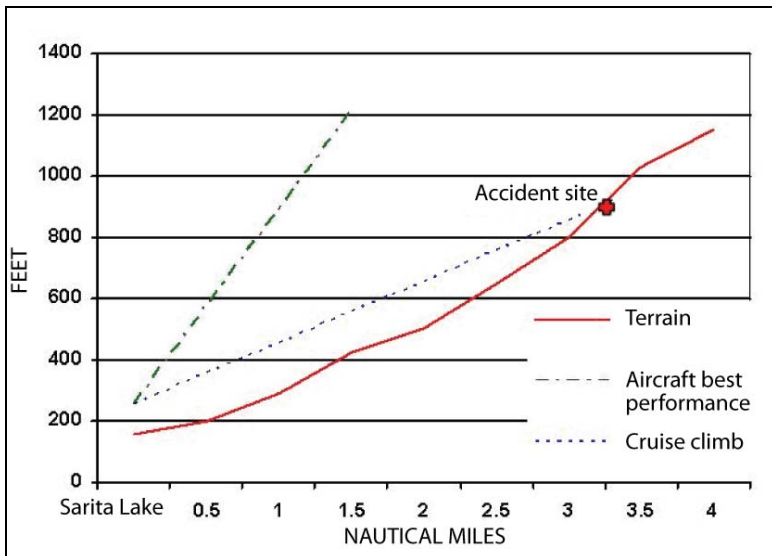
It could not be determined why the aircraft was so close to terrain in the area of the accident. It is possible they were flying low to look at something on the ground. It is also possible they had made a practice landing and take-off at Sarita Lake, but they should have been able to climb above terrain on their presumed route, unless optical illusions delayed their realization of the rising terrain and they were operating in a cruise configuration until the last moments of the flight.

**Figure 4.** Aircraft performance and terrain profile (angles exaggerated for clarity)

1. The aircraft was operating close to terrain and was reversing course when it stalled and started a spin at an altitude from which there was insufficient height to recover before it collided with terrain.
