**AVIATION INVESTIGATION REPORT
A07P0357**

LOSS OF CONTROL - COLLISION WITH BUILDING

**PIPER PA-34-200 SENECA C-GHFD
RICHMOND, BRITISH COLUMBIA
19 OCTOBER 2007**

Report Number A07P0357

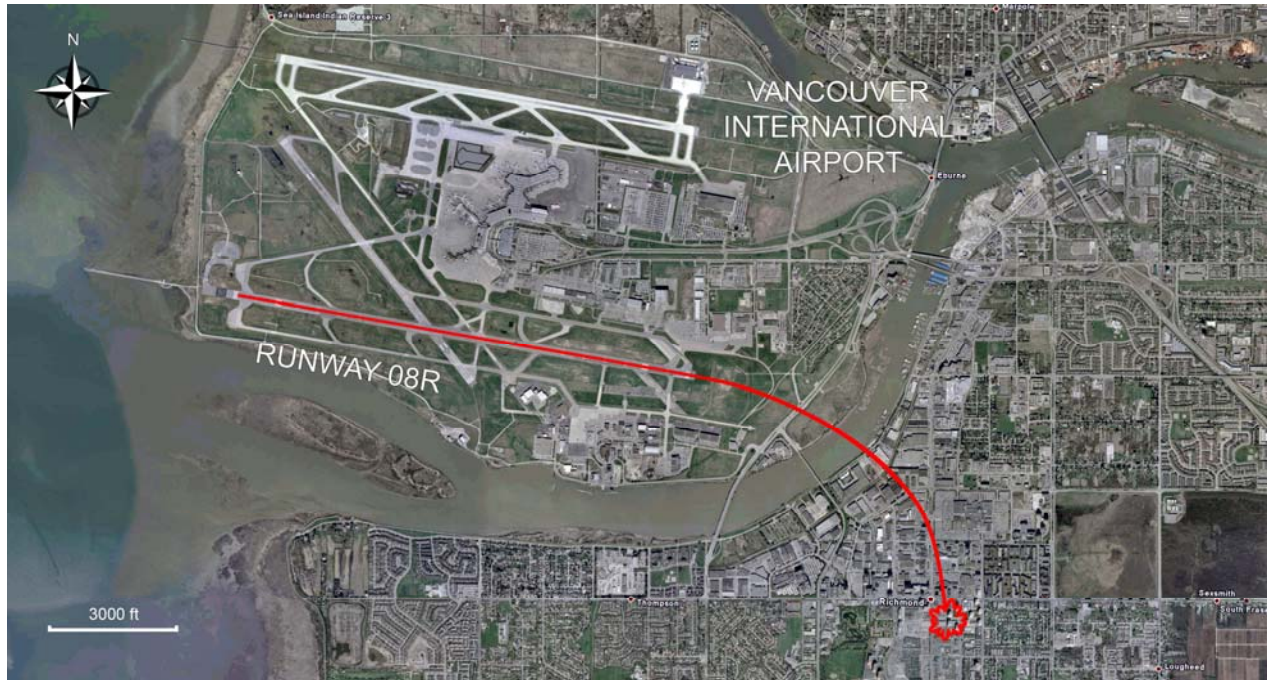
During the turn, the altitude profile of the flight changed from a climb to a descent. The airspeed was calculated to be about 141 mph passing the departure end of the runway (above the manufacturer's recommended climb speed of 120 mph) and the aircraft accelerated continuously to 174 mph at the last radar return before the collision.

The aircraft was at a low altitude the entire time it was airborne. The aircraft's altitude was estimated at about 400 feet above ground level (agl) shortly beyond the departure end of R08R, and at about 200 feet agl by the time it crossed a location about 0.25 nm northwest of the accident site. The aircraft was travelling at high speed, with the landing gear retracted. The sound of the engines was normal to very loud. The aircraft was in a right bank and in a steady, shallow descent (See Figure 1).

Figure 1. Aircraft flight path

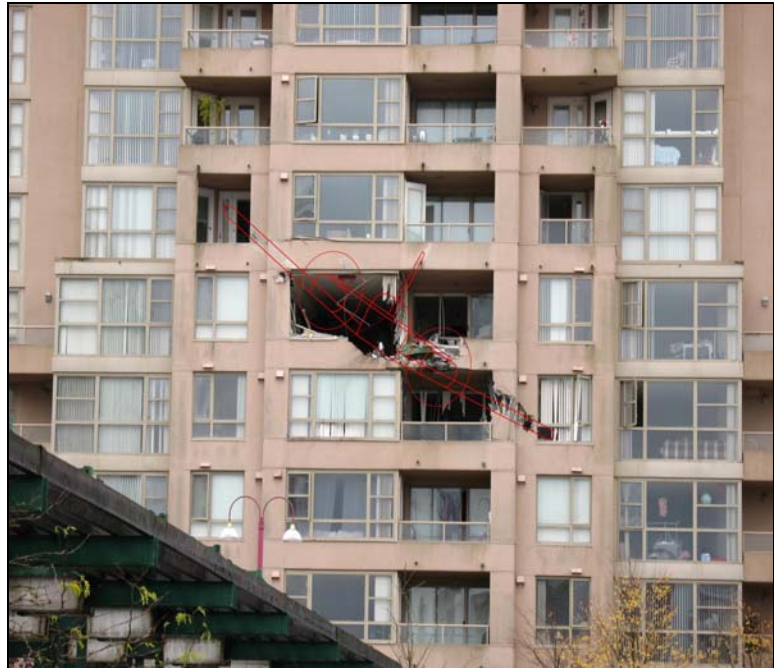
The aircraft entered the residential building in a right bank (see Photo 1). The left engine entered the apartment building with the fuselage through a large window. The right engine directly impacted the building's 9th floor exterior concrete wall, separated from the aircraft, and fell to the 4th floor parking lot. Damage signatures from the right engine showed the last one-half of a revolution during the impact before stopping. The right engine was severely damaged and could not be disassembled. An examination was conducted on the left engine and did not reveal any evidence of pre-impact damage that would have prevented normal operation.

Photo 1. Impact damage

The damage to both propellers was indicative of rotation with power at the time of impact. Engine power output could not be ascertained. There were no discrepancies noted that would preclude normal operation. All damage was consistent with impact damage.

Examination of the wreckage did not reveal any aircraft structural deficiencies, engine or system failure. There was no indication of external interference, such as a bird strike or other emergency situation, before the collision with the building.
