AVIATION INVESTIGATION REPORT

A07W0072

LOSS OF SEPARATION

Report Number A07W0072

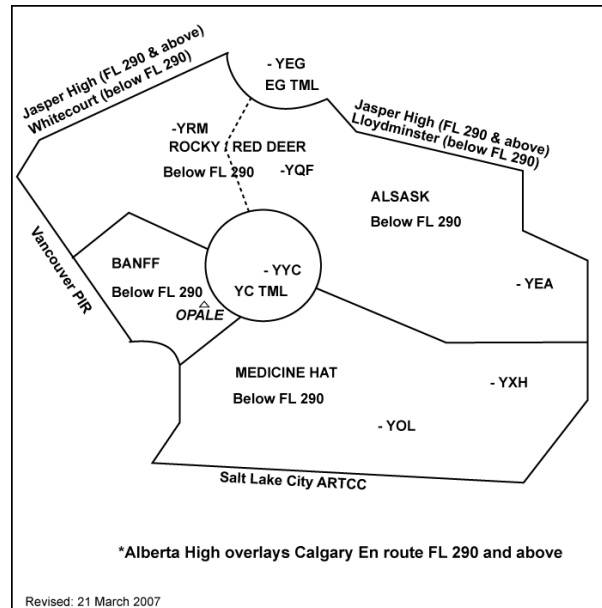
Figure 1. Calgary En route Specialty

The Calgary En route Specialty of the Edmonton Area Control Centre (ACC) comprised five sectors covering controlled airspace below flight level (FL) 290: Banff, Rocky Mountain House, Red Deer, Alsask, and Medicine Hat (see Figure 1). Overlying those sectors from FL 290 and above were three Alberta High sectors: Lethbridge, Drumheller, and Canmore.

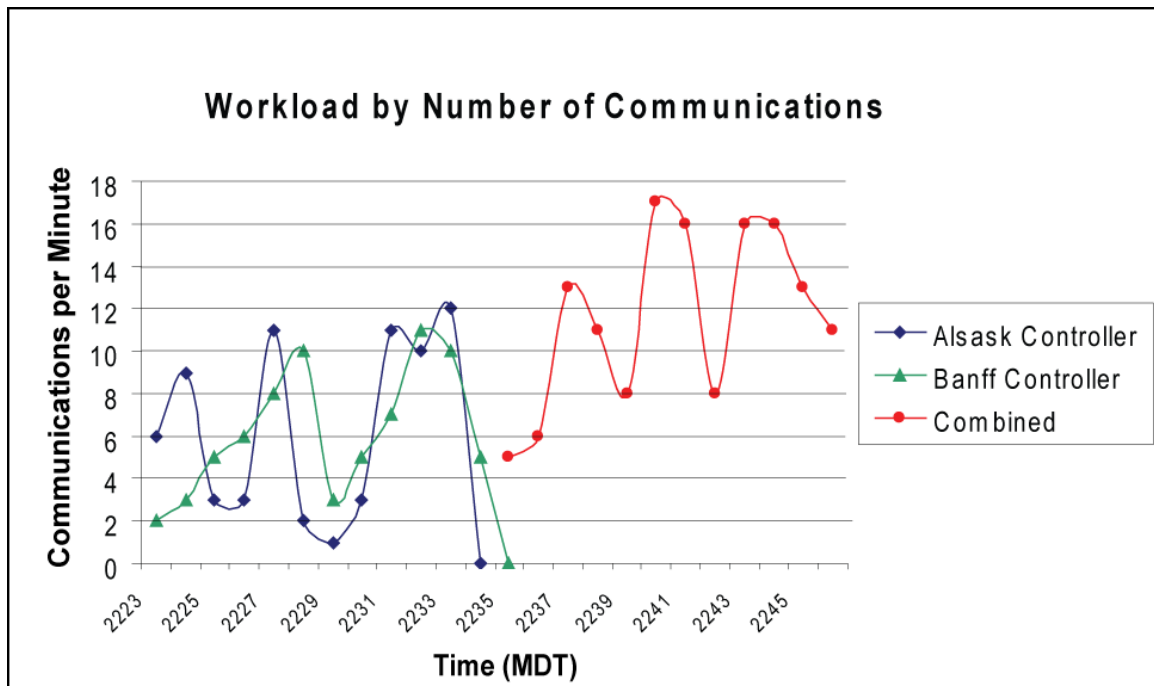
Figure 2. Workload by number of communications

Although the requirement for flow control had just ended, the traffic level was considered to be moderate. The complexity was higher than normal for the time of day due to the flow control. In the 12 minutes preceding the sector combination, the Alsask and Banff controllers conducted an average of 6.0 and 6.2 communications per minute respectively, with each peaking at 11 per minute. After the sectors were combined, the relieving controller conducted an average of 11.7 communications per minute, peaking at 17 per minute (see Figure 2). When the relieving controller took his position, he was responsible for 20 aircraft in the combined sector.

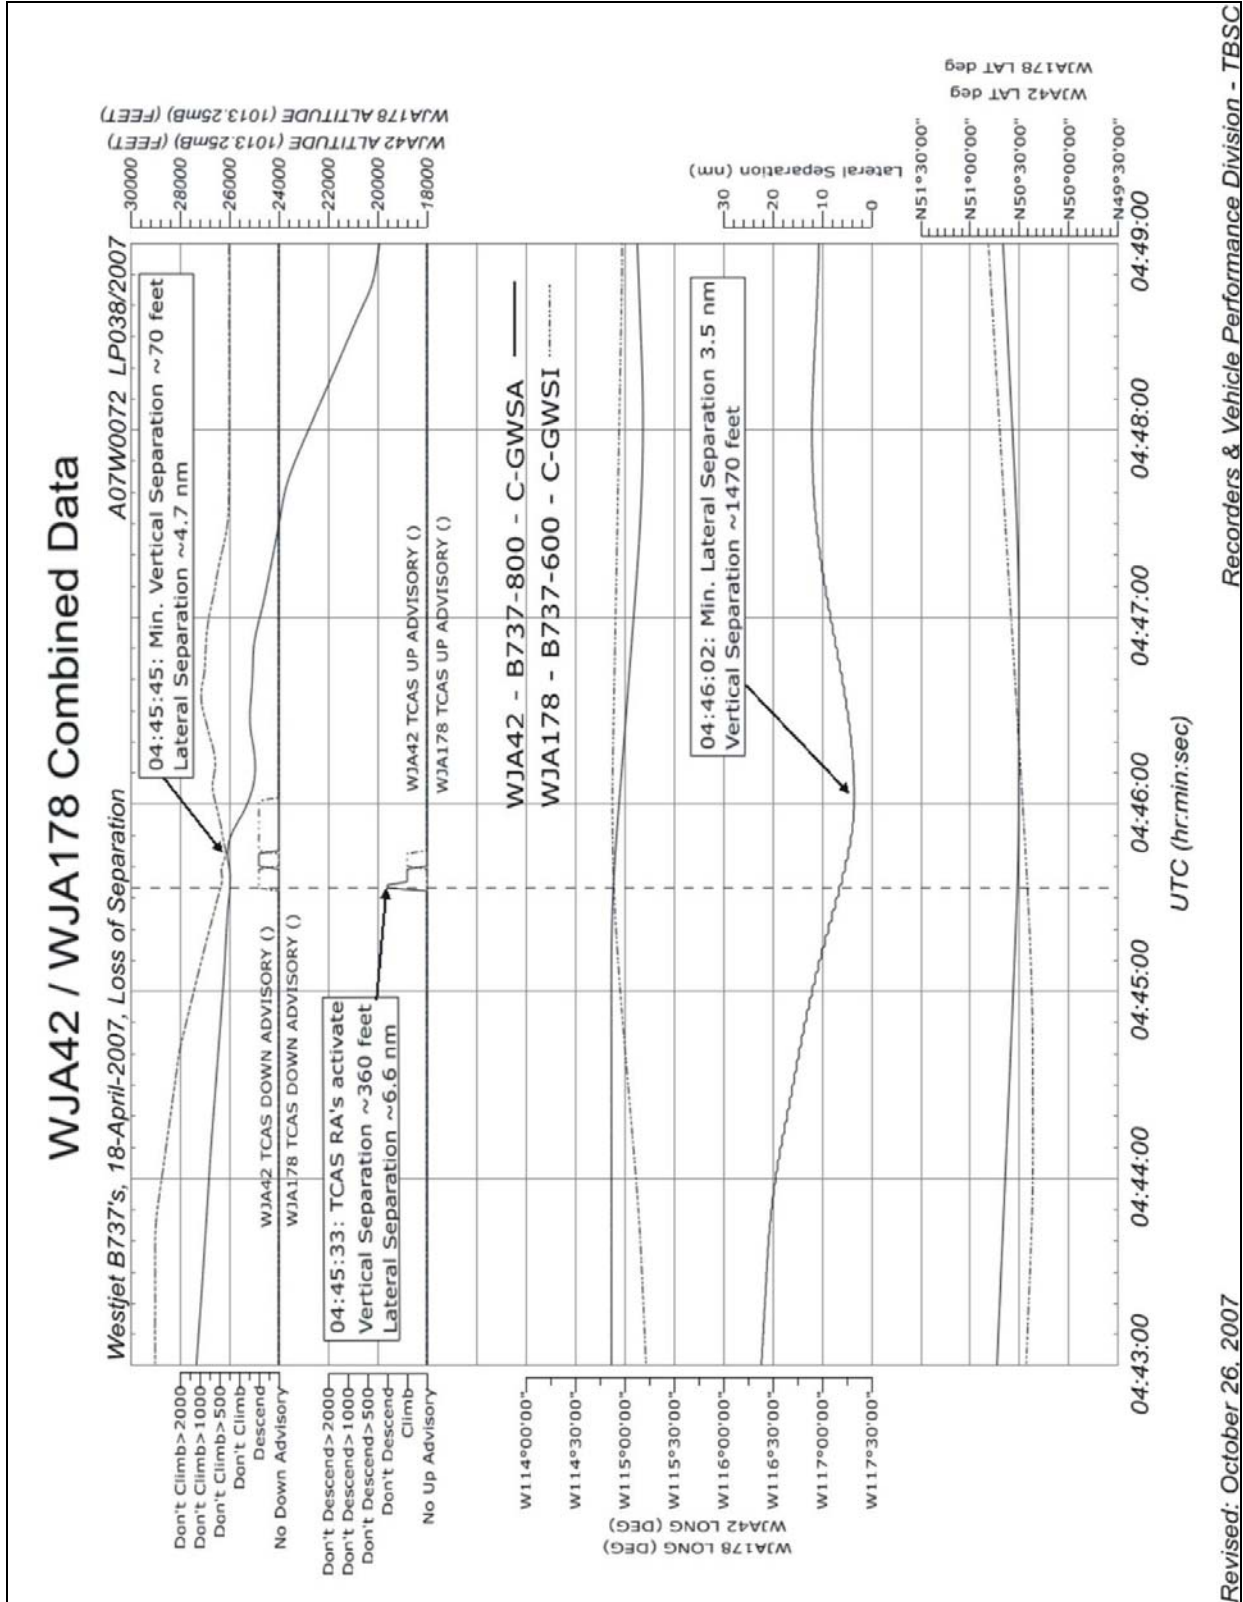
Appendix A – Combined Digital Flight Data Recorder Data, WJA 42 / WJA 178

At 2245:33, when the aircraft were separated by 6.6 nm laterally and 350 feet vertically, the traffic alert and collision avoidance system (TCAS) in both aircraft generated simultaneous resolution advisories (RAs). WJA 42's TCAS issued a "do not descend" RA that was followed

immediately by a “climb” RA (see Appendix A). The captain, who was the pilot flying, disconnected the autopilot and obeyed the RA. Eight seconds after the “climb” RA, the WJA 42 TCAS command changed to a “descend” RA. The captain obeyed that advisory while tightening the right turn in response to the position of WJA 178 appearing on his TCAS display.

At the same time that WJA 42 received the initial TCAS RA to climb, WJA 178 received an RA to descend. Within six seconds and coinciding with the WJA 42 “descend” RA, the WJA 178 RA changed to “climb.” Five seconds later, at 2245:45 the WJA 178 TCAS again commanded a descent. It is normal for TCAS to adjust commands as it recalculates changing position and altitude trends of conflicting aircraft. The controller was not informed of the TCAS RAs by the flight crews until after separation was regained.

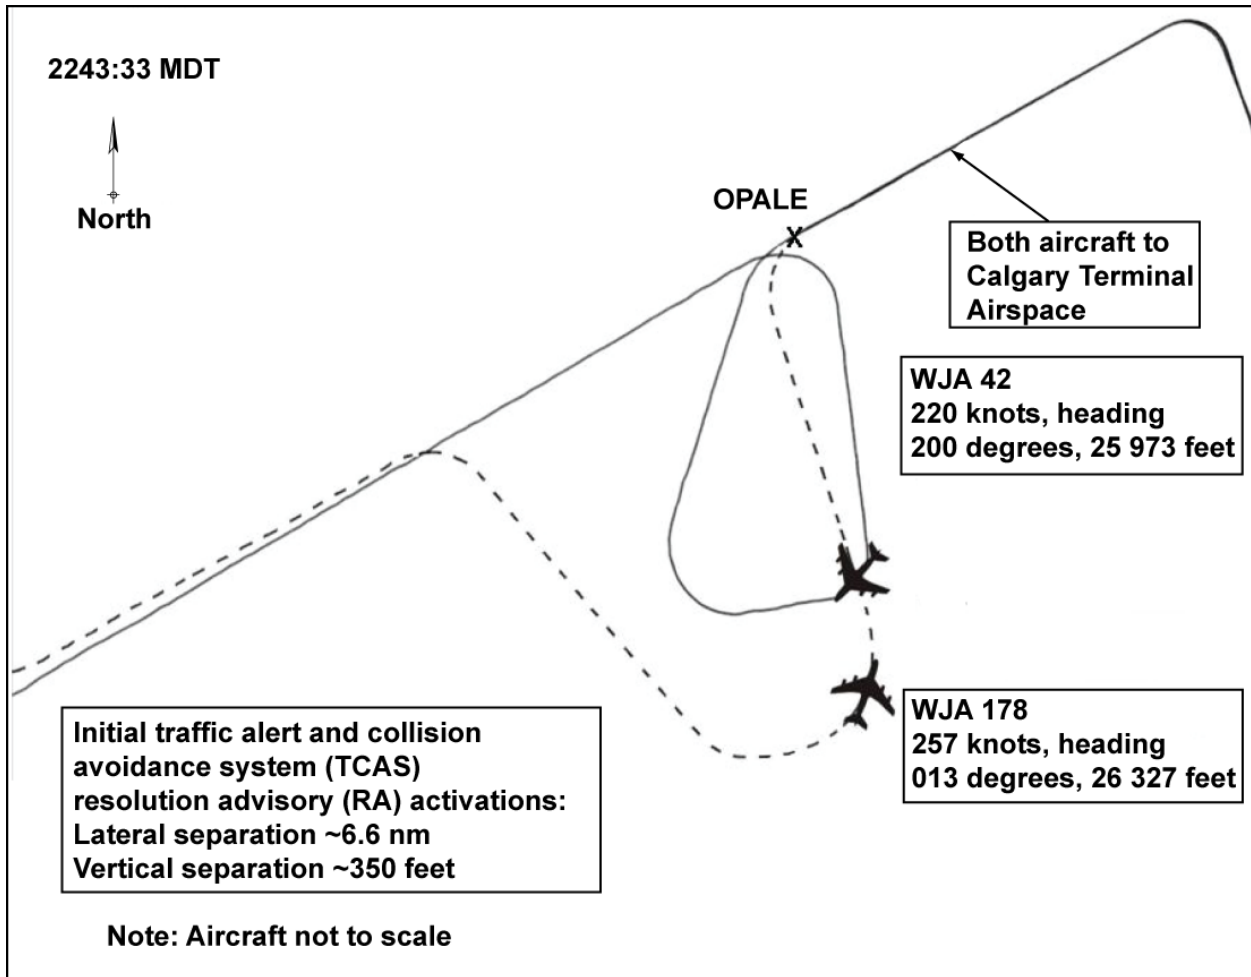
Appendix B – Plan View of Flight Paths, WJA 42 / WJA 178

The controller received a traffic alert at 2245:38, followed by a conflict alert at 2245:48. At that time, WJA 42 was on a heading of 201°M at FL 261, and WJA 178 was on a nearly reciprocal heading of 012°M at FL 261 (see Appendix B). The conflict ended at 2245:57 when separation increased to 3.5 nm laterally and 1200 feet vertically, with the aircraft on diverging tracks and altitudes.
