AVIATION INVESTIGATION REPORT

A08A0095

ENGINE FAILURE AND COLLISION WITH TERRAIN

LABRADOR AIR SAFARI (1984) INC.
DE HAVILLAND DHC-2 MK 1 (BEAVER) C-FPQC
SCHEFFERVILLE, QUEBEC, 70 nm E

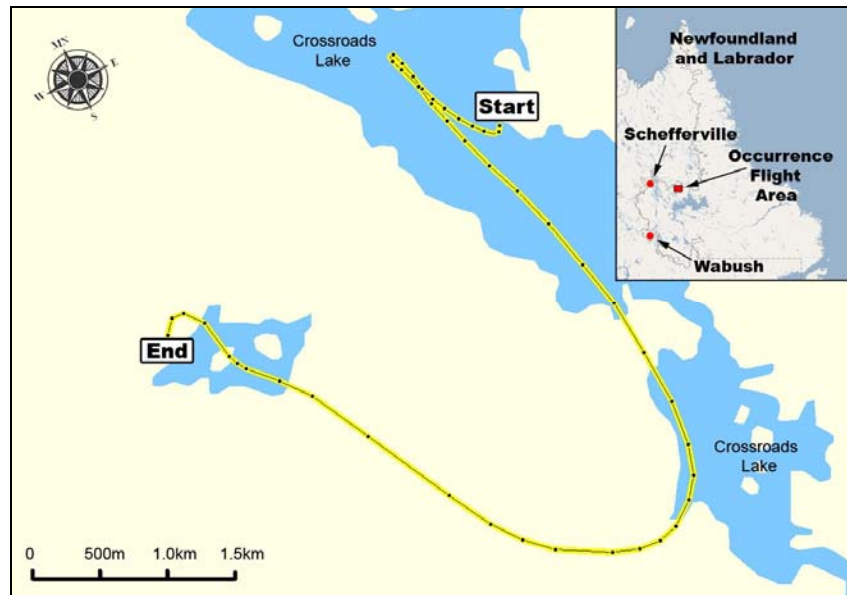
The aircraft departed in a south-southeast direction, then turned to the right and rolled out on a northwest heading and continued to climb (see Figure 1).

Within two minutes, the engine briefly sputtered and then abruptly stopped. The pilot initially banked the aircraft to the right and then began a left turn towards a bog bordering a small pond that the aircraft had just flown over. Airspeed was steadily decreasing as the aircraft lost altitude and the rate of descent increased.

During the left turn, the aircraft went through approximately a 130° change in heading before making contact with the bog.

Figure 1. Map of local area and occurrence flight

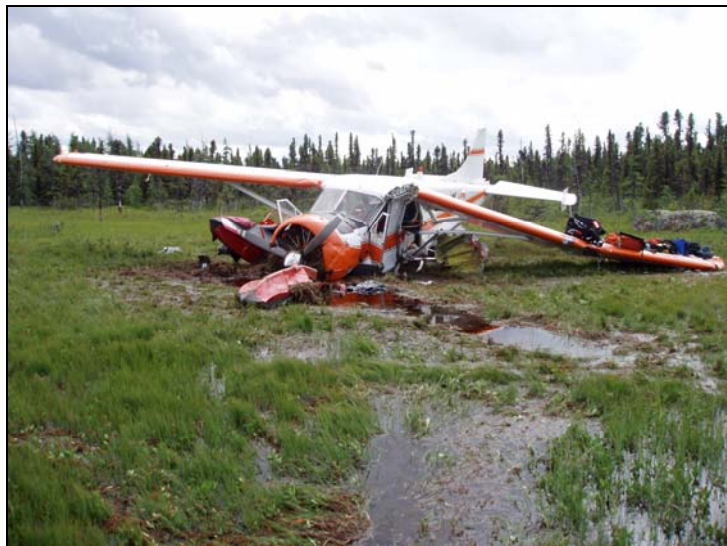
The force at impact was enough to cause major structural damage to the engine mount, cowlings, left wing, and both floats. The cushioning effect of the bog prevented more serious damage and helped the Beaver rebound out of the initial impact point to the position shown in Photo 1. The impact forces were strong enough to cause serious injury to some passengers.

Photo 1. The damaged aircraft after the accident

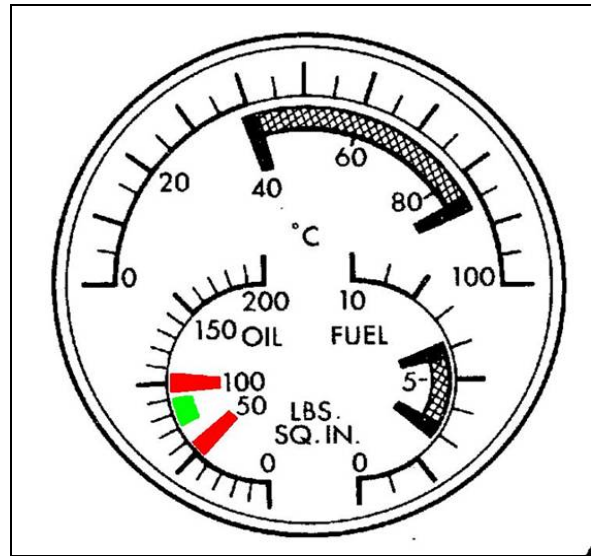
Engine documentation requires the minimum oil pressure to be 50 psi and the maximum oil pressure to be 100 psi. The engine data plate identifies the minimum oil pressure in cruise operation as 70 psi. The Beaver flight manual shows that the oil pressure operating range is between 50 and 100 psi, and 70 to 90 psi (green arc) for continuous rich mixture operation (see Figure 2). The flight manual states that in a yellow or cautionary range, "danger may exist under certain conditions." There are no yellow range markings on the oil pressure gauge. The flight manual does not provide any written instructions for the pilot as to what to do when the engine oil pressure is operating outside the green arc.

Figure 2. Oil pressure gauge

Aircraft manufacturers consider any instrument gauge green arc to be the normal operating range. However, industry practice for the Beaver aeroplane equipped with the P&W R985 indicates that the engine can be safely operated as long as the oil pressure is within the 50 to 100 psi range (between the two red arcs on the oil pressure gauge).

Industry practice is such that the green arc (70 to 90 psi) on the oil pressure indicator is usually described as the safe operating range. However, the Beaver aeroplane equipped with the Pratt & Whitney R985 can be operated as long as the engine oil pressure is within the 50 to 100 psi range (between the red arcs on the indicator). This inconsistency with industry practice could lead to confusion and inadvertent landings if a pilot thought the oil pressure was too low while operating the engine out of the green arc.
