**AVIATION INVESTIGATION REPORT
A08C0164**

AIRSPEED DECAY – UNCOMMANDED DESCENT

**AIR CANADA JAZZ
BOMBARDIER CRJ 705, C-FNJZ
WINNIPEG, MANITOBA, 180 nm SE
01 AUGUST 2008**

Report Number A08C0164

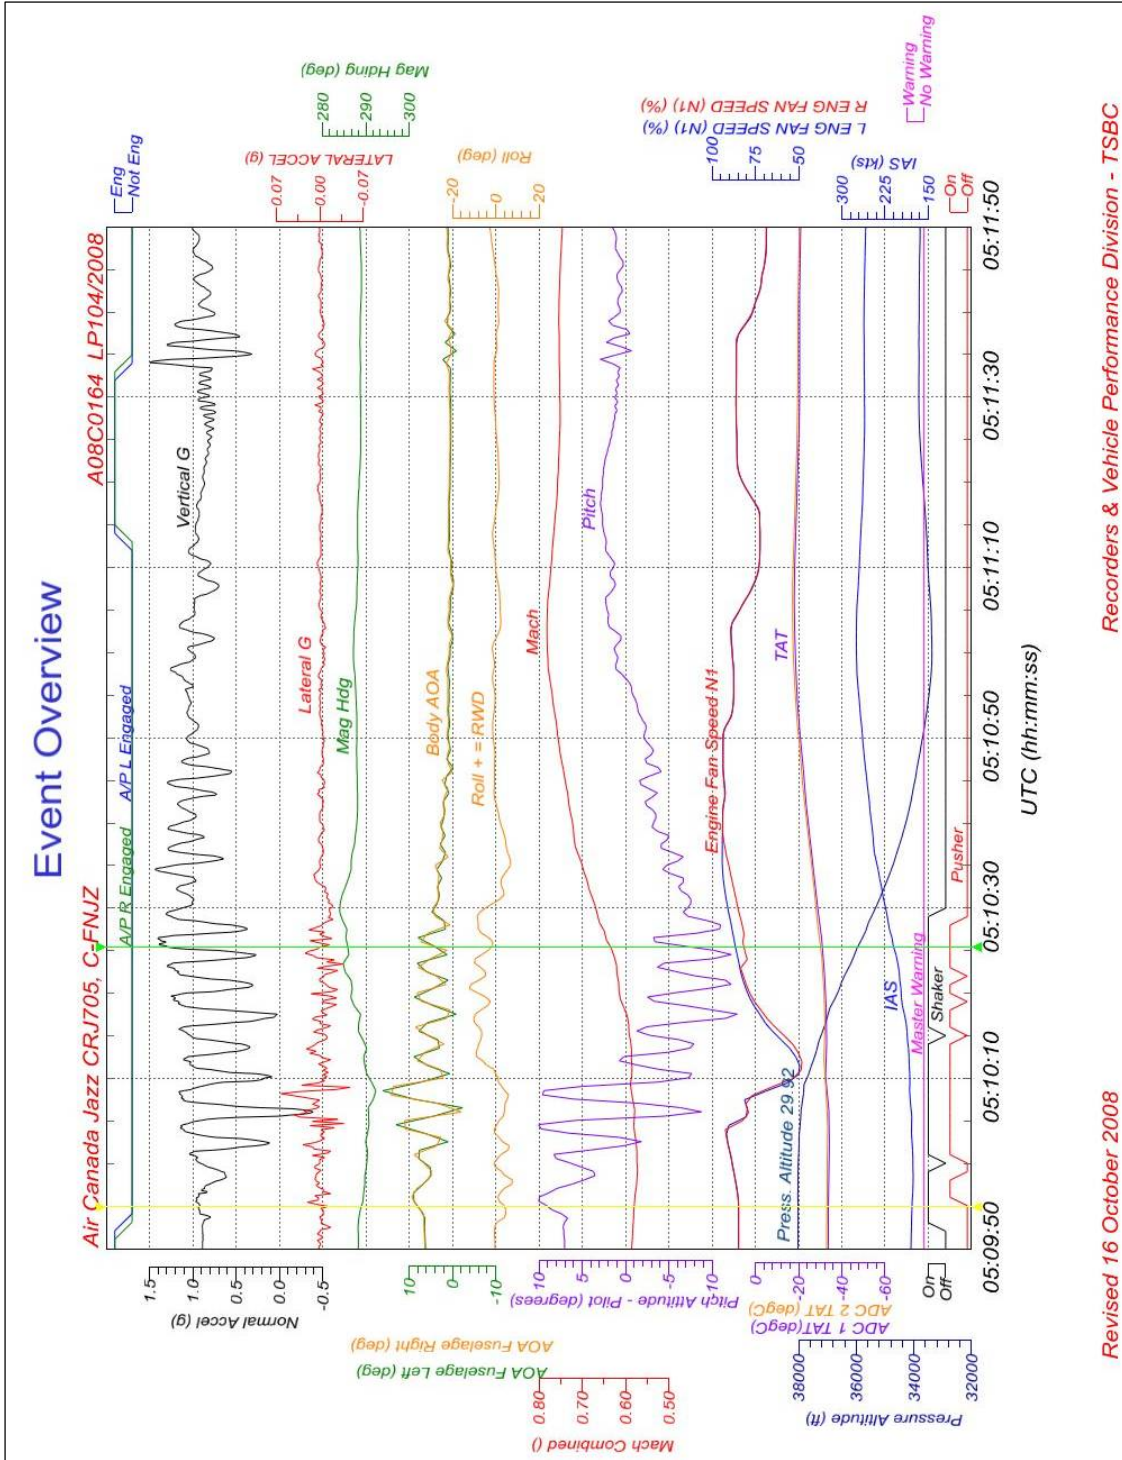
Appendix A – Event Overview

According to the digital flight data recorder (DFDR), approximately two minutes after levelling off, a stable airspeed of Mach .77 or 243 knots indicated airspeed (KIAS) was maintained for several seconds only, after which it began to decrease. Gradually, over a period of about 17 minutes, the airspeed decreased to 180 KIAS³ as the angle of attack (AOA) gradually increased while the autopilot attempted to maintain altitude. Engine N1's and fuel flows also decreased about one per cent and 200 pounds per hour respectively as the aircraft decelerated. The aircraft was not equipped with auto thrust capability to maintain a selected speed or Mach number and the DFDR showed that the power levers were not adjusted in this timeframe.
