**AVIATION INVESTIGATION REPORT  
A08O0035**

**RUNWAY OVERRUN**

**WESTJET AIRLINES  
BOEING 737-700, C-GLWS  
OTTAWA, ONTARIO  
17 FEBRUARY 2008**

Report Number A08O0035

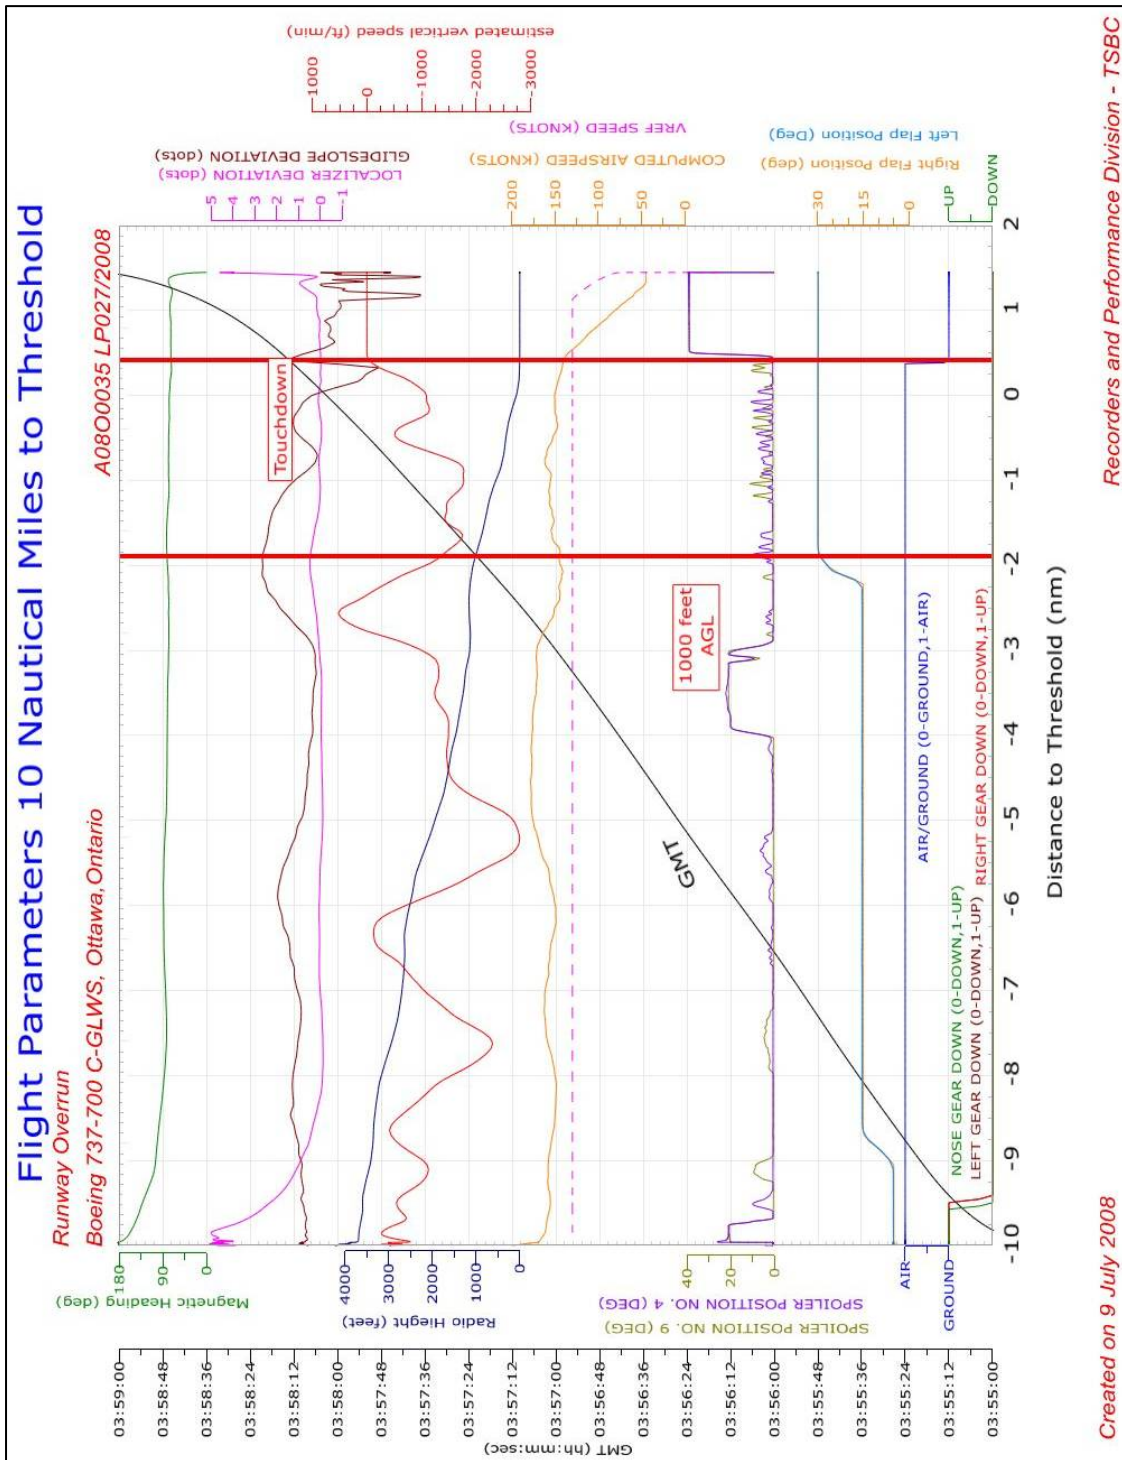
# Appendix D – Flight Data Recorder Plot, Last 10 Nautical Miles

At 2256:32, the glide path was intercepted, and in accordance with company standard operating procedures (SOPs), flaps 30 should have been selected. However, the aircraft speed was above the flaps 30 selection speed and the speed brakes were deployed to reduce the airspeed. The crew had not yet contacted Ottawa Tower and at 2257:06, WJA 846 was asked by the tower if they were on frequency. A 20-second communication exchange ensued during which several activities were concurrently happening in the cockpit. WJA 846 advised that they had a strong tailwind and might have to initiate a go-around. At approximately 1500 feet above ground level (agl), the crew disconnected the autopilot in order to level off and reduce airspeed for the flaps 30 selection. The speed brakes were then stowed, but not re-armed for landing and flaps 30 was selected. The airspeed on final approach varied between 145 and 177 knots (see Appendix D - Flight Data Recorder plot, last 10 nautical miles).

Immediately following the flaps 30 selection and the conversation with tower, the crew momentarily considered the requirement to conduct a missed approach. The decision was deferred even though the aircraft was approaching the 1000-foot above airfield elevation point. At the 1000-foot point, the aircraft flight parameters were as follows: in final landing configuration, thrust levers idle, airspeed 145 knots, and above glide path. Except for the momentary level-off, the thrust levers were at idle for the entire final approach. The aircraft was above glide path during the final approach except for three brief moments: at three nautical miles (nm), at  $\frac{3}{4}$  nm from the threshold, and at threshold crossing (at 50 feet agl). The rate of descent was in excess of 1000 feet per minute for most of the final approach (see Table 1).
