AVIATION INVESTIGATION REPORT
A08O0235

NOSE LANDING GEAR FAILURE DURING LANDING

AIR CREEBEC INC.
EMBRAER EMB-110P1 C-FPCU
COCHRANE, ONTARIO
31 AUGUST 2008

Report Number A08O0235

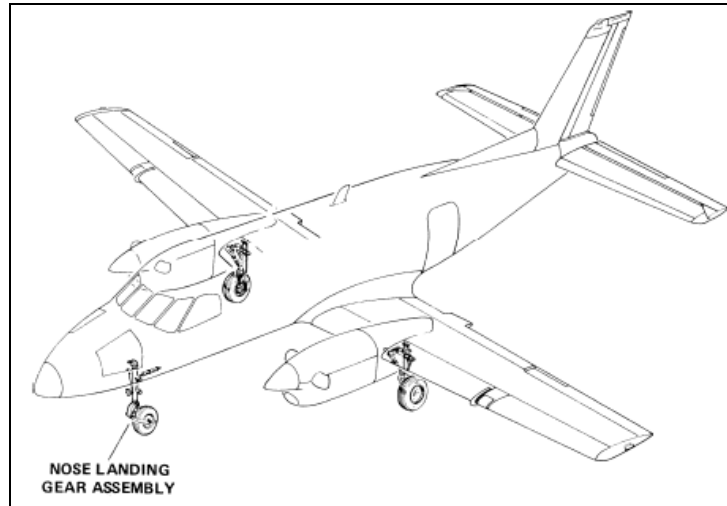
Figure 1. Nose landing gear

The complete nose gear assembly was shipped to the TSB Engineering Laboratory for examination. In service records since overhaul were also obtained from the operator. The nose landing gear (see Figure 1) was identified as part number 110P2-410-21, serial number 507 and was originally manufactured by a French company called ERAM (now Messier-Dowty).

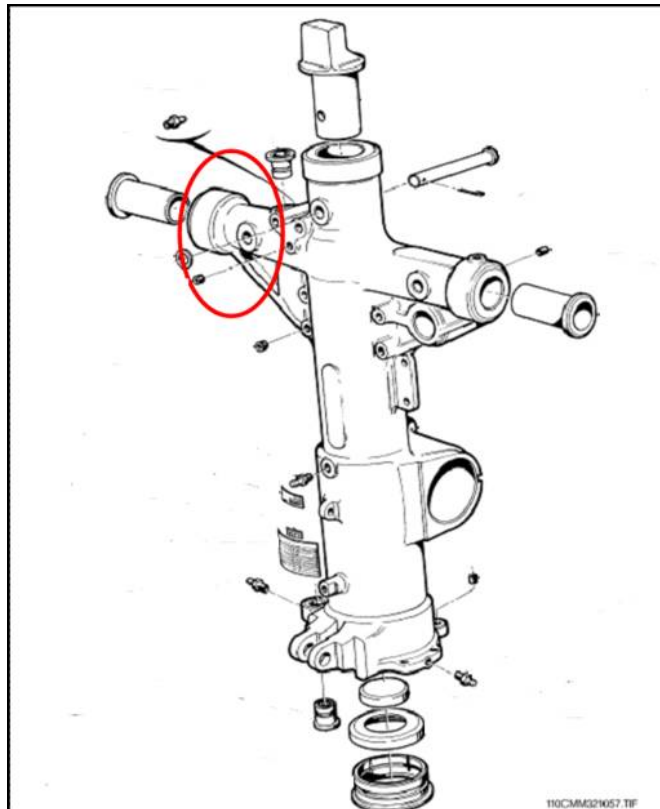
Figure 2. Nose landing gear - failure point

The area of the nose gear failure is shown in Figure 2.

1. The nose landing gear failure was caused by the fracture of the oleo strut housing trunnion link arm, which was initiated by an existing fatigue crack in the bore of the link arm.
2. The crack propagated during the pre-overhaul service life of the nose gear and progressed further during the post-overhaul service of the aircraft, leading to an overload fracture.
3. For undetermined reasons, the crack went unnoticed at overhaul.

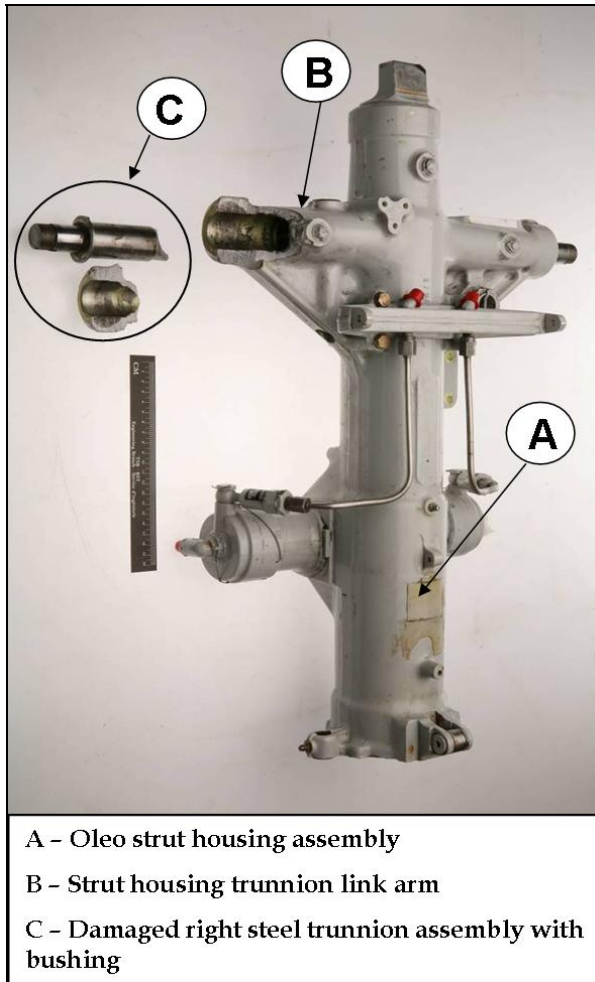
Photo 1. Top nose gear assembly

The nose landing gear (see Photo 1) was overhauled by Aeromil (formerly Aeromech PTY LTD) in Australia on 11 January 2007. The time since new on the Authorised Release Certificate from Aeromil was marked "Unknown," indicating Aeromil may not have been provided with this information when the nose gear was shipped to them for overhaul. Air Creebec Inc. received the nose gear and installed it on the aircraft on 28 January 2007. At the time of installation, the aircraft had 24 859 hours and 37 591 cycles in service.

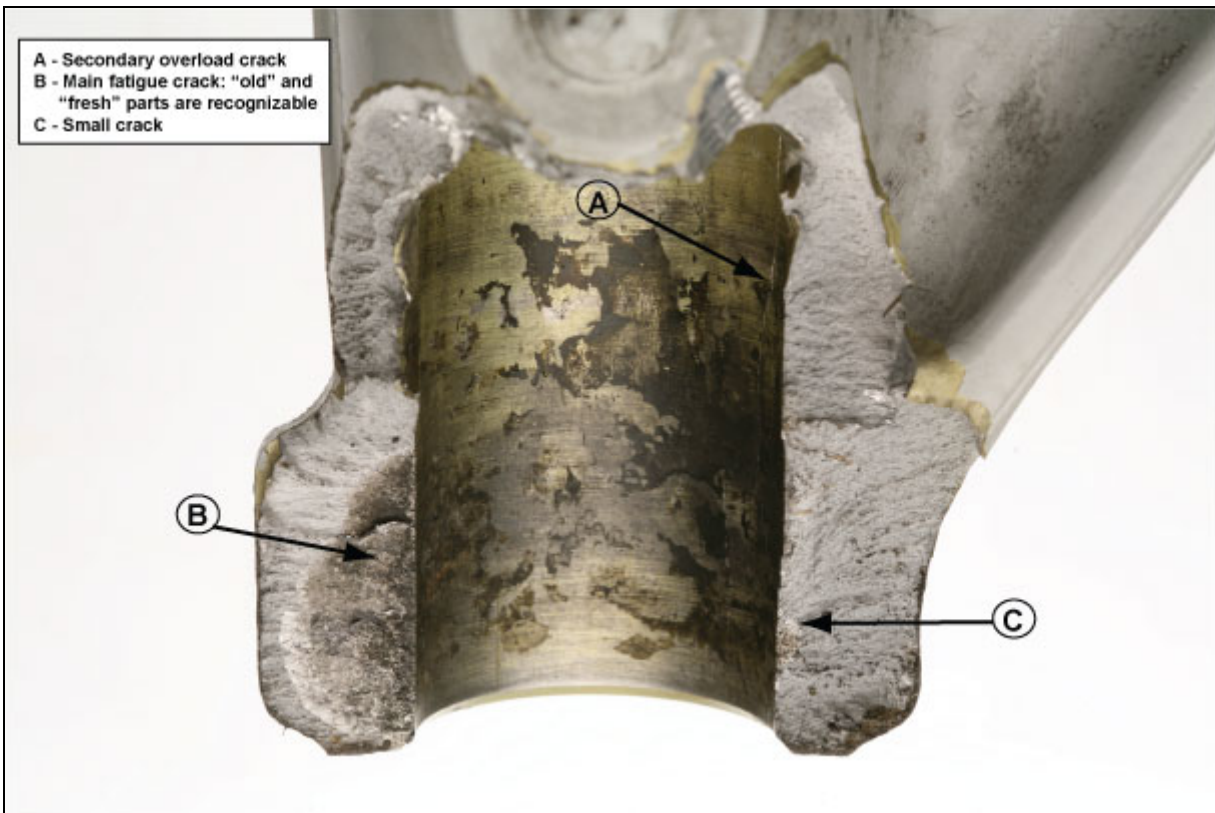
Photo 2. Close-up of the extremity of the strut housing arm

A visual inspection of the fractured surfaces identified several visible features on the fractured strut housing trunnion arm. The main fatigue crack consisted of a large dark area; in addition, smaller fingernail-shaped fatigue cracks were visible on the opposite bore diameter of the fractured housing. The rest of the fracture indicated a ductile overload failure. The inner surface of the aluminum alloy strut housing arm displayed an uneven yellowish colour, which is characteristic of anodized aluminum. The colour became paler towards the opening of the arm, indicating some wear at the surface (see Photo 2). Ratchet marks and progression marks were also visible and are characteristic of fatigue cracks.

Optical microscopy confirmed some of the surface features identified during the visual inspection, such as beach marks and small fatigue cracks. After the degreasing of the parts, an obvious distinction remained between two sections of the main fatigue crack. The bore surface also displayed evidence of surface wear, and the surface colour changed from an anodized aluminum surface to almost bare metal (see Photo 2).

Examination of the fractured surfaces by visual, optical and SEM methods suggested that the failure of the strut housing in a single-cycle ductile overstress mode was preceded by progressive mode cracks. These cracks were fatigue cracks and the main larger crack led to the eventual failure of the nose landing gear. The main fatigue crack had two distinctive areas that grew in two stages over an unknown period of time. One area had clear fatigue striations with little oxidation and debris. The second area had severe oxidation, rubbing, and an integrated substance, and is considered to be the older of the two sections. The substance was identified as hardened bushing locking adhesive, with elements of carbon, oxygen, silicon, and sulphur.

The main fatigue crack in the housing displayed multiple initiation sites. There were also imperfections on the inner surface of the housing that could have contributed to the initiation of the crack. This could not be proven because the bore surface was worn and damaged. The multiple initiation fatigue crack origins possibly indicate more than one point of initiation for the fatigue crack. The origin of the initial crack could not be ascertained. It may have been induced during the machining process of the inner bore surface at manufacture, or possibly due to the condition of the tooling used in fabrication, or it could have been initiated by the introduction of foreign matter or debris.
