**AVIATION INVESTIGATION REPORT
A08P0035**

LOSS OF VISUAL REFERENCE / COLLISION WITH TERRAIN

**SEQUOIA HELICOPTERS LIMITED
BELL 212 (HELICOPTER) C-GERH
GOLDEN, BRITISH COLUMBIA, 9 nm W
07 FEBRUARY 2008**

Report Number A08P0035

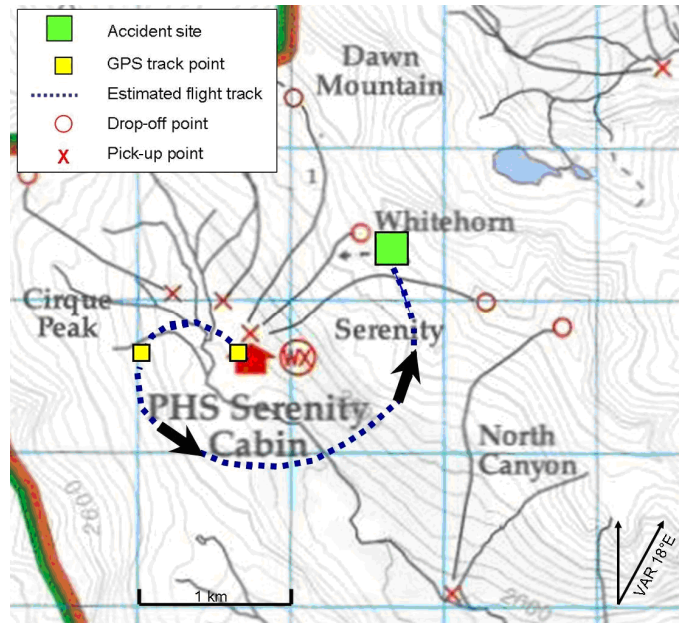
Figure 1. Helicopter flight path

The data indicate that the route flown on the accident flight (see Figure 1) was similar to the routes flown between Serenity Cabin and the Whitehorn drop-off site on three flights completed earlier in the day. All of the approaches to the landing area were made from the southeast, across the mountainside. However, the helicopter's rate of climb during the enroute part of the accident flight was greater than on previous flights and the approach to the drop-off site was flown at a slightly lower altitude. The last GPS data indicate that the helicopter had slowed to 30 knots (ground speed) when it was approximately 30 feet above and 900 feet southeast of the flagged site. On the previous flight to Whitehorn, the helicopter had slowed to 25 knots while approximately 95 feet above and 600 feet southeast of the flagged site.
